**Report 97-208**

**Ro-Ro general cargo vessel *Union Rotoma***

**engine room fire**

**3 December 1997**

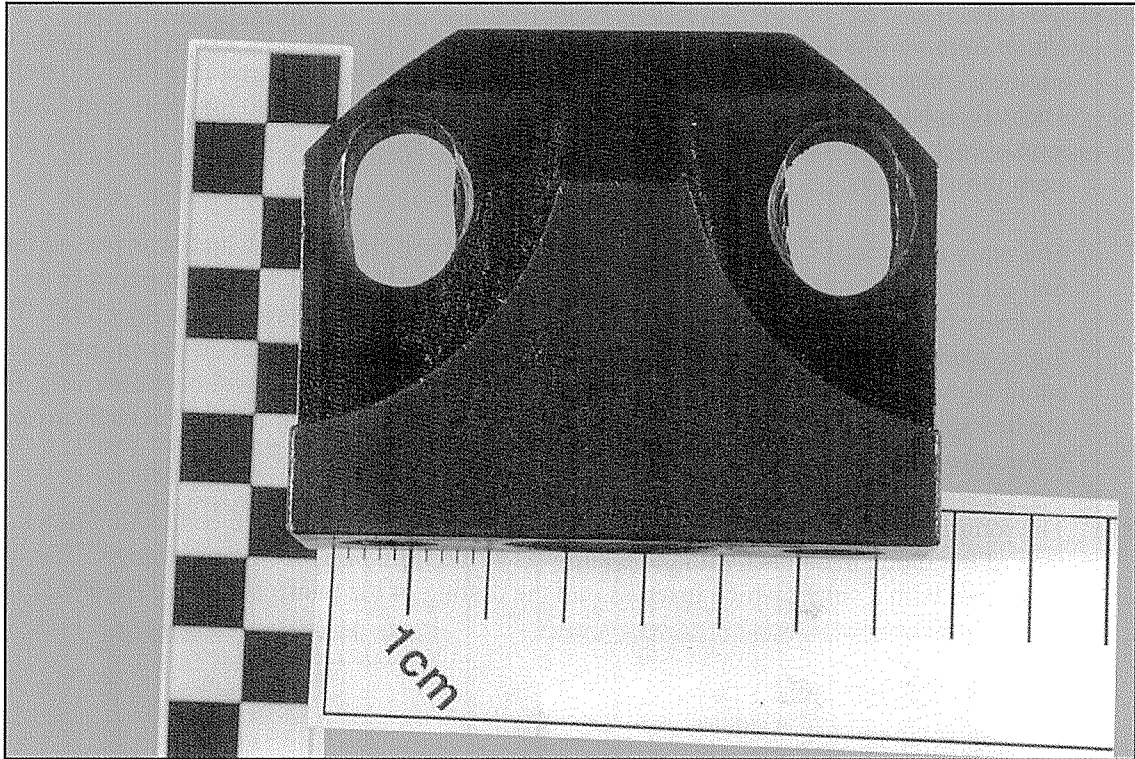
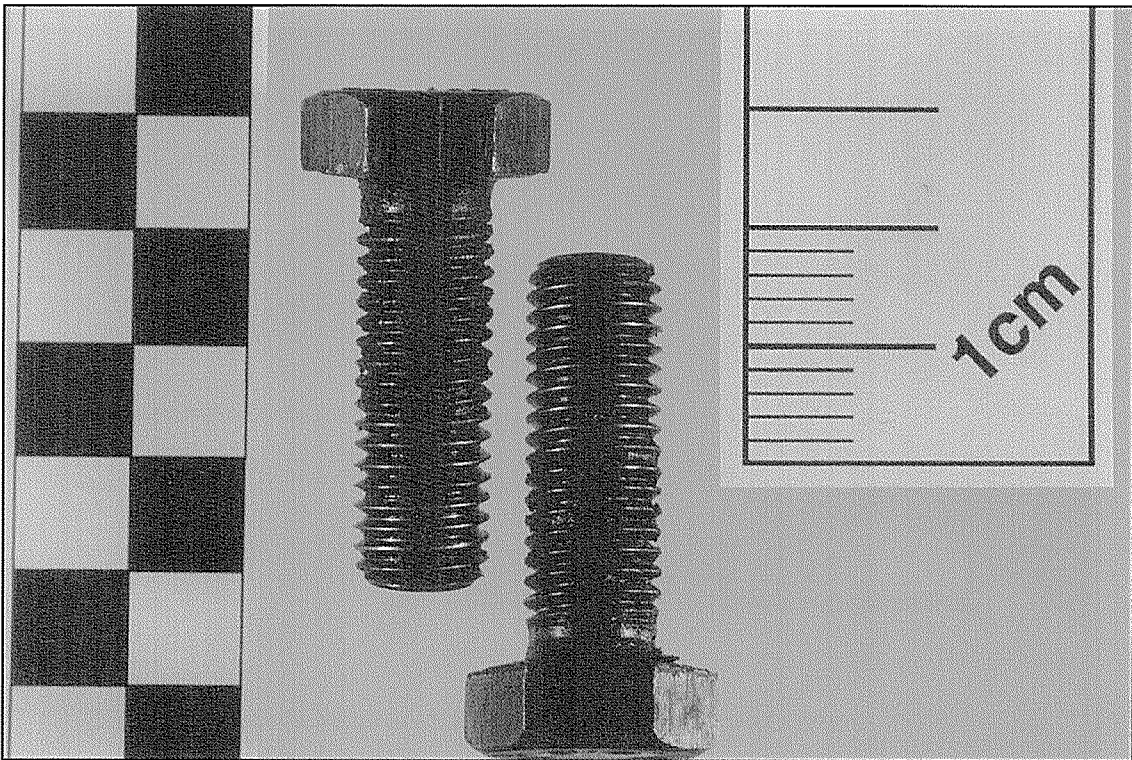
**Figure 3**  
**Photographs showing the return-fuel line connecting block and the two screws thought to have been securing it to the main body of number 9 fuel pump.**

- 1.3.1 After the fire, it was observed that the return-fuel line from number 9 fuel pump on the port main engine had separated from the pump body, the two screws intended to secure the flanged connecting block to the pump were missing. The pipe had sprung and the spigot on the connecting block had come part way out of the recess in the pump body, allowing a considerable flow of heated return fuel oil to escape at approximately 6 bar pressure. Evidently this escaping fuel oil was ignited by the hot surfaces of the turbocharger, close by the pump.

- 1.3.2 During the investigation, a number of set screws were found lying amongst debris on the top of the engine entablature alongside number 9 unit. Although others had the correct thread, only two were of the same length. These showed a relatively clean thread corresponding to the length of thread which would have screwed into the casting of the pump body. Therefore, these screws were probably the two which had secured the flange of the fuel return line to the body of the pump. The screws were undamaged (see Figure 3).

- 1.3.3 The flanged face of the connecting block had two oversize slots through which passed the two set screws, of 12 mm (nominal) diameter × 1.75 mm pitch, securing the flange to the pump. The slots averaged 13.8 mm in width and 21.8 mm in length, while the actual diameter of the set screws fitted was 11.8 mm. There was thus a clearance around the screws of 2.0 mm across the slot and 10.0 mm in the length of the slot. The hexagon heads of the set screws averaged 18.9 mm across the flats (21.5 mm across the corners). As a result, and as can be clearly seen in Figure 3, the underside of the head bore on a very small area on each side of the slot in the flange.

- 1.3.5 With such a small bearing surface on little more than the corners of the hexagon head, the edges of the slot were easily distorted, both when the screw was tightened on assembly, and by vibration. Examination of the 14 spare flanges, used prior to 1991, indicated that a dish-shaped indentation had been formed around the slots by the heads of the set screws. This would have led to a loss of the pre-load in the screws and facilitated their further loosening by vibration.

- 3.3 The connecting block on the fuel-return line became displaced when two set screws securing the flange to the fuel pump body vibrated out.
- 3.4 Poor joint design, combined with engine vibration, contributed to the loosening of the set screws.

- 4.1 Following the fire, substantial flat washers were fitted to each existing set screw to compensate for the lack of bearing surface in way of the oval slots in the connecting blocks. Additionally, each screw has been drilled and lock wired to prevent it loosening due to vibration.
- 4.2 Additional local shielding was fitted around each fuel pump, covering the low pressure pipe screws and the fuel pump low pressure pipe block bolts. The purpose of the shielding was to divert any fuel leakage, resulting from connection failure, away from the engine exhaust system.
- 4.3 The gas sampling equipment is now kept in the chief engineer's cabin, and must be signed out when in use, and signed in on return.
