## **Report 97-209**

**tug (*Sea-Tow 22*) and barge (*Sea-Tow 17*)**

**tow line parting and subsequent grounding of tug and barge**

**Greymouth Bar Harbour entrance**

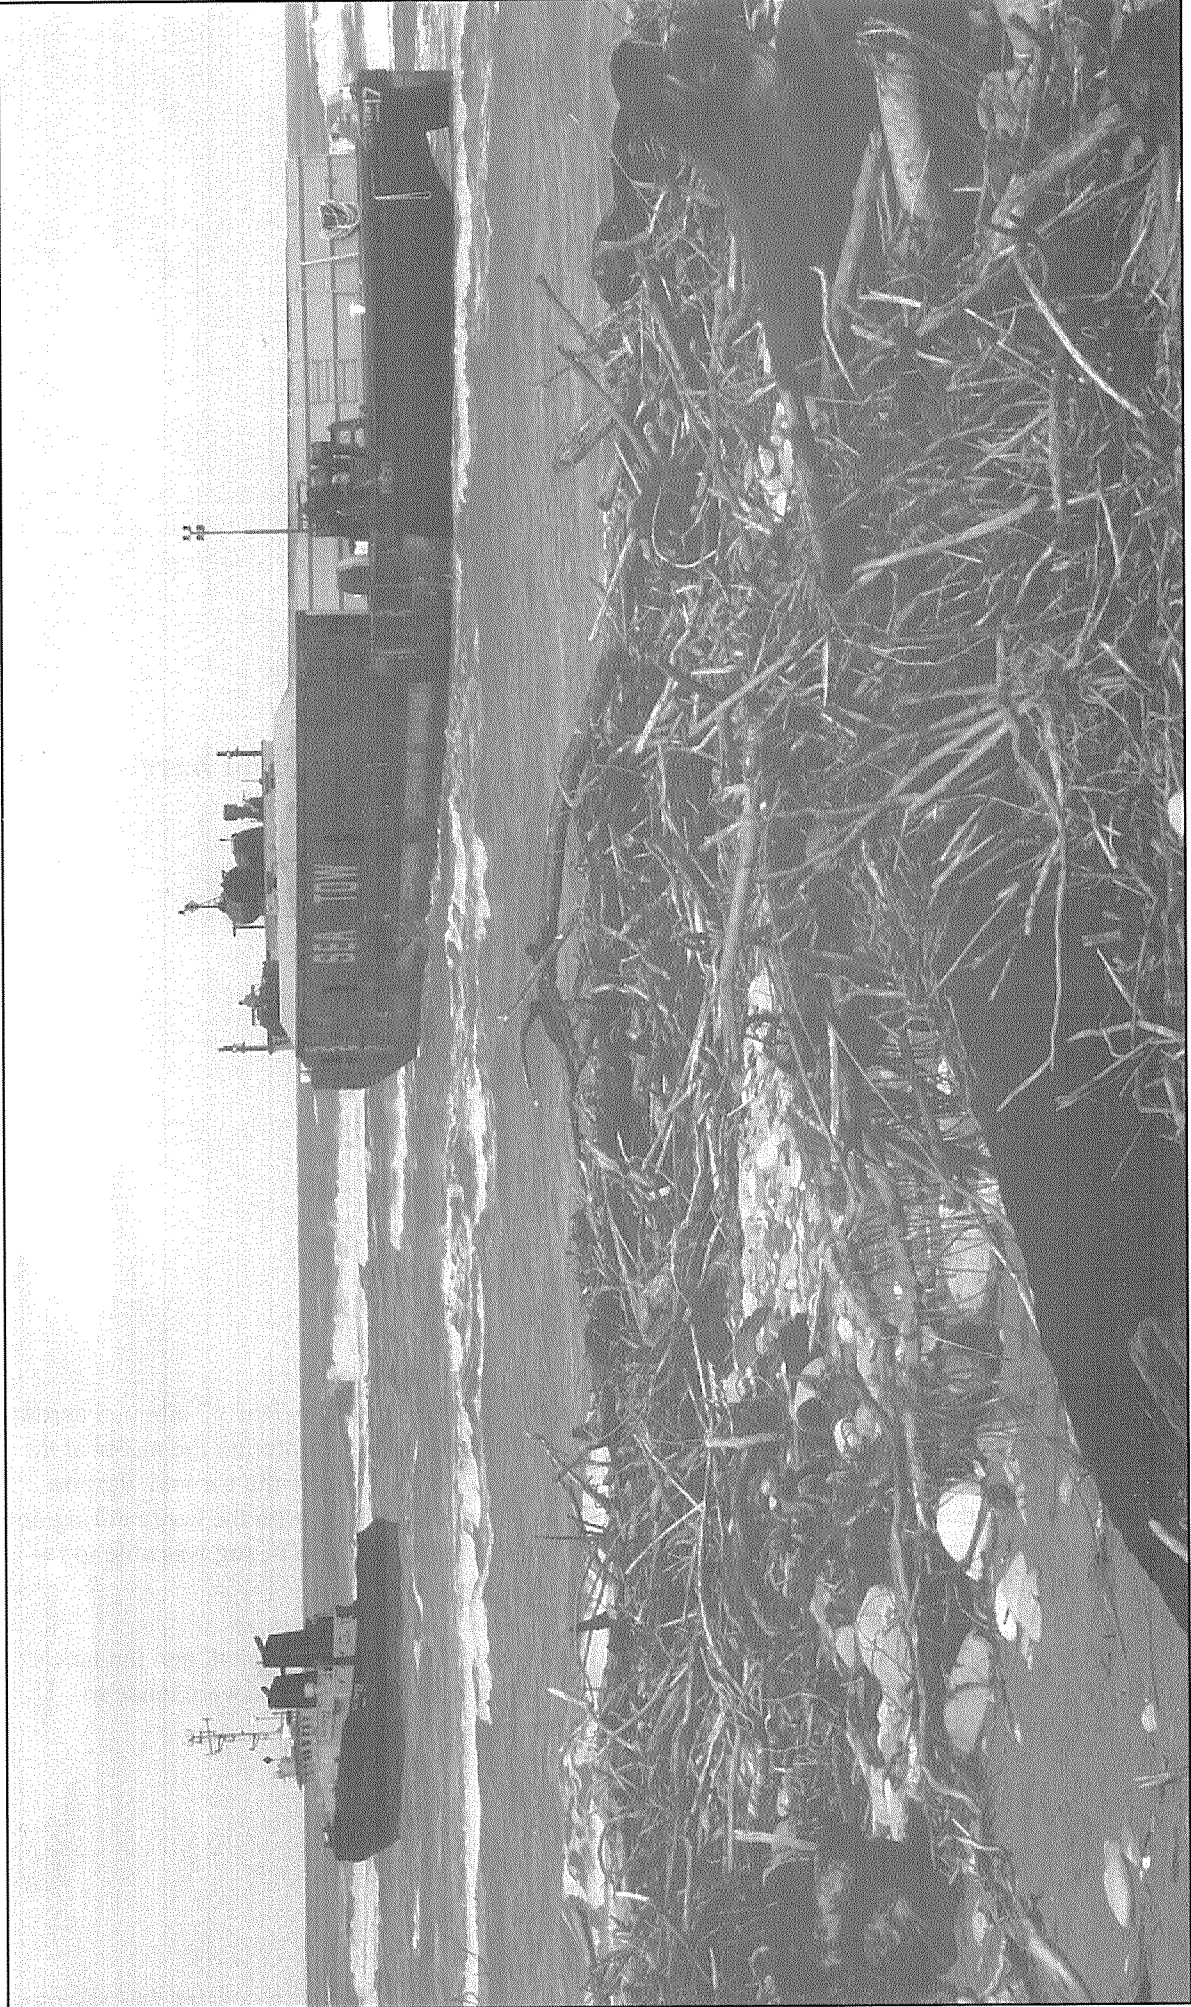
Tug *Sea-Tow 22* and barge *Sea-Tow 17* aground off Cobden Beach (photograph courtesy of the Christchurch Press)

Nature of damage:	Moderate damage to towing winch and shell plating	Moderate damage to shell plating

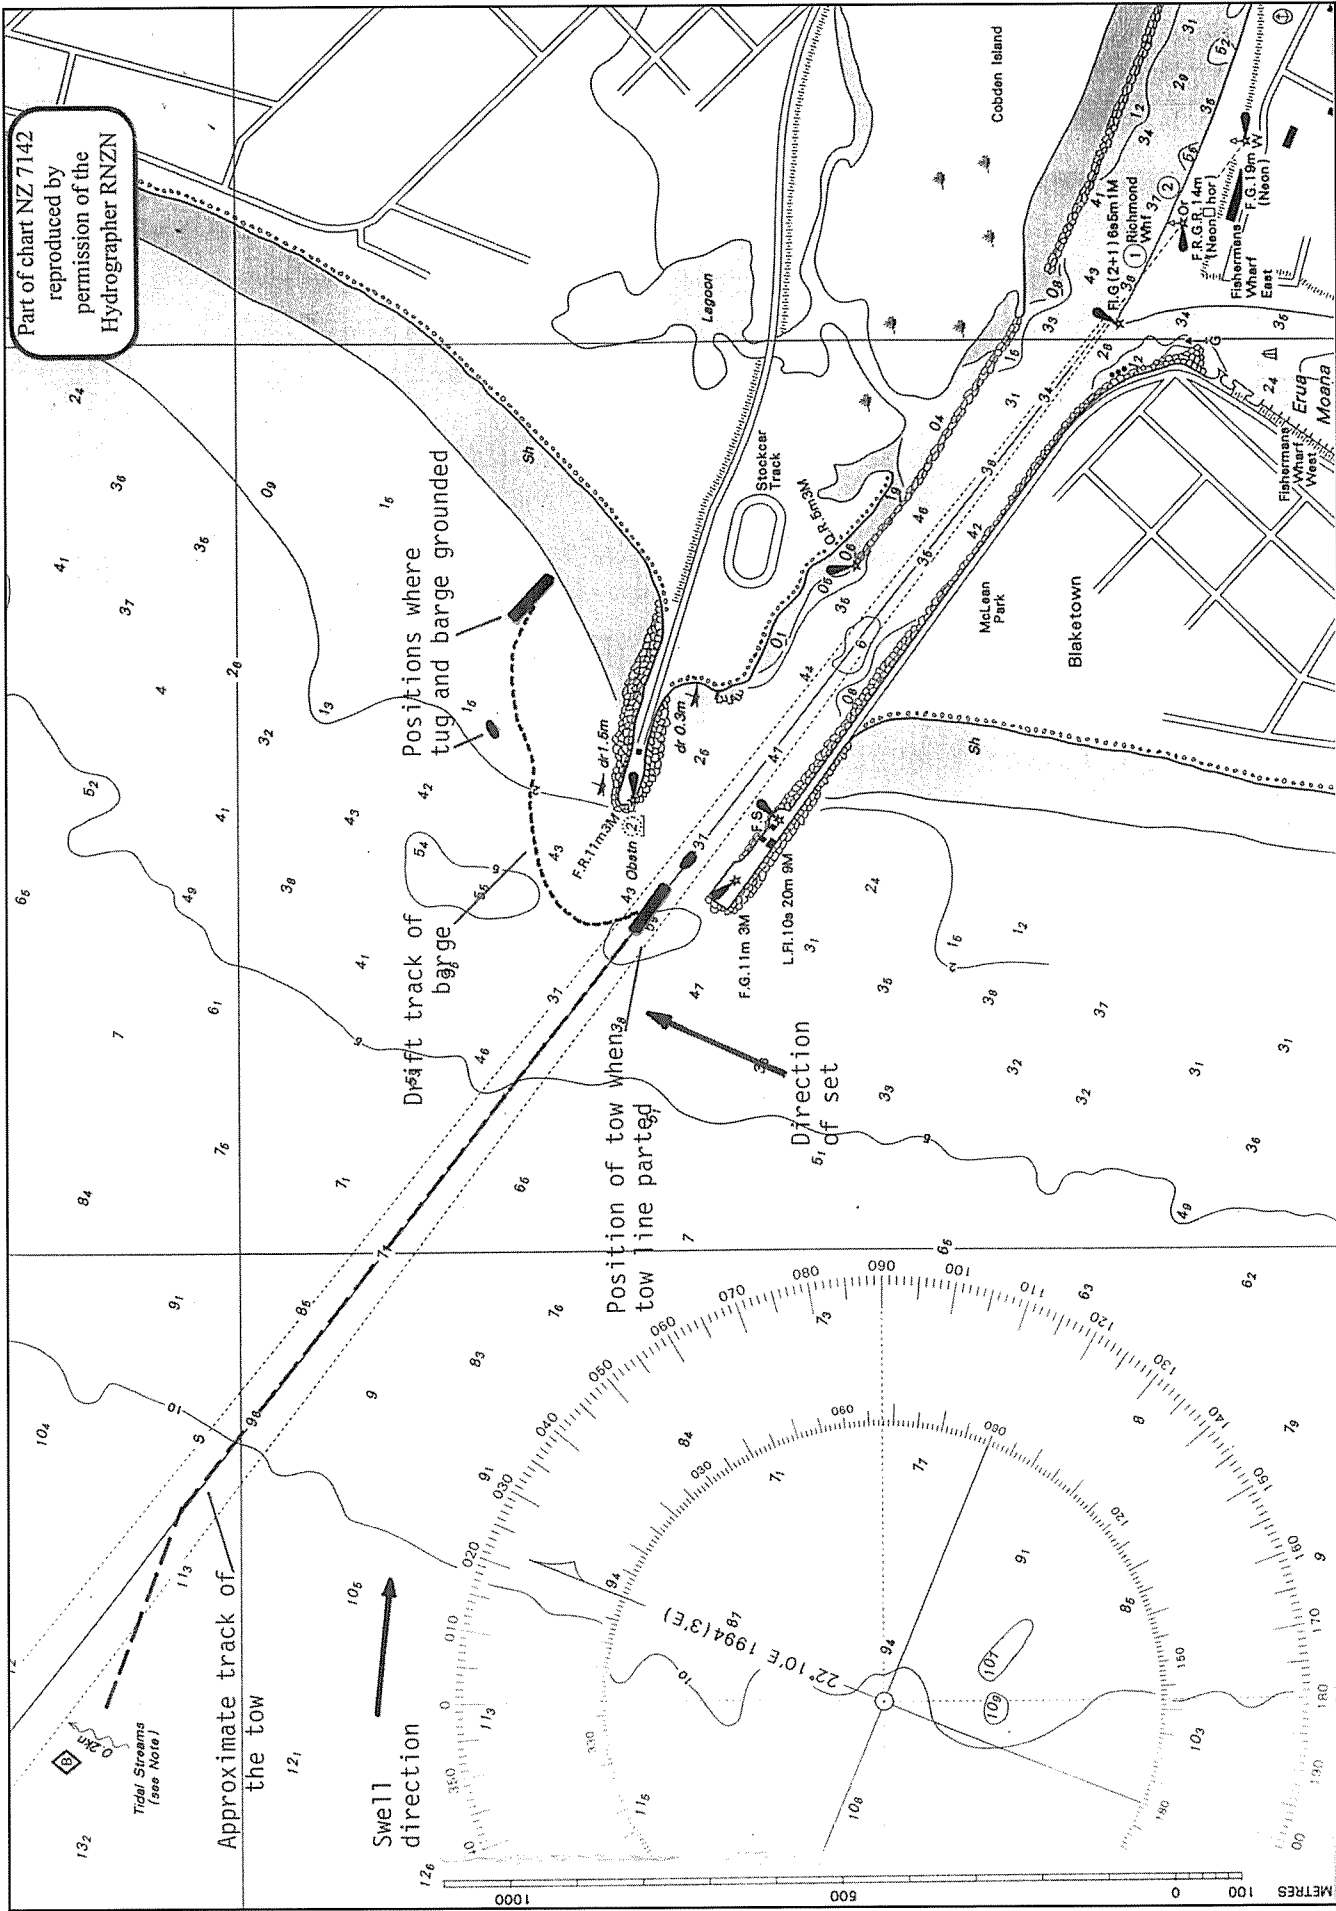
Figure 1  
Part of chart NZ 7142 showing key information (diagram broadly to scale)

- 1.1.18 The barge, having drifted out of the main river run, was being pushed by the surf into the shallows off Cobden Beach, just north of the north mole (see Figure 1). The harbour supervisor, realising that the barge was being pushed around the north mole, left the south mole to drive through town, across the bridge and out on to the north mole.

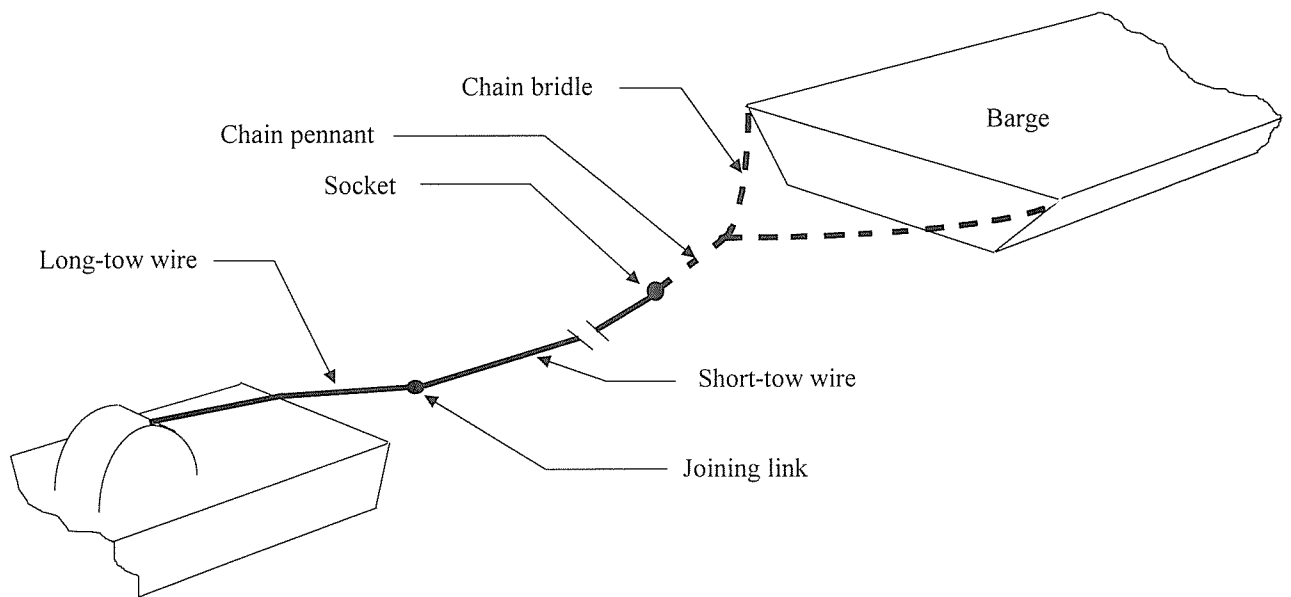
**Figure 2**  
**Typical Sea-Tow towing arrangement**  
**(Diagram not to scale)**

- 1.3.3 The tow line consisted of two 48 mm diameter, 6 x 36 strand, galvanised steel wire ropes (short tow and long tow). The short and long tow wires were joined in one length, using a joining link, and laid onto a single-drum, low pressure hydraulic tow winch. The tow wires had a specified normal breaking strain of 148 t. The short tow and long tow were about 240 m and 510 m long respectively, giving a total tow length of about 750 m. One end of the short tow wire was set into an eye-and-socket fixture, to which the barge chain pennant was attached, and the other end of the long tow wire was made fast to the winch. (See Figure 2)

- 1.3.7 The towing arrangement at the bow of the barge (see Figure 2) comprised three chain pennants: one from each shoulder of the barge coming together to a single attachment, forming the bridle, and the third from the bridle to the socket on the end of the tug tow line. The third chain pennant was 36.5 m long, and together with the bridle, if stretched tight, would range about 54 m ahead of the barge.

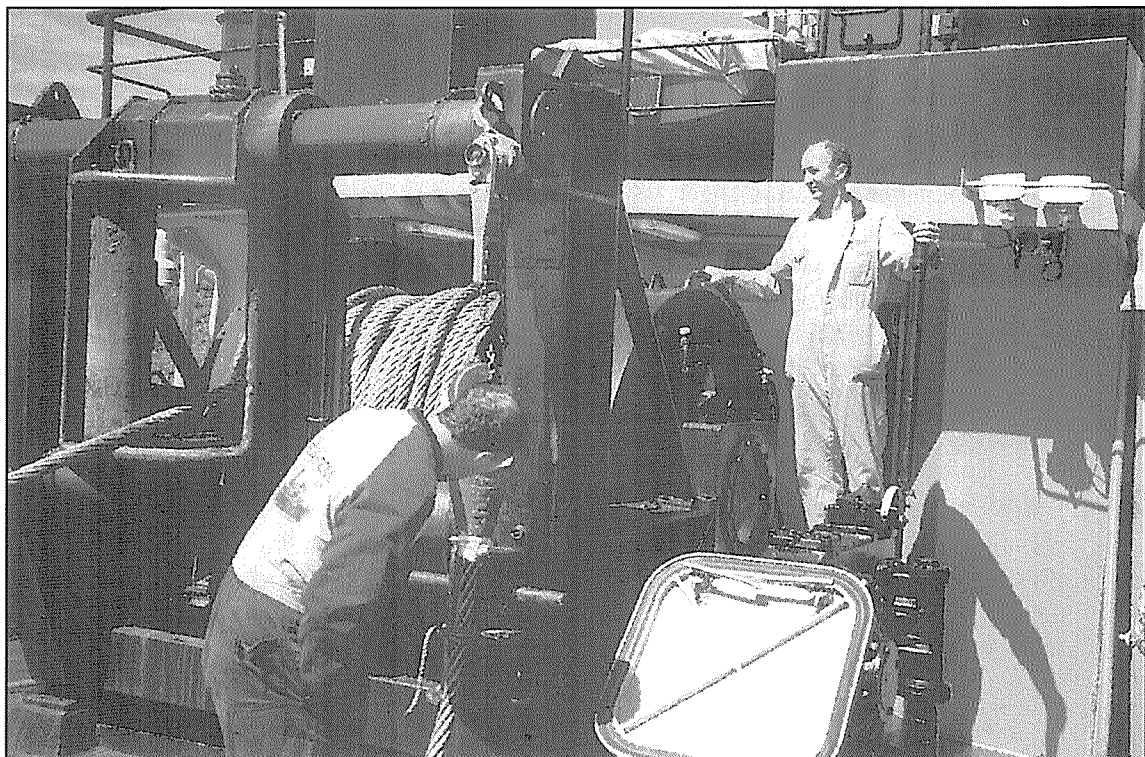
**Figure 3**  
**Photograph showing the position of the winch operator**

- 1.4.3 When crossing the bar, the chief engineer operated the tow winch. The winch was always left in gear and with the manual brake off. The chief engineer's role was to supplement the shock absorbing characteristic of the catenary in the tow line by: paying the wire out if it became taut, and winching it in if the wire became slack; but keeping the over-all length of the tow the same.

- 2.3.5 Over the years, various methods to improve communications between the winch operator and the skipper had been tried, but were generally unsuccessful due to the winch operator requiring both hands for his task: one to hold on and the other to operate the winch. Radio and intercom communications were found to be unreliable due to water ingress.

- 3.7 The chief engineer focusing on playing the tow wire in the marginal conditions, his limited over-all view of the tow line and barge, and poor communications between him and the skipper resulted in the tow line becoming too short.

- 4.3 It was recommended to the Chief Executive of Sea-Tow Limited that Sea-Tow Limited:
- 4.3.1 Liaise with the appropriate sea staff and document recommended procedures for deep-sea and harbour towing, including guide lines for entering and leaving bar harbours (003/98); and
  - 4.3.2 Continue to implement good crew resource management on all of their tugs (004/98); and
  - 4.3.3 Clarify and reinforce the procedure whereby all barges must be manned when in or approaching confined waters. As these procedures will vary between ports, consultation with the relevant port authorities should be undertaken (005/98); and
  - 4.3.4 Install remote control for the towing winches on their tugs in a location where the winch operator can effectively communicate with the skipper, and can work in relative safety with a good view of the tow line (006/98); and
