Report 98-001

Cessna 172P

ZK-EWH

collision with terrain

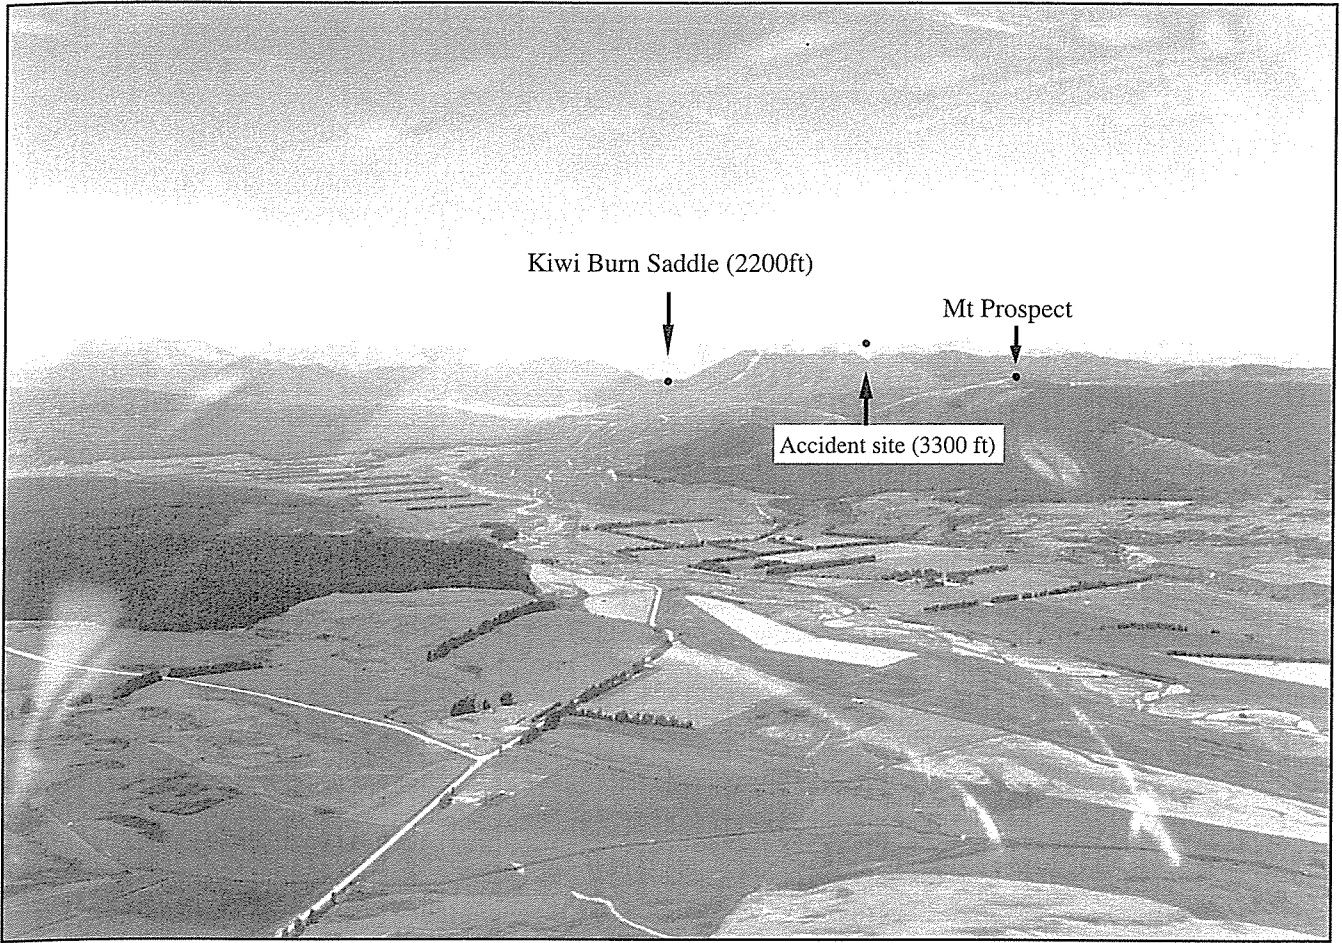
View to north-east showing Whitestone River in foreground

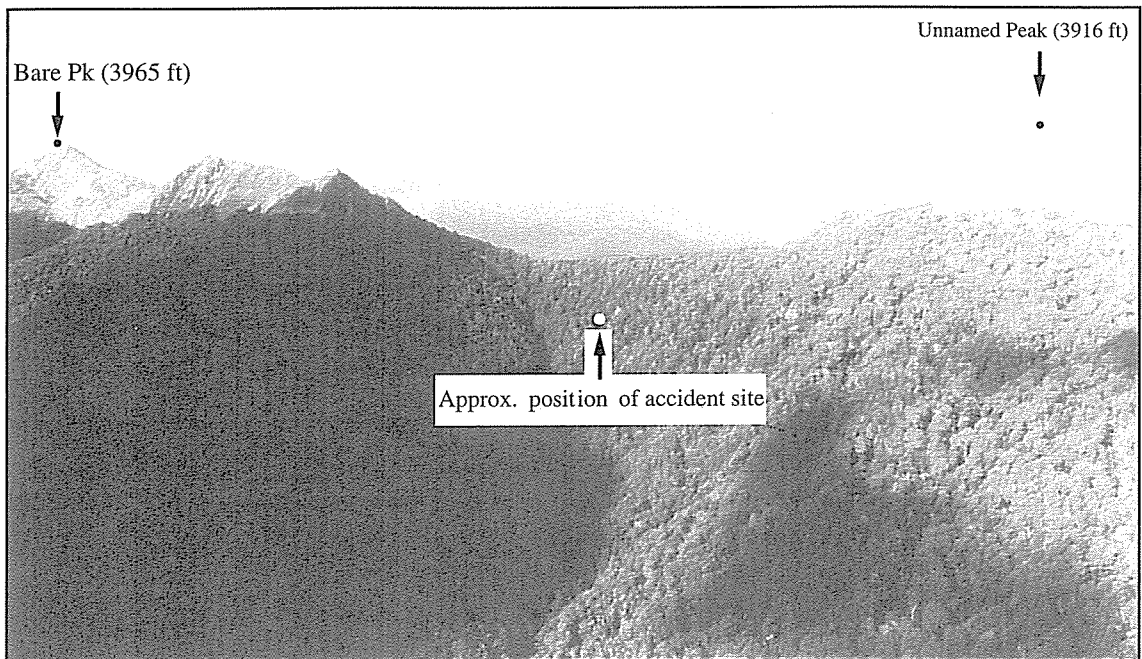
**Figure 2
Accident area**

Close-up of accident site

- 1.12.2 The wreckage of ZK-EWH was not readily visible as the aircraft was lying at the base of closely spaced beech trees some 50 to 60 feet high, growing on a 45° to 50° slope. A narrow entry swath, with damage to the forest canopy confined to a width probably less than half the wingspan, suggested that the aircraft was banked steeply to the right when initial tree contact occurred.

- 1.12.3 ZK-EWH had come to rest rolled onto its right side on a heading of 110° M. Impact forces had almost completely severed the right wing and strut from the aircraft. The left wing and strut remained attached to the primary structure but the wing was slewed forward. Both wing leading edges had sustained severe compressive damage as a result of the descent of the aircraft through the forest growth. The propeller and engine were semi-buried in the forest floor.
