**Report 98-005**

**Aerospatiale AS350D**

**in-flight engine failure**

**19 April 1998**

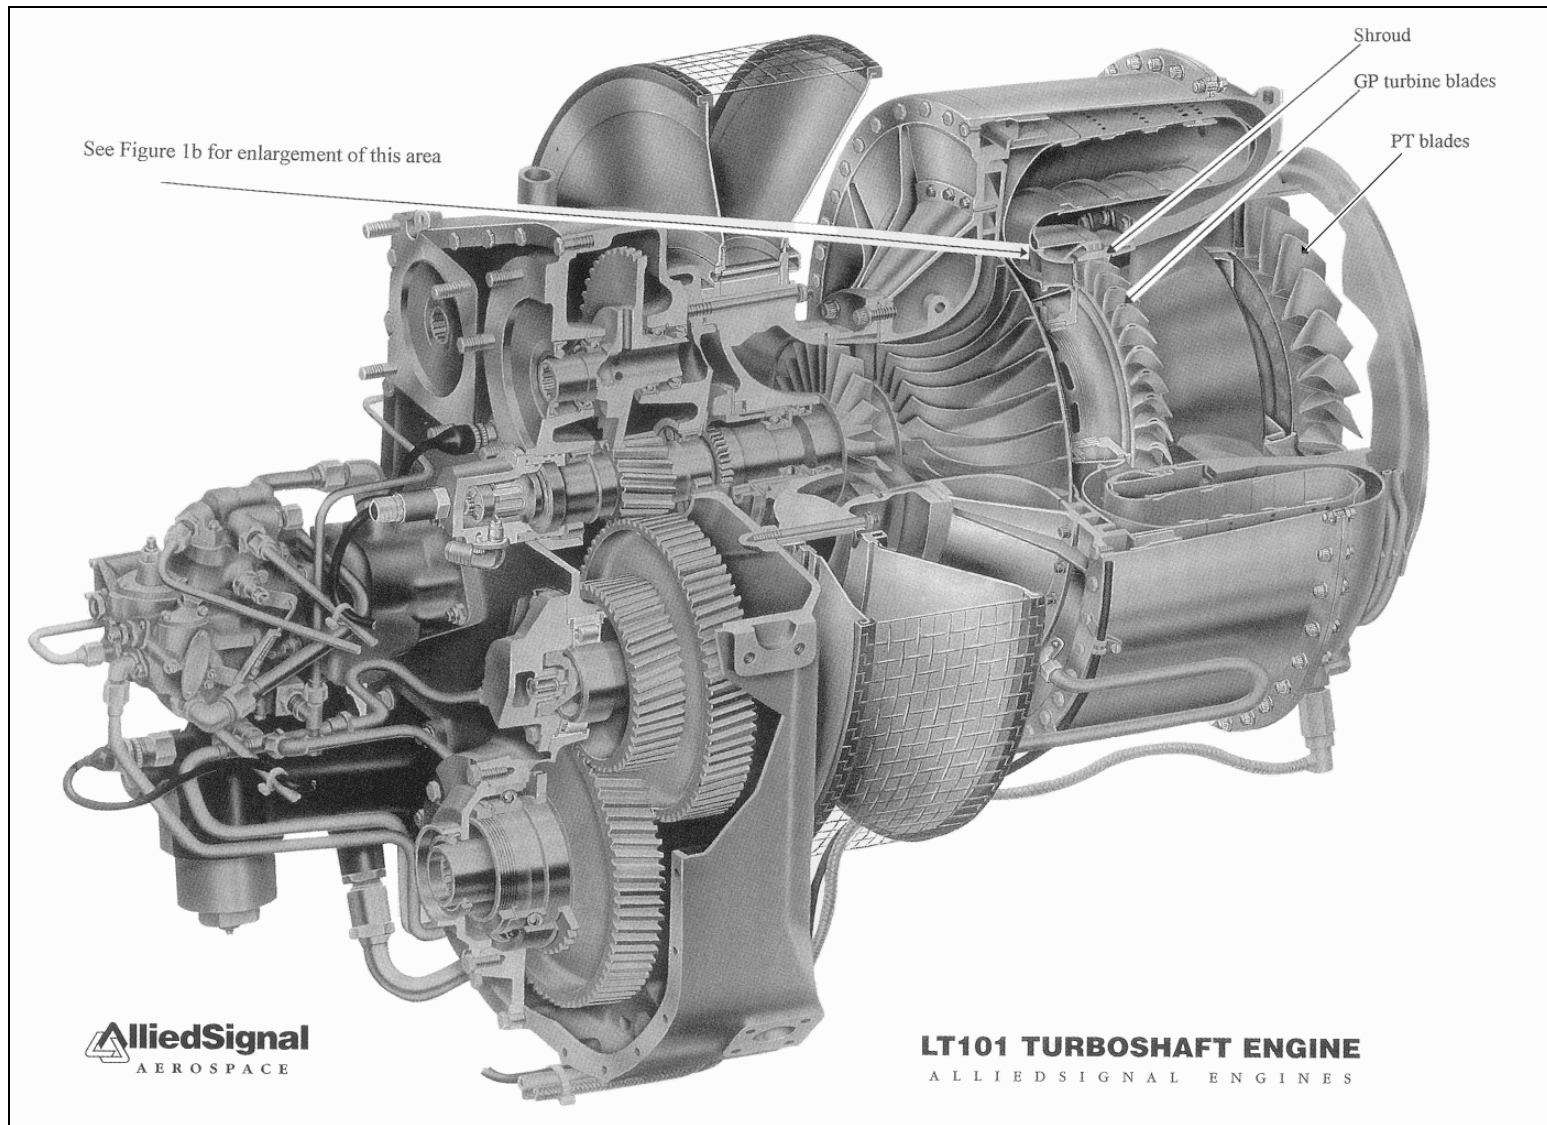
**Figure 1a**  
**LTS 101 engine**

- 1.54 During normal operation of the engine the GP turbine blades rotated inside the GP turbine rotor shroud with minimal clearance or light rubbing between the blade tips and the inner diameter of the shroud (see Figures 1a and 1b).

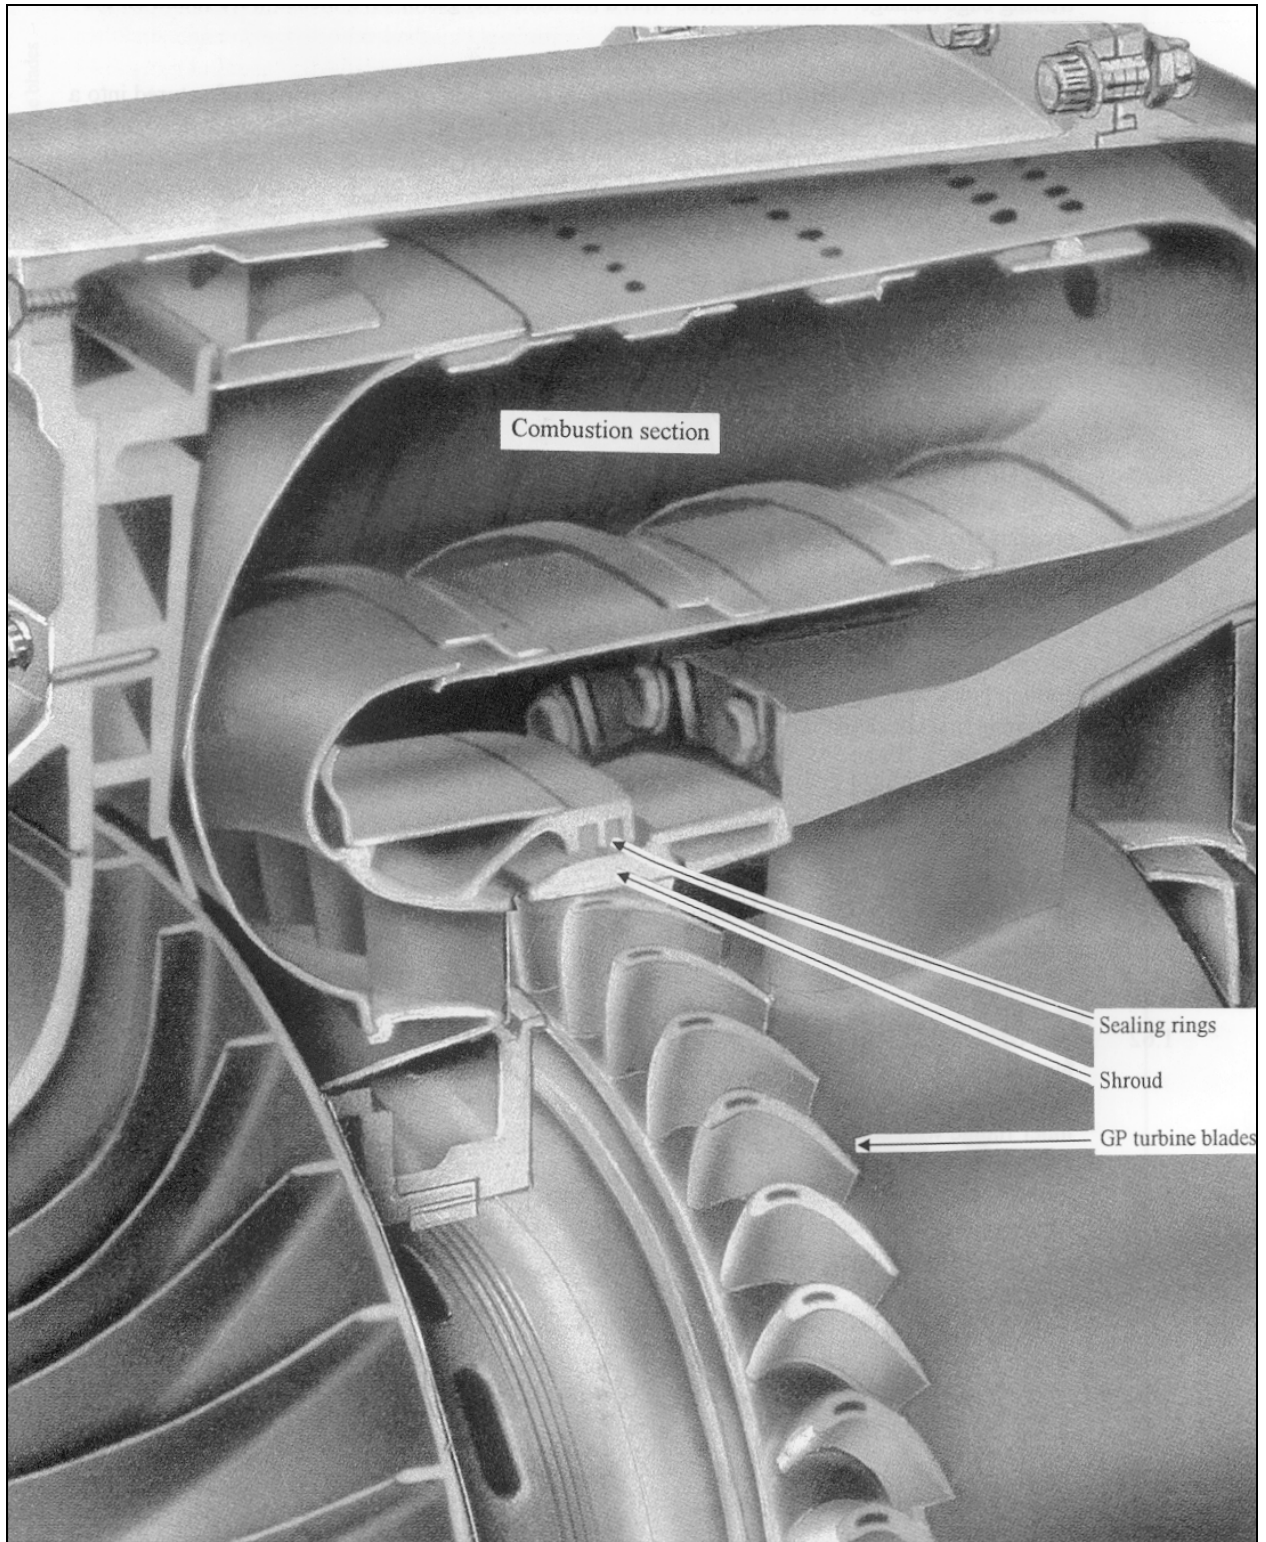
**Figure 1b**  
**LT101 sectional enlargement**

- 1.58 Fitted around the outside diameter of the GP turbine rotor shroud were two shroud sealing rings. The sealing rings were designed to fit firmly around the shroud to prevent excessive leakage of compressed air from around the outside of the combustion chamber past the shroud to the GP turbine blades. During normal operation of the engine the sealing rings rub against the shroud and eventually wear (see figure 1b).

- 1.59 Both GP shroud sealing rings, although intact, were worn excessively. The wear was more than 0.060 inches in diameter in excess of the maximum wear allowed by the manufacturer. Material analysis showed that the material and its hardness were to the correct specification and that the wear was characteristic of erosion over time. No sulphidation was observed on the sealing rings.

- excessive leakage of air over the GP turbine rotor shroud to the GP turbine blades, due to the badly worn shroud sealing rings, resulted in contraction of the GP shroud and reduced GP turbine blade tip clearance and increased turbine temperature,
