Report 98-008

Cessna 402C

ZK-VAC

double engine failure and ditching

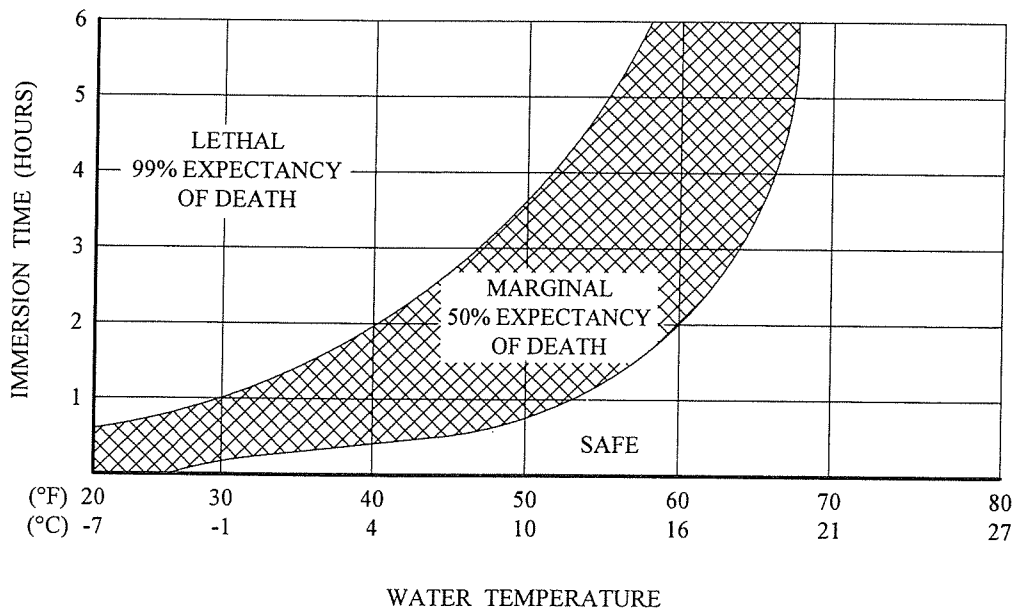
Figure 1
Life expectancy of uninjured survivors immersed in seawater at various temperatures

- 1.15.6 Expert medical opinion was that swimming and efforts to stay afloat would have become impossible for immersed swimmers without lifejackets in approximately 15 minutes, given the sea state and temperature of 9°C. Survival for longer than this period would have required the use of a lifejacket. With lifejackets, and with the quite light clothing worn by most passengers, hypothermia would have presented an increasing risk to survival after approximately 40 minutes. (See Figure 1).

This graph is derived from mathematical models of body cooling, and shows the time for body core temperature to fall below 34°C, which represents moderate hypothermia.
