Report 98-103

Train 1603

collision with transition head

Rail Incident Report 98-103

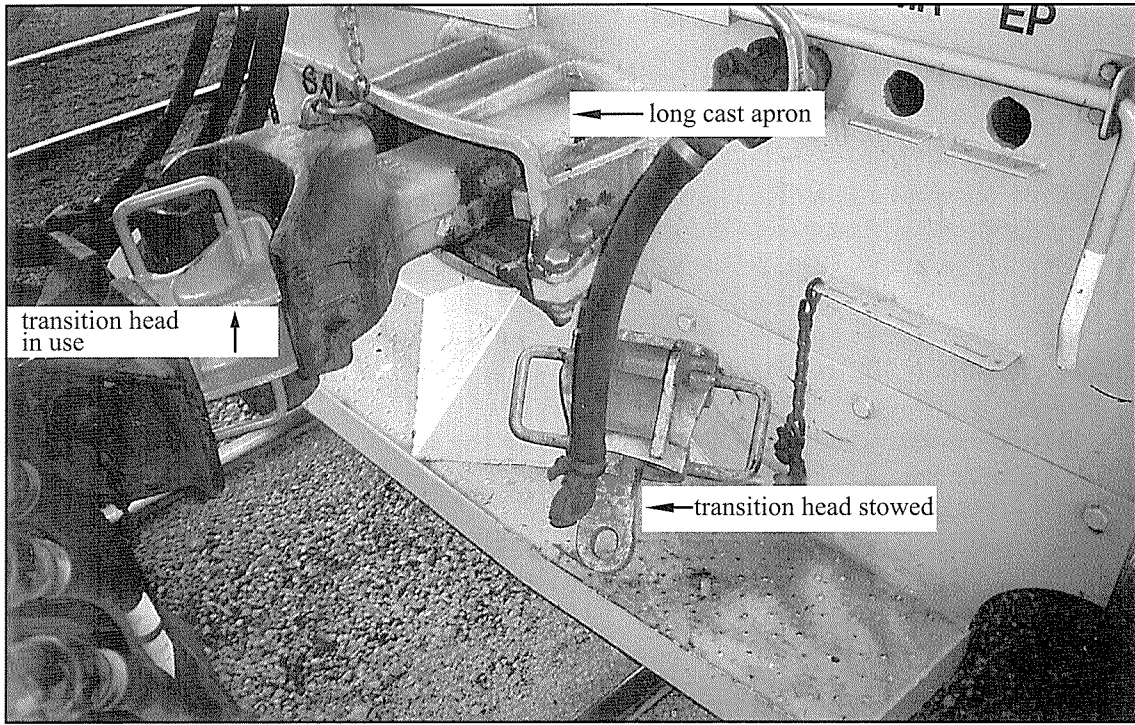
Figure 1

A transition head in use between “Alliance” couplers (right) and hook couplers (left).

Note the long cast apron on this locomotive (QR2027). Photograph taken 12 March 1998. Spigots had not been repositioned following the incident (cf. Figure 2) as they allowed a transition head to be stowed as intended. Field staff had not installed the spigots to the original plan, presumably to overcome the design deficiency.

- a short cast apron on which the stowage plans were based (Figure 3)
- a long cast apron as fitted to DQ6324 (Figure 1)
- a long fabricated apron as fitted to DQ6367.

- those fitted with spigots, installed to the plans, which did not allow correct stowage of a transition head (this category included DQ6324, the trailing locomotive in the incident), or
- those fitted with spigots, installed to the position shown on the plans but shortened from 125 mm to 70 mm (this category included DQ6347, the leading locomotive in the incident), or
- those fitted with correct length spigots installed further forward on the locomotive than shown on the plan to enable the transition head to be stowed in the manner intended.

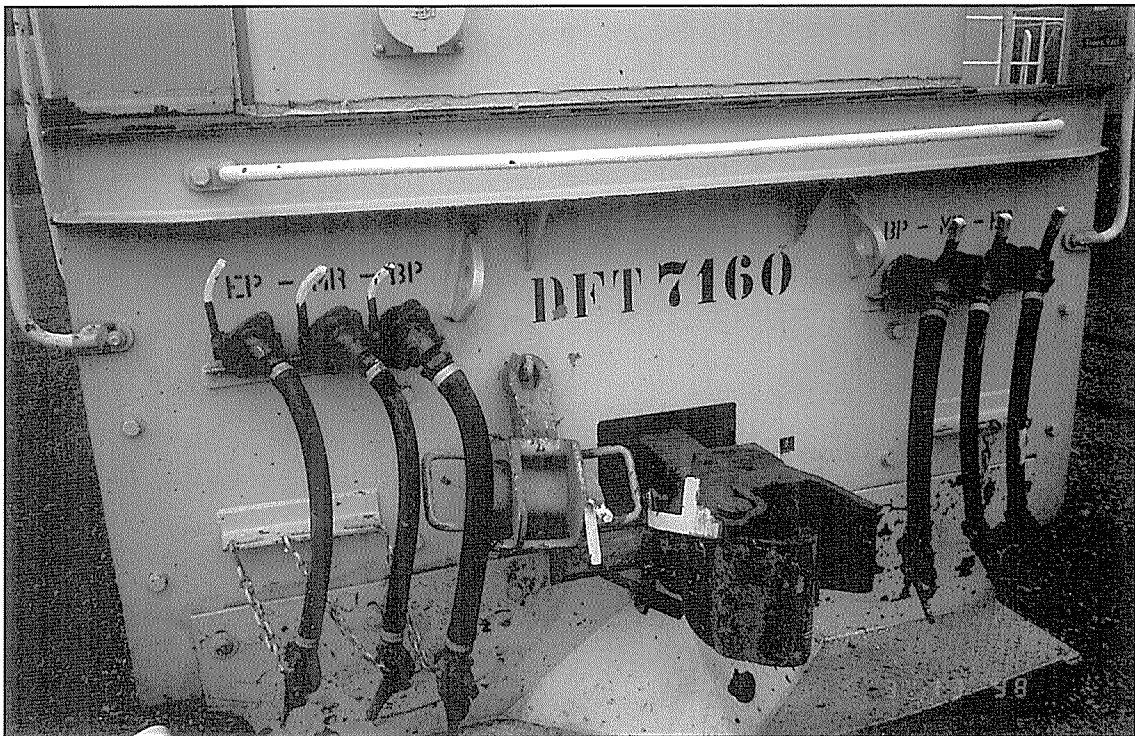
A stowed transition head on a Tranz Rail DFT locomotive

- 1.2.7 Transition heads on Tranz Rail locomotives have generally been stowed on a hook at a relatively low level because of their weight. Figure 2 shows a typical detail for a DFT locomotive. The drawbar apron and other equipment at low level on DQs and QR¹s precluded this solution and gave rise to the spigot detail for these locomotives. The two 25 mm diameter spigots were welded to the central portion of the cowcatcher (Figure 3). The transition head was intended to be stowed by placing it on the spigots, using two locating holes, with the opposite end supported on the level area of the cowcatcher, as shown in Figure 1.

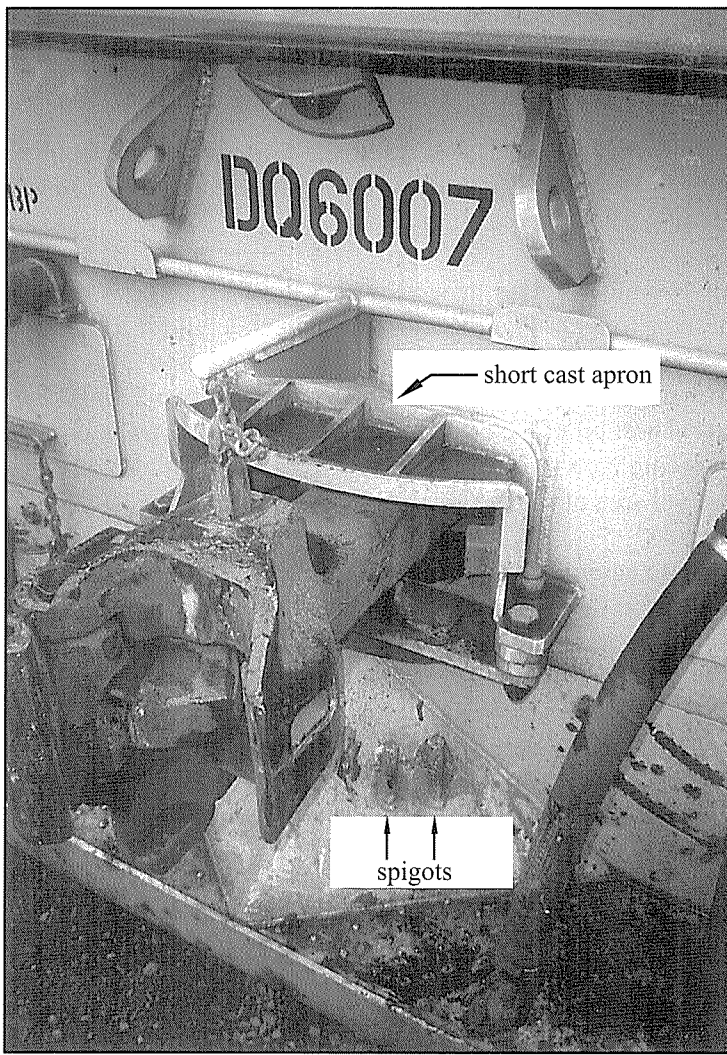
Figure 3
 A typical short cast apron locomotive. Photograph taken on 12 March 1998. Spigots, originally installed to plan, have not been repositioned as the clearance available allowed a transition head to be correctly stowed.

1.5.3 The first locomotive had a short drawbar apron similar to that shown in Figure 3 and the staff member who prepared the plans stated that he was not advised of any physical differences in the drawbar apron detail of the locomotives which were to follow the one on which he based the design.

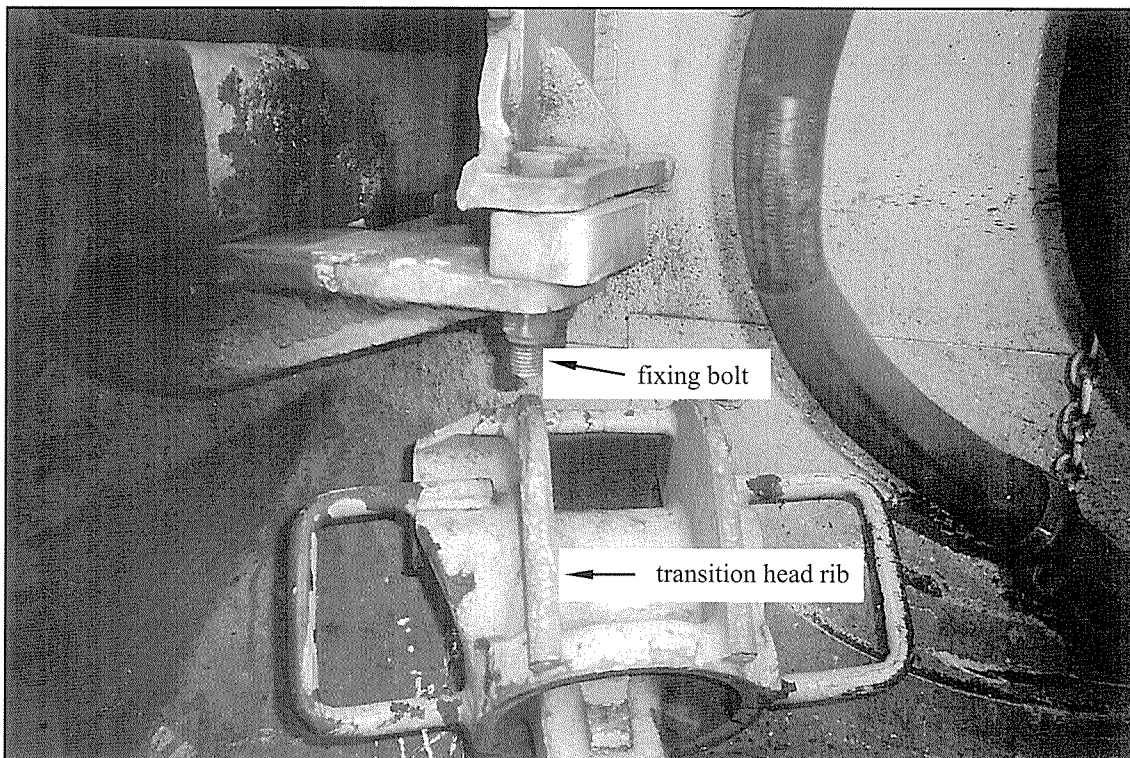
Figure 4
 DQ6347 showing a transition head stowed on the short spigots on this locomotive. When placing or removing the transition head interference could occur between the protruding fixing bolt and the transition head rib

As part of the conversion program the bottom support of the apron was lowered when necessary to drop the drawgear to the correct height for Tranz Rail operations. This required removal of the fixing bolts. Some of these fixing bolts protruded further than others when replaced and adversely affected the removal/placement of the transition head for both short and long apron configurations, but particularly the latter. (Figure 4)

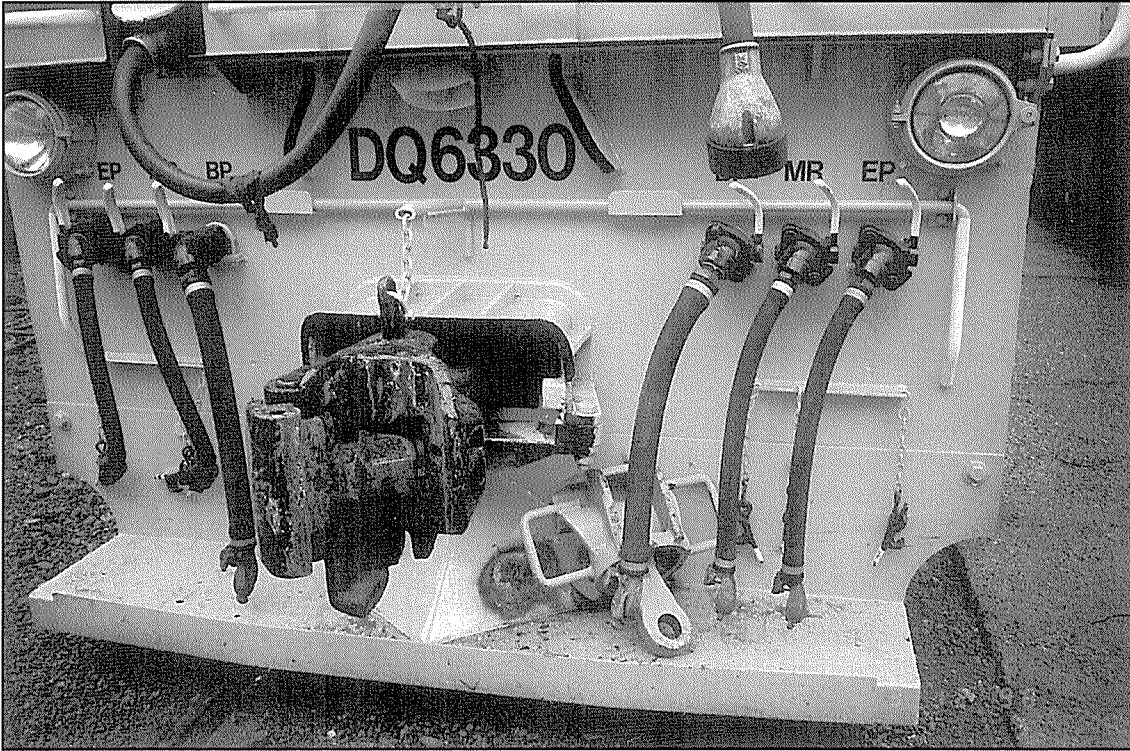
A correctly stowed transition head on a locomotive with a long cast apron. Photograph taken on 12 March 1998. The original position of the spigots prior to repositioning on 10 March 1998 can be clearly seen by the gas cut evidence

- 2.2.3 The original securing detail had the potential for the dynamic effect of train motion to dislodge the transition head as a major portion of its weight was supported away from the spigots. The post-incident resiting of the spigots further down the cowcatcher may have decreased the safety factor of the original securing detail.

- 1.5.10 On 10 March 1998, the day after the incident, Tranz Rail commenced resiting of spigots on all QR and DQ locomotives which did not permit correct stowage of transition heads. Figure 5 shows the result of one such modification.

- 4.1 Tranz Rail took immediate interim action following the incident to relocate spigots on all commissioned locomotives as necessary to permit correct stowage of transition heads.
- 4.2 Following the incident Tranz Rail issued procedures regarding the correct manner of stowing transition heads on QR and DQ locomotives.

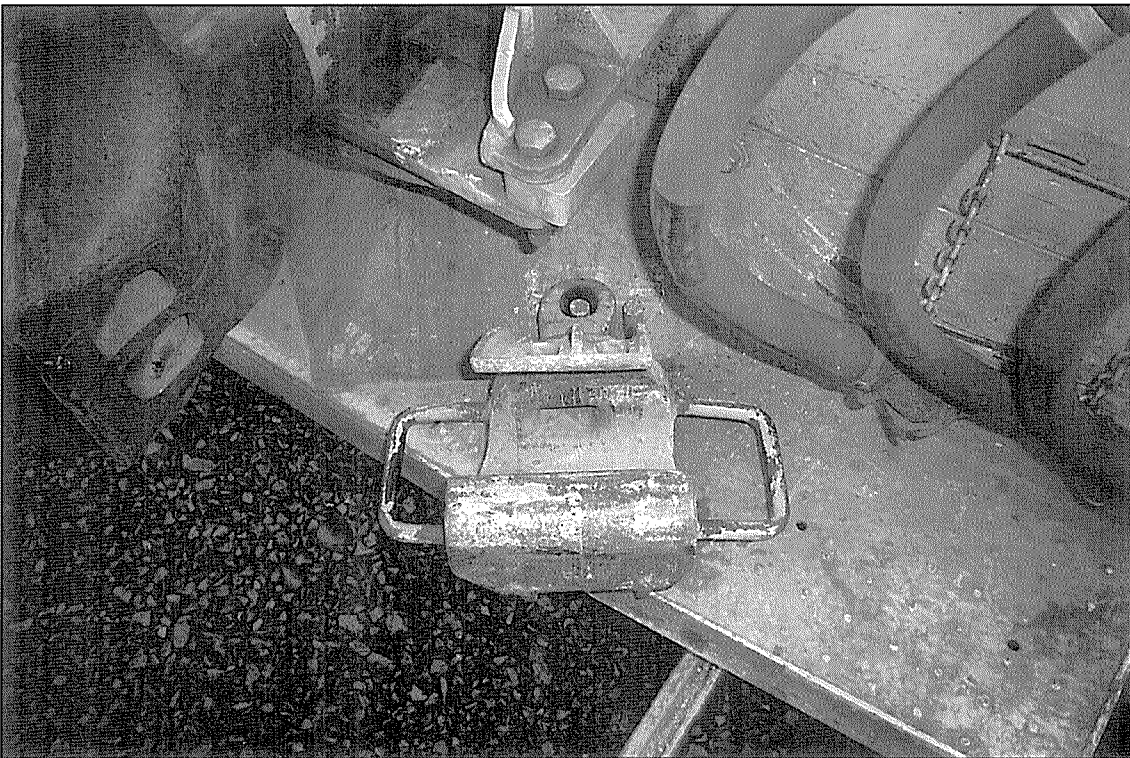
Figure 6

DQ6347 showing a transition head stowed with the coupling hole over one short spigot. This is the likely stowed position on the day of the incident

- 2.2.1 Late notification of the incident meant it was not possible to establish with certainty where the transition head which fell was stowed. Reports indicated that both of the coupled long-hood ends carried transition heads which were incorrectly stowed on one spigot only. It is more likely that the dynamic effect of the train's motion dislodged a transition head from the short (70 mm) spigot on the trailing end of DQ6347 than from the correct length (125 mm) spigot which was on the leading end of DQ6324. This was supported by the damage to the leading cowcatcher lip on DQ6324 which was more consistent with the transition head falling from DQ6347.

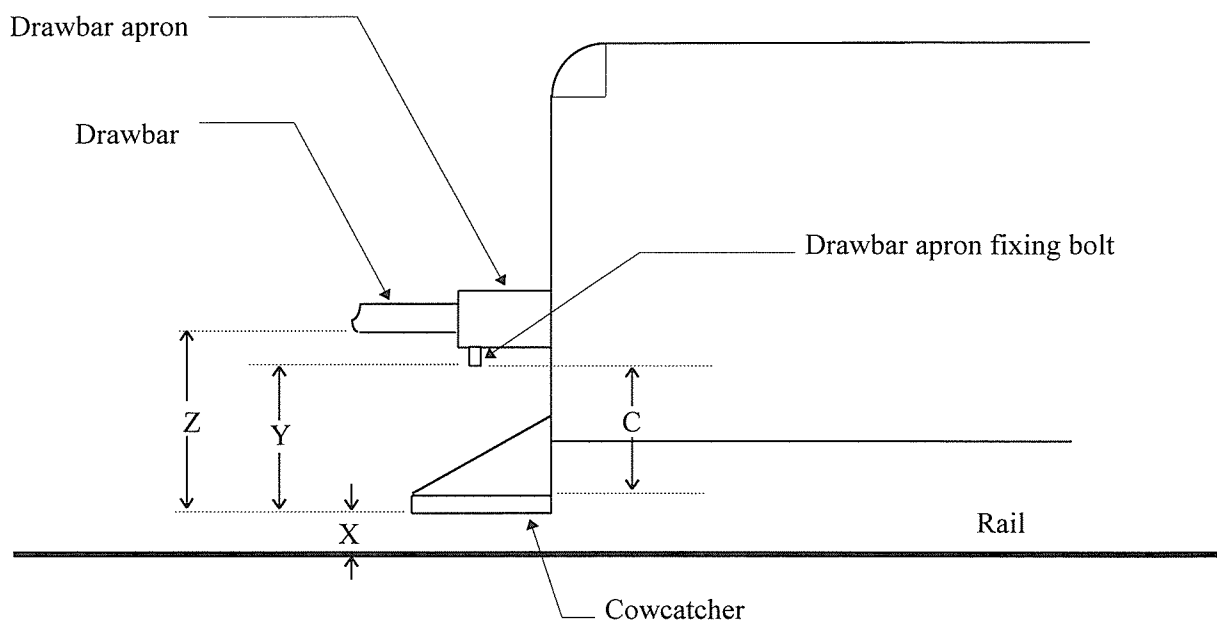
Figure 7
Vertical clearance in stowage area

- 1.5.14 Field tests carried out by the Investigator-in-Charge following the incident confirmed it was not possible to stow a transition head as intended on DQ6324. Although it was possible to stow a transition head as intended on the two short spigots on the long-hood end of DQ6347 an interference fit was also possible and stowage became a trial and error process.
- 1.5.15 Following the incident a series of measurements were taken on DQ6347 and DQ6342 to quantify the vertical clearance in the stowage areas of these two locomotives with the results shown in Table 1. Figure 7 shows the source of the measurements taken.

X Rail level to underside of cowcatcher	Y (to underside of bolt)	Z (to drawbar bearing height)	C Vertical clearance in stowage area
DQ6347				
Long-hood end	105 mm	475 mm	550 mm	375 mm
Cab end	150 mm	500 mm <td 560 mm	400 mm	
DQ6324				
Long-hood end	90 mm	510 mm	560 mm	415 mm
Cab-end	85 mm	495 mm	565 mm	395 mm

- 1.5.16 The specific height at which a cowcatcher was installed within the code range on any particular Queensland locomotive during conversion depended on its wheel wear and suspension details at the time, and is the reason for the 15 mm range in the Z dimension. Variations in bolt length accounts for the 35 mm range in dimension Y. The combination of these factors give a 40 mm variation in the vertical clearance C in the transition stowage areas of these two locomotives.
