Report 98-104

Train 928

derailment

near Purakanui

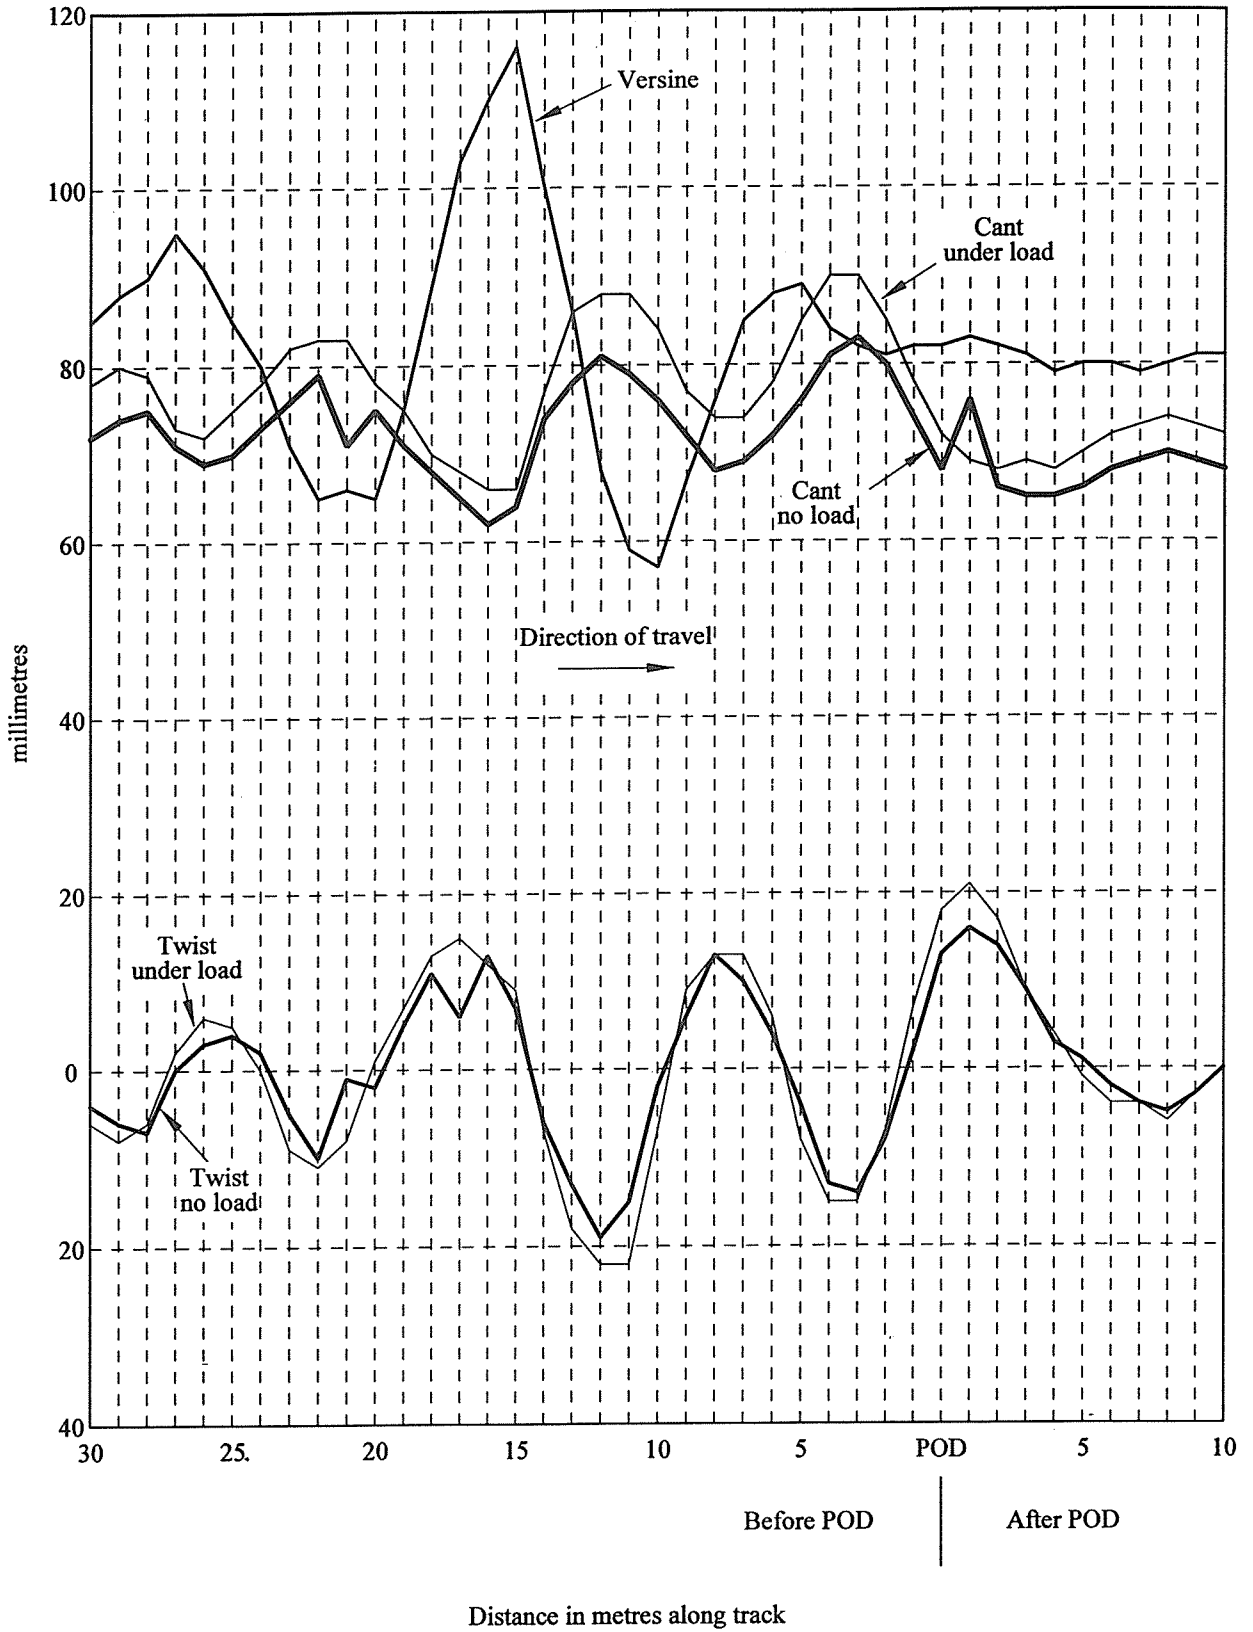
Figure 1
Track measurements taken following the derailment

- 1.4.5.4 The track measurements taken after the derailment recorded a maximum twist of 19 mm at 12 m before the derailment.
- 1.4.5.5 With the track remeasured under live load so that all voiding was taken out the maximum twist recorded was 22 mm at 12 m before the POD with a reading of 21 mm at one metre past the POD.
- 1.4.5.6 The EM80 track evaluation car output on 4 February recorded a Class 1 priority twist exceedance of 23 mm between 363.826 and 363.837 km.
- 1.4.5.7 The twist exceedances measured after the derailment showed a cyclic pattern just prior to the POD with peaks occurring at approximately 8 m centres (refer Figure 1).

- 2.6.1 Figure 1 shows the track measure up in graphical form and illustrates the cyclic nature of the twist and alignment readings just prior to the POD.
- 2.6.2 At a train speed of 25 km/h (7 m/sec), the distance between each twist cycle (approximately 8.5 m) represents 1.2 seconds. This time is very close to the 1 second natural oscillation period of a loaded bogie wagon and the series of cyclic twists encountered would have emphasised any rolling action set up in the wagons.
- 2.6.3 There was also a similar, although not so pronounced, cyclic variation in the track alignment prior to the POD. Apart from the major "peak" in the alignment 15 m before the POD, there were cyclic variations at approximately 10 m intervals and generally in synchronisation with the twist peaks. This would have accentuated any rolling action.

- 3.3 The likely cause of the derailment was dynamic interaction between vehicle and track as a result of a combination of cyclic track tolerance exceedances in alignment and twist.

- 4.1.3 Ensure that any necessary track geometry improvements required following derailments which show obvious signs of likely track related factors are carried out based on an understanding of the detailed site measurements taken following the derailment and take appropriate account of the latest track evaluation car data available. (039/98)
