Report 98-106

Train 201

collision with displaced load

Rail Incident Report 98-106

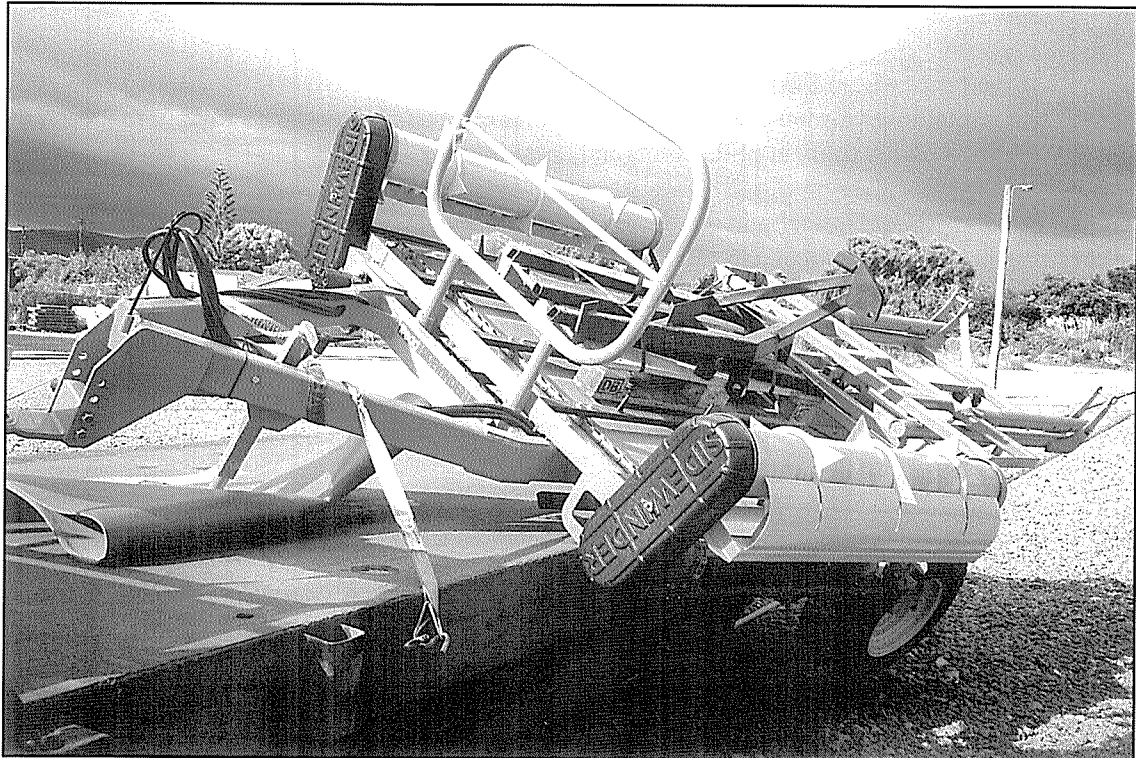
- 1.2.1 The displaced load was a trailer mounted agricultural implement (“Sidewinder”) with large section pneumatic tyres on its single axle. Figure 1 shows the load temporarily secured back to the side of the wagon following the incident.
- 1.2.2 Movement of the load during transit had allowed the rear of the load to fall off the left side of the wagon (in direction of travel) with the load restrained only by the front stop. The LE of Train 242 stated that when he looked back at his train he was unaware of the situation as he was seated on the right side of the locomotive.

Figure 1
The displaced load

- 1.2.5 The front strop had been looped around each leg of the drawbar and tensioned down to either side of the wagon. The tensioning force was resisted by the front trailer prop which was fixed in the “down” position with the foot bearing on the deck of the wagon. These details can be seen in Figure 1, together with a knot in the webbing strop near the top edge of the drawbar “A” frame.

- 1.2.6 The rear strop on the axle end of the appliance had parted during transit near the left side of the wagon (in the direction of travel), leaving no remnant on that side of the wagon. The right side remnant of the strop was still fixed to the side of the wagon by the ratchet tensioner with the end trailing on the ground. The broken portions of the strop were later identified by Ancra New Zealand Ltd as being part of a batch complying with NZS 5445:1986.

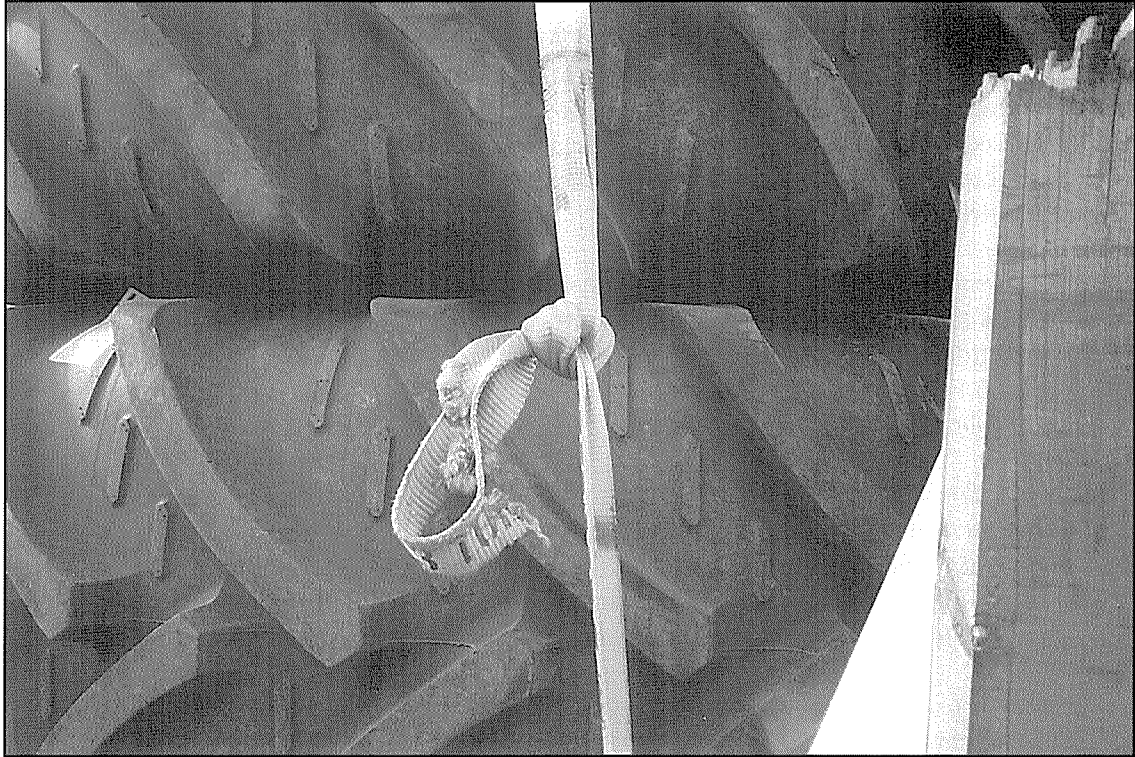
- 1.2.8 Figure 2 shows details of one of the strops used to secure two tractor tyres on wagon US3985 and in particular the knot placed in the strop to overcome a weak section of the strop. Although knotting can reduce strength by up to 50% the tractor tyres had not moved on the wagon.

Figure 2
Knotted strop securing tractor tyres

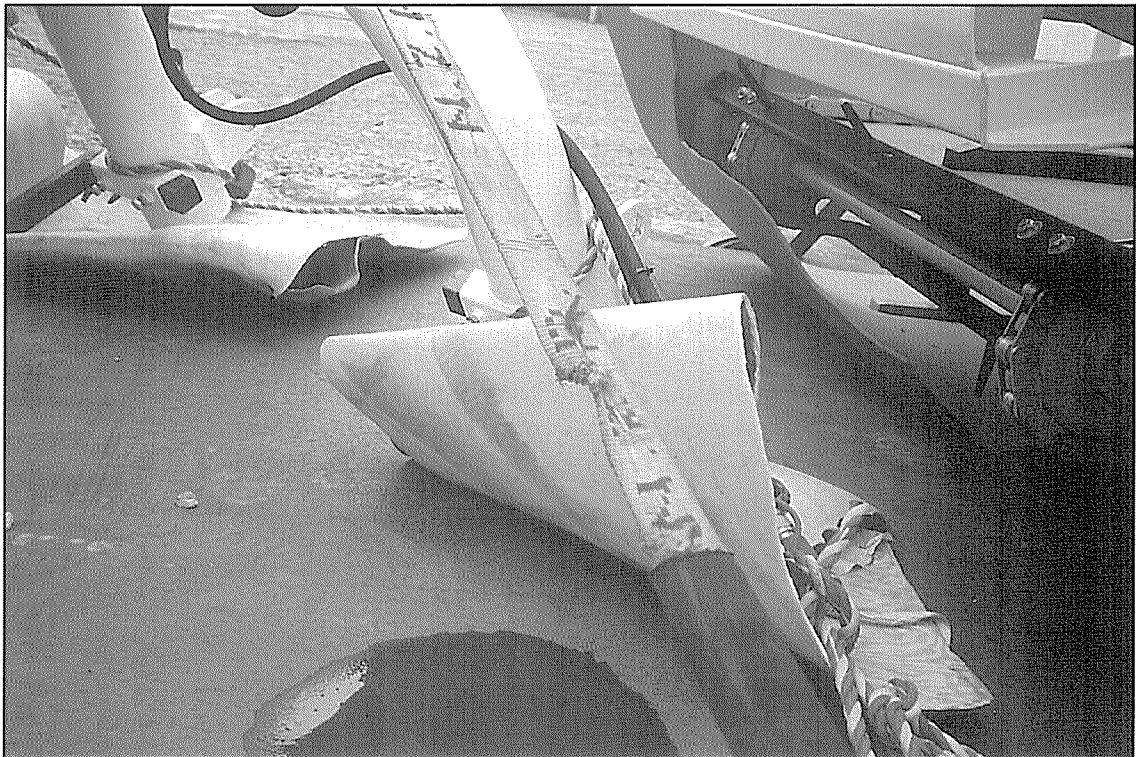
- 1.2.9 Figure 3 shows a partially severed old “NZR” strop used in fixing one of the other pieces of agricultural machinery to wagon US3985. This strop was in poor condition and had no safe working load stated on it. The load it restrained had not moved.

Figure 3
Partially severed strop used on wagon US3985

The evidence of knotted and partially cut strops on wagon US 3985 indicated the loading team used substandard strops. Freight handling personnel at Timaru stated this practice developed due to a lack of suitable strops at Timaru.
