**Report 98-107**

**Train 411**

**wrong line running**

**Ngaruawahia**

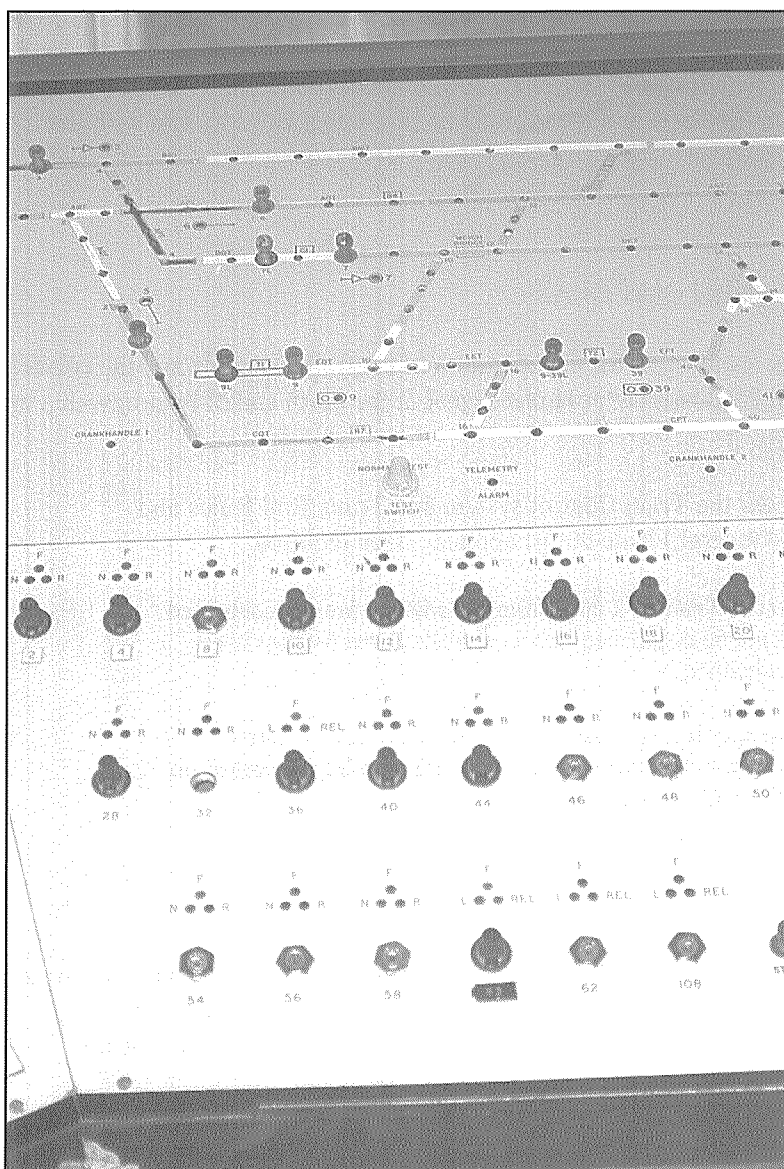
**Figure 2**  
 Three position keys for individual point setting (part of the Te Rapa control panel)

Three position keys having normal, centre and reverse positions, are provided for each set of points. [See Figure 2] With the key in the centre position the points are available for operation by route setting circuits. By moving the key to the left and pushing the start button for the particular interlocking the points can be set normal. Similarly by moving the key to the right and pushing the start button they can be set reverse. Under these conditions the points cannot be operated by route setting circuits, but it is possible to set up a route over the points in the position in which they are locked.
