Report 98-109

Train 482

near collision

Rail Incident Report 98-109

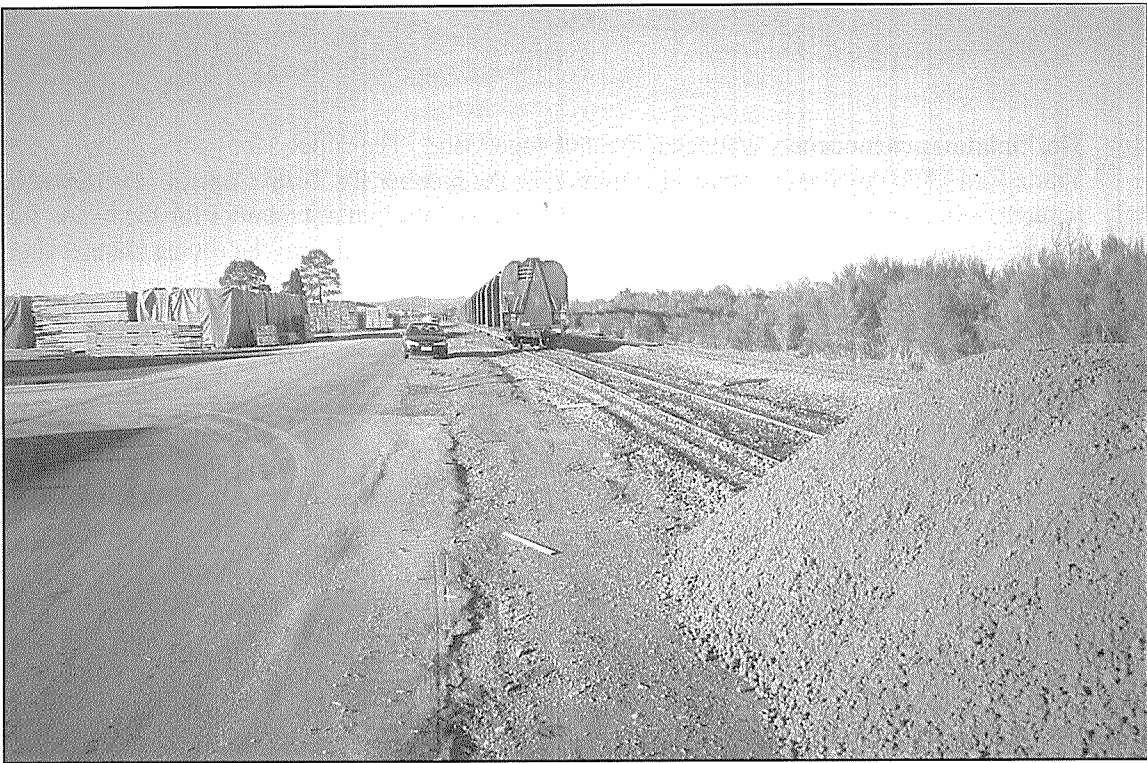
Figure 2
Looking south from the end of the siding, internal mill road on the left

2.4.2 In addition any runaway wagons derailed at the stop block created a potential hazard for road traffic on the heavily used mill road adjacent to the siding on the east side (see Figure 2).

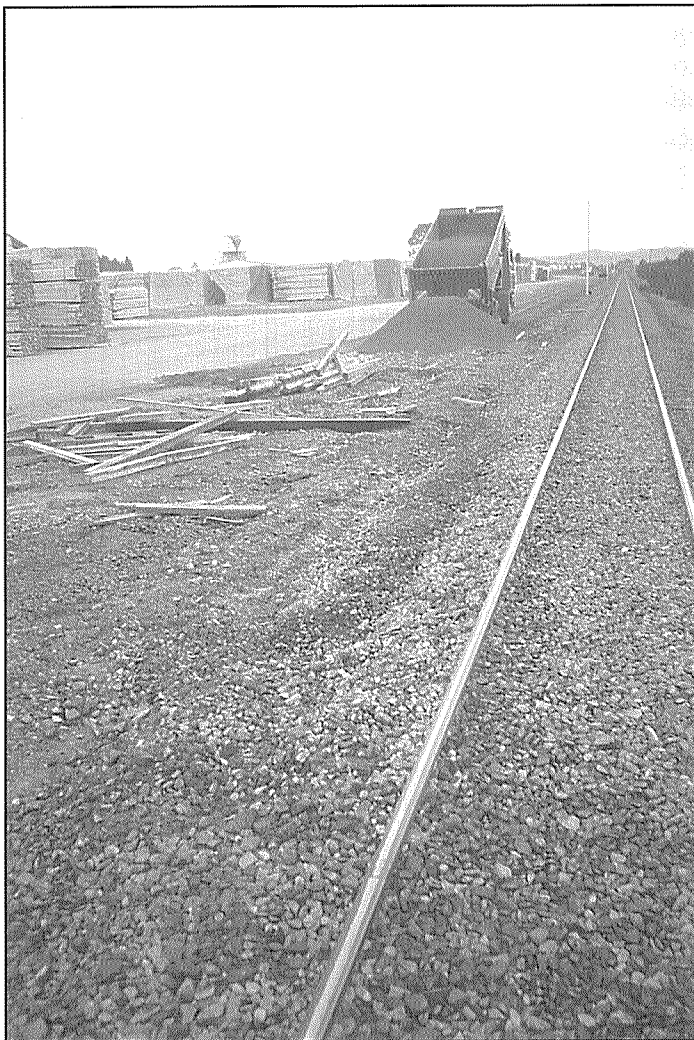
- 1.1.6 The torch was being held by a truck driver who had been operating from the Carter Holt Harvey Tokoroa saw mill. The truck driver had been making a series of trips from the saw mill to Kinleith Mill. He had noticed wagons stored at the south end of the Tokoroa timber siding (see Figure 1) at approximately 0130 hours that morning. At approximately 0330 hours when he returned to the saw mill he noticed when driving down the internal mill road parallel to the siding (see Figure 2) that the wagons had moved to the north end of the siding and, despite the poor visibility, he noted one was derailed at the end of the siding. The wagon had derailed into some timber stacks that were behind the stop block (see Figure 3).

- 1.2.7 The eight wagons which ran away came to rest still coupled, with the two leading wagons derailed and with the leading wagon foul of the main line and 27 m beyond the concrete stop block at the end of the siding.

Figure 3
Looking south from the position of
the derailed wagon fouling the main line

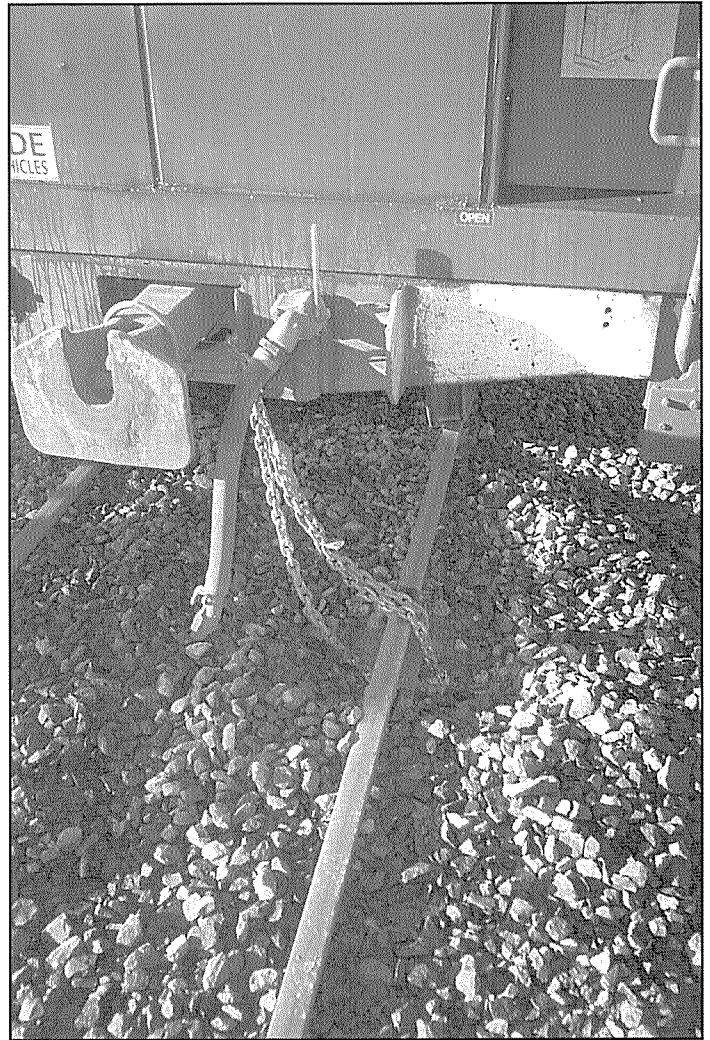
Figure 4
Typical chaining detail

- 1.2.8 Following the incident the chain used to secure the last wagon was found on the ground between the siding rails at 60.387 km adjacent to the hole dug under the rails by the roving shunter to place the chain. The chain was coupled, with the coupled lengths shorter than that required to reach and secure a wagon.
- 1.2.9 The first Tranz Rail staff on site who inspected the eight wagons following the incident found no air brakes or hand brakes applied.
- 1.2.10 The distance from the chaining point to the stop block at the end of the siding was 260 m. The eight wagon rake which ran away was 132 m in length.

1.5.3 Tranz Rail confirmed that there were no operating procedures or rules which refer to the chain system that was being used in this siding, other than the instruction covered in the draft joint operating plan.
