Report 98-110

Train 902

derailment

28 June 1998

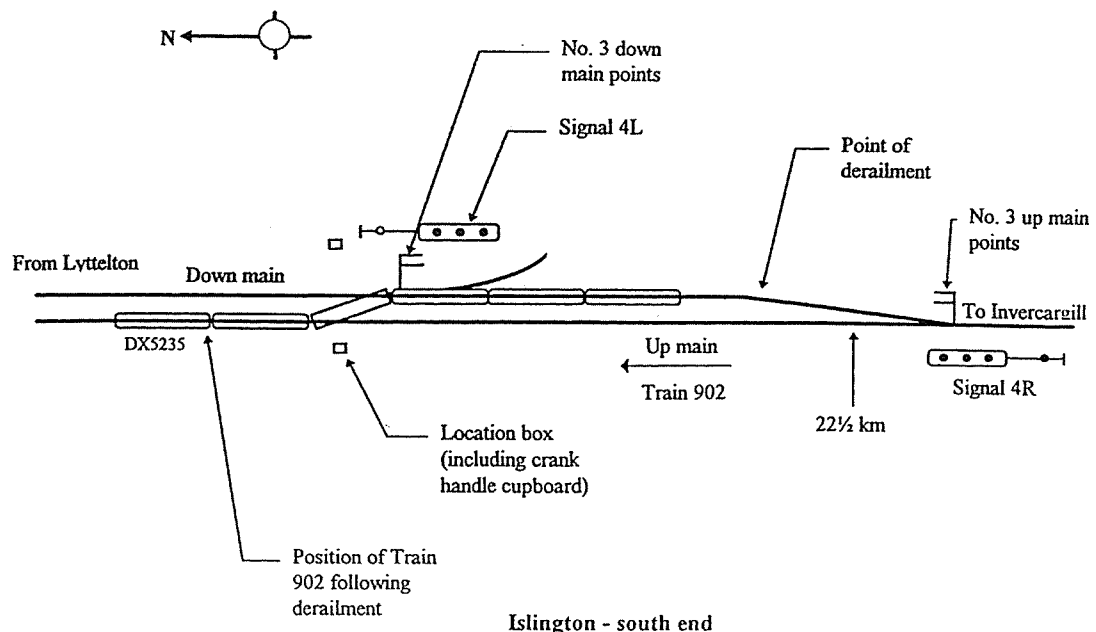
Figure 1
Track layout and signalling details

- 1.1.4 The red indication was displayed because of previous planned work which had required a power disconnection. The work had been completed some 25 minutes earlier. Although power had then been restored to the signalling, power had not been restored to the points motors which operated the points of No. 3 crossover joining the single line track south of Islington to the double line track into Christchurch. Figure 1 shows the layout and signalling details.

1.2.3 After the derailment the locomotive, wagon and leading bogie of AG118 were on the up main. The trailing bogie of AG118 was derailed to the left of the down main in the direction of travel. Alliance couplings between the rear of AG 118 and carriage A019 had parted. The 2 carriages and the buffet car were on the down main (see Figure 1).

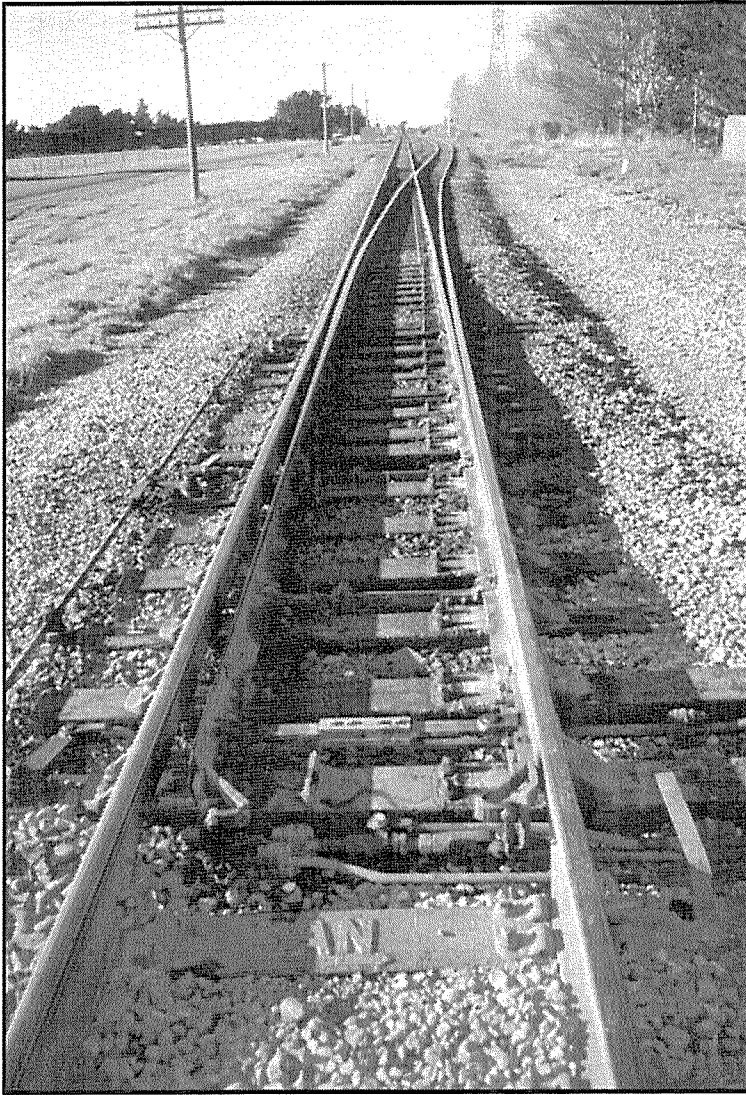
Figure 2
No. 3 points viewed from the south
looking north

- 1.1.6 The LE checked the points were “correctly set” for his movement and immediately moved his train forward on this authority and passed over No. 3 points to the up main at slow speed. Figure 2 shows No. 3 points viewed from the south looking north.

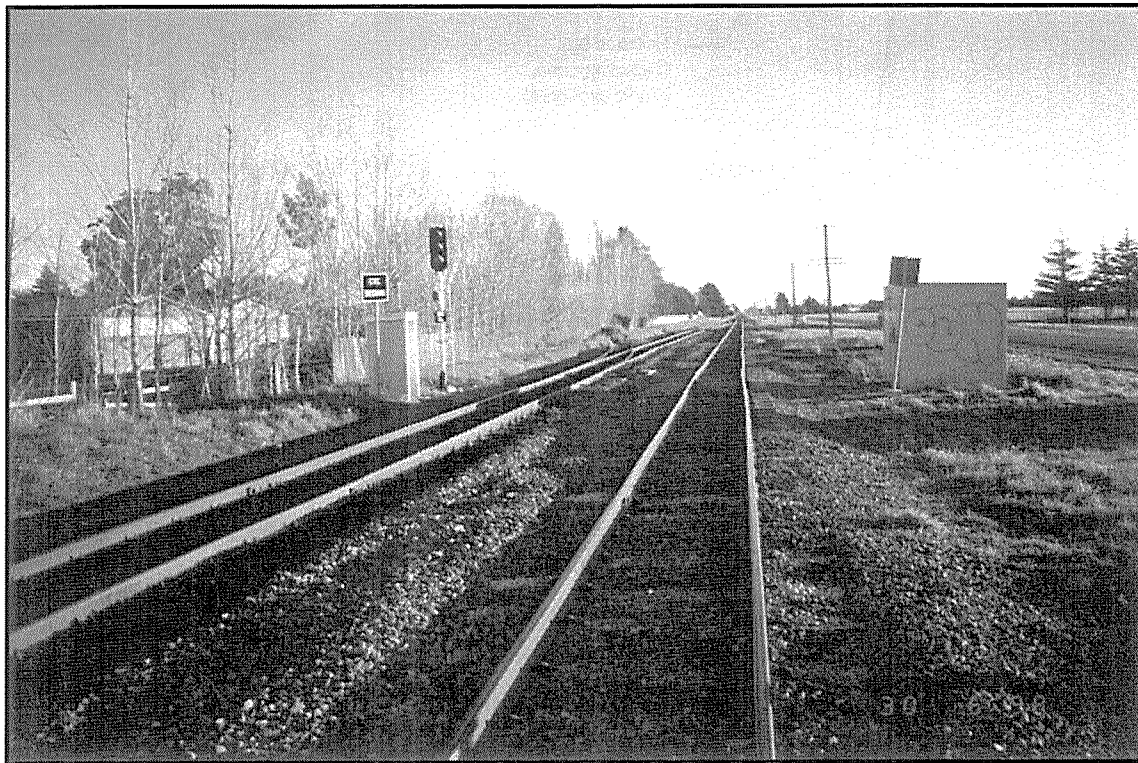
Figure 3
Looking south. Location box on the right containing the crank handle

- 1.1.10 The RO stated that following his arrival at Islington he:
- noticed Train 902 arriving from the south
 - stopped his vehicle on the main road alongside the location box containing the crank handle for hand operating of No. 3 points (see Figure 3)

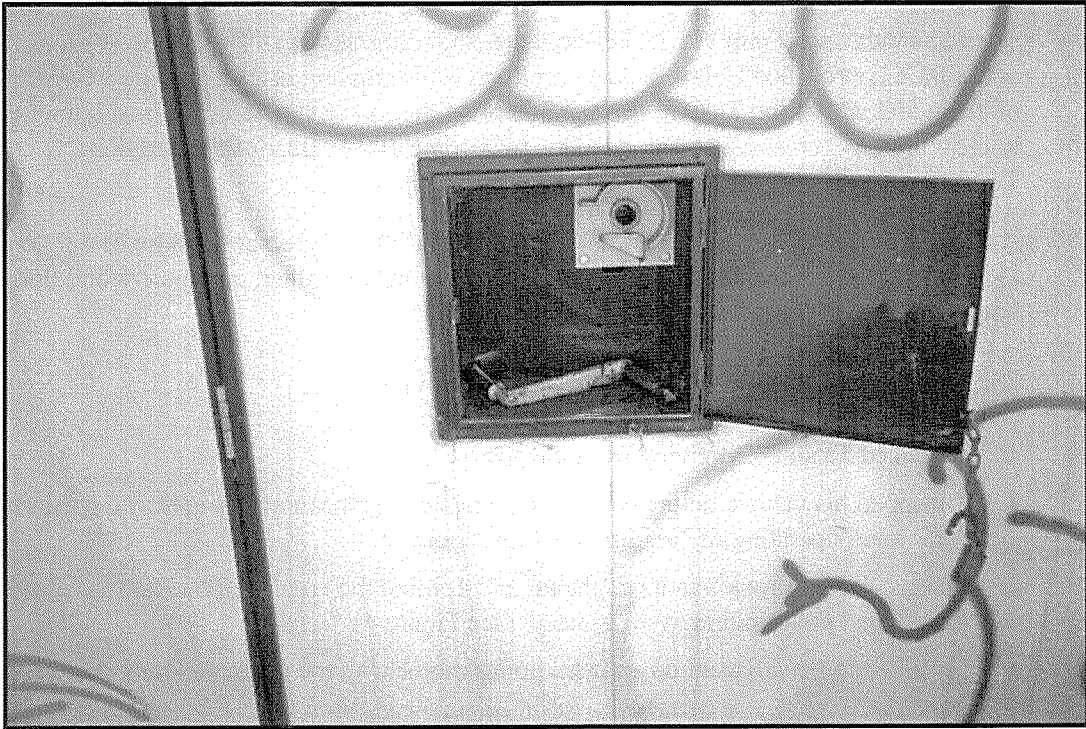
Figure 4
The crank handle in its “appointed place” when No. 3 points were isolated

- unlocked the crank handle cupboard and uplifted the crank handle from its appointed place for when motor points were isolated¹ (see Figure 4)
 - walked to the adjacent down main points motor with the crank handle in his hand

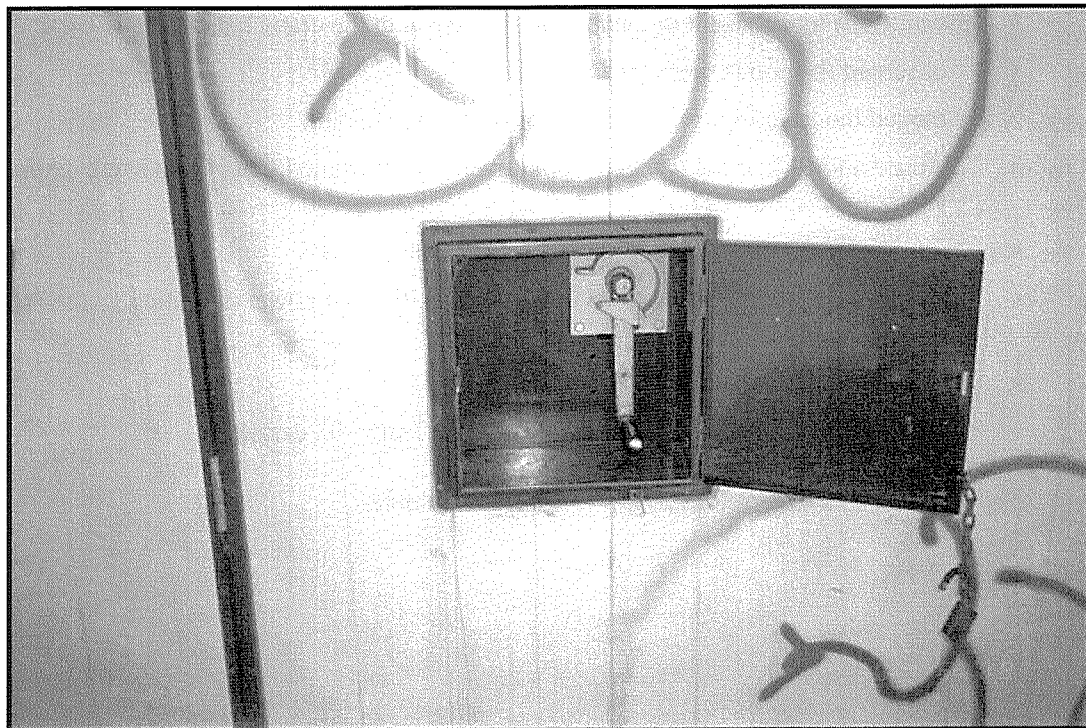
Figure 5
The crank handle in its “appointed place” when power was supplied to No. 3 points

- returned to his car and reversed back to the location box
 - returned the crank handle to its appointed position for power operation of the motor points (see Figure 5)

- turnouts set for a down main movement
- motor points for the up main turnout locked, with the isolating ring in the motorised position (see Figure 6)
- the crank handle in the power position inside the crank handle cupboard (see Figure 5).

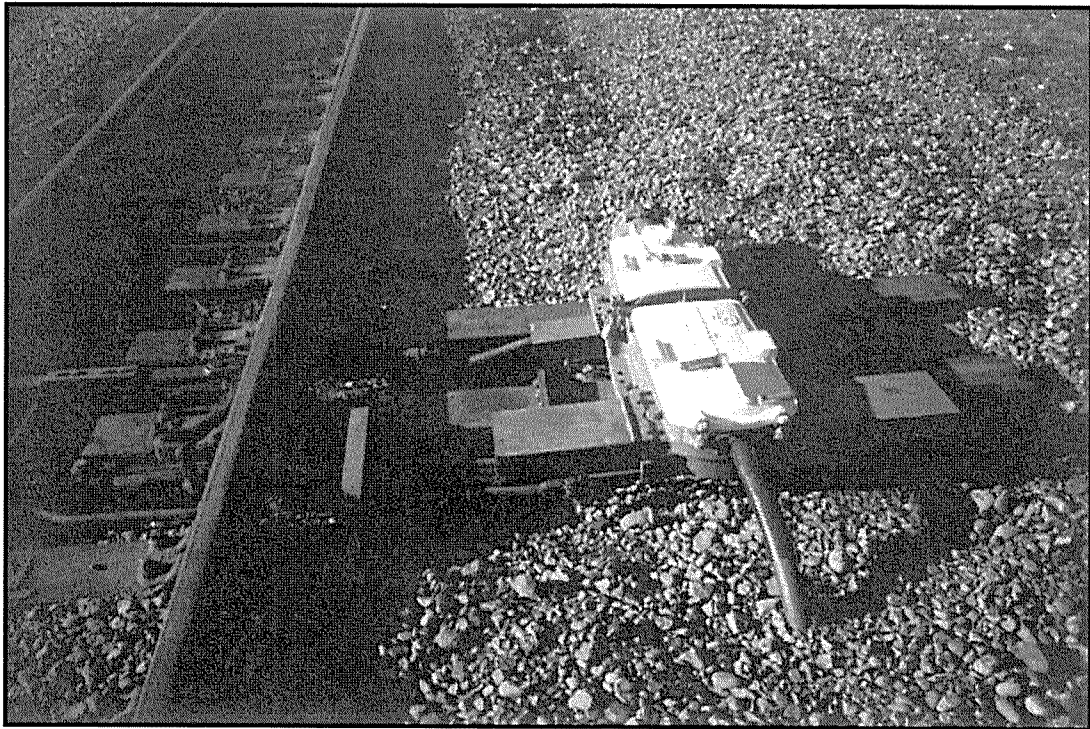
- observed the points were set in the normal position (this meant they were set for the derailing road, protecting an up movement)
 - moved the isolating ring to the “motor operating” position (see Figures 6 and 7 and Appendix 1 for details of the Nippon points motors installed at No. 3 crossover)

Figure 6
Nippon points motor at No. 3 main line points
(Points cover locked in the closed position, isolating ring therefore in the motor operating position)

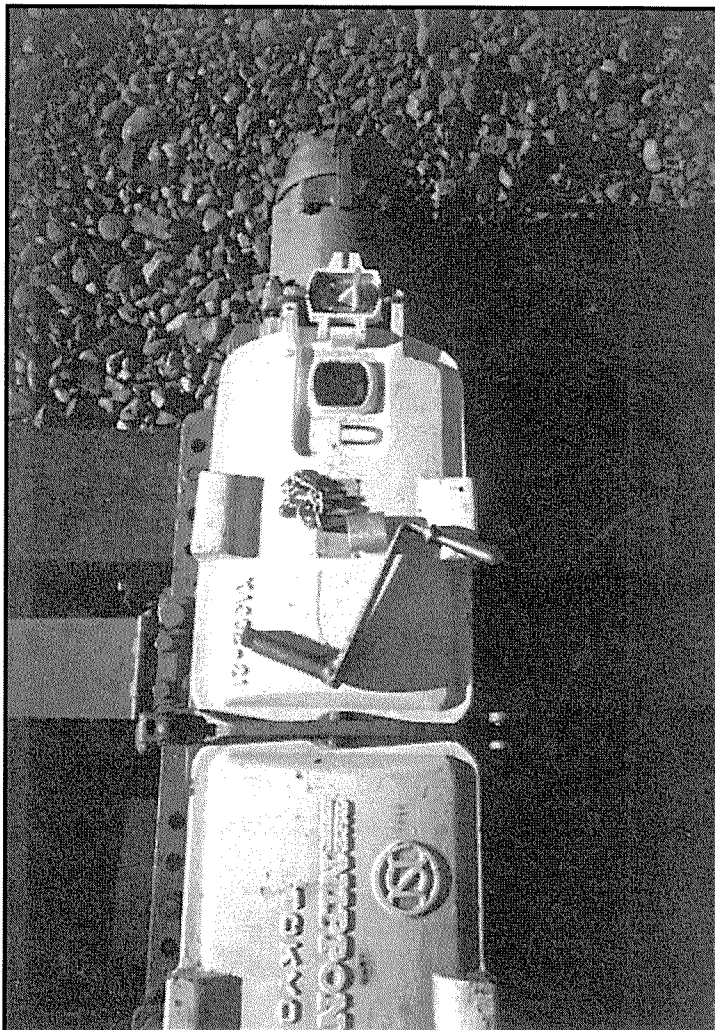
Figure 7
View with points cover open,
isolating ring to the right, i.e.
points isolated, cover cannot be
closed and locked
