Report 98-111

Train 2125

collision with pedestrian

17 August 1998

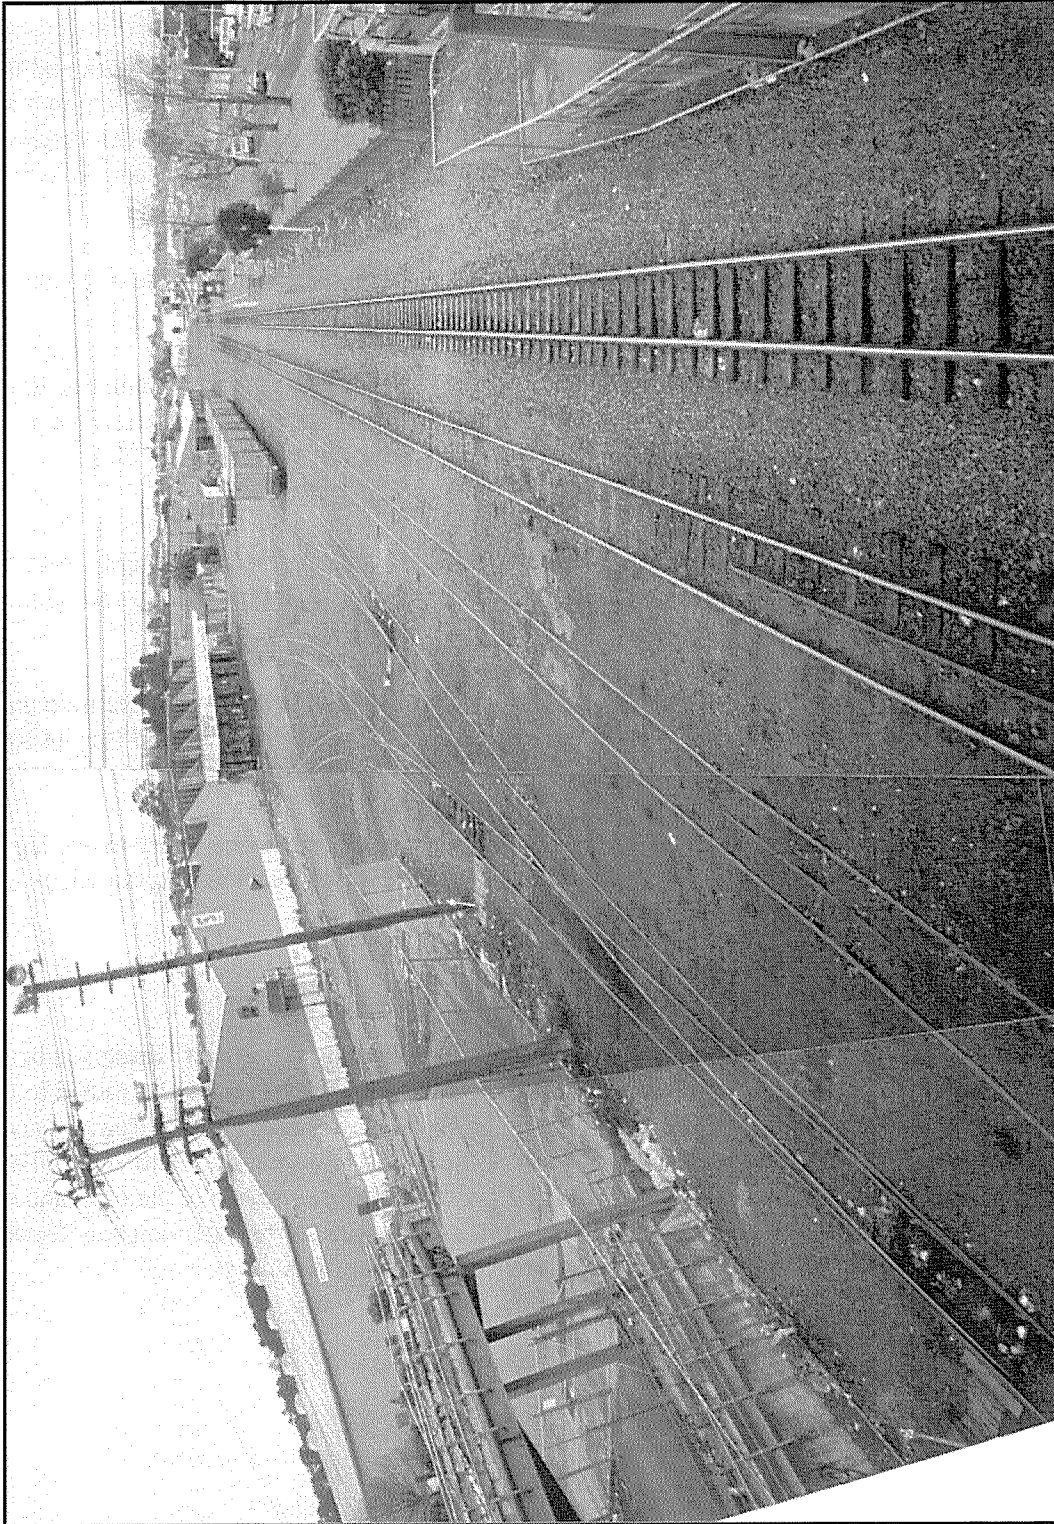
- 1.1.2 The group included a cyclist who had dismounted to push his bicycle across the rails, and was walking south between the main line, on his left, and loop, on his right, towards a gap in the east boundary fence line. This gap was under the ramp of a pedestrian overbridge which crossed the tracks at this location. The general area is shown in Figure 1, and Figures 2, 3 and 4 show details.

Figure 1
Overall perspective of the crossing point looking north from the footbridge span

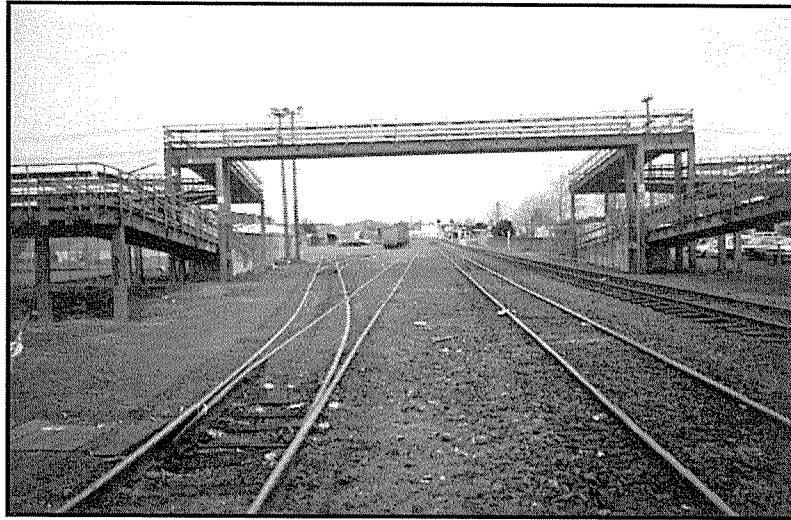
Figure 2
Looking north to the footbridge and crossing point beyond

- 2.2.2 A combination of perceived adverse features associated with the pedestrian overbridge (length of approach ramps and associated time to cross; grade of the ramp; side fencing) and open access to the west side of the yard resulted in trespass being the norm rather than the exception. Train operating staff expected this as part of normal daily operations.

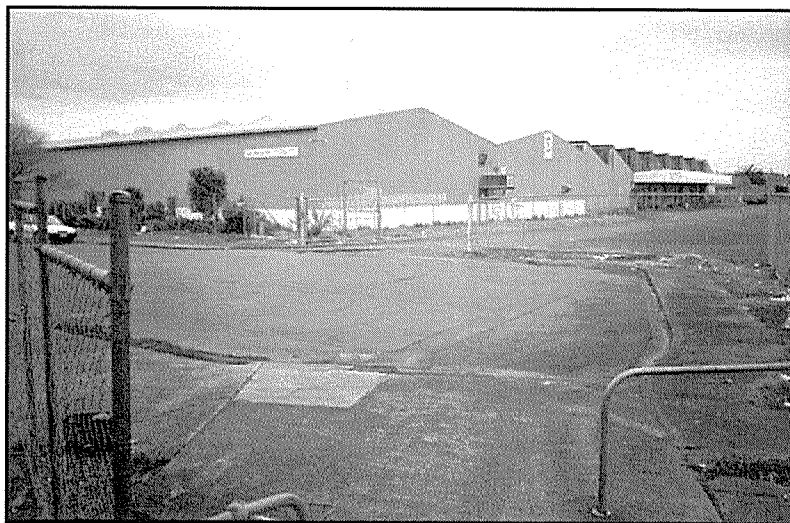
Figure 3
Open gateway entry to the west side of the yard

1.7.1 Hickory Avenue provided public road access to the footbridge from the west side. The end of Hickory Avenue was fenced off from the railyard except for a vehicle gateway giving road access into the yard. The gate was always open and the gateway was used by all persons crossing the tracks at the south end of the yard.

- 2.2.4 The main encouragement to unauthorised access was the open gate on the west side of the yard, and there was no signage near the gate to warn of the dangers of unauthorised crossings. Signage that was present in the area lacked impact and was not sited to best effect. One method of discouraging trespass is to prosecute, and Tranz Rail and the Police have considered such action. Signage should be to a standard to support any such prosecutions.

- Physical and attitude surveys were carried out to define the extent of the problem.
- The gate at the south end is now locked when not in use.
- Fences at Hickory Avenue and Smythe Road were repaired and strengthened (and have been repeatedly breached and repaired since).
- New signage has been installed.
- An extensive education campaign, comprising safety posters, use of the media, and involvement with the local community, has been completed.

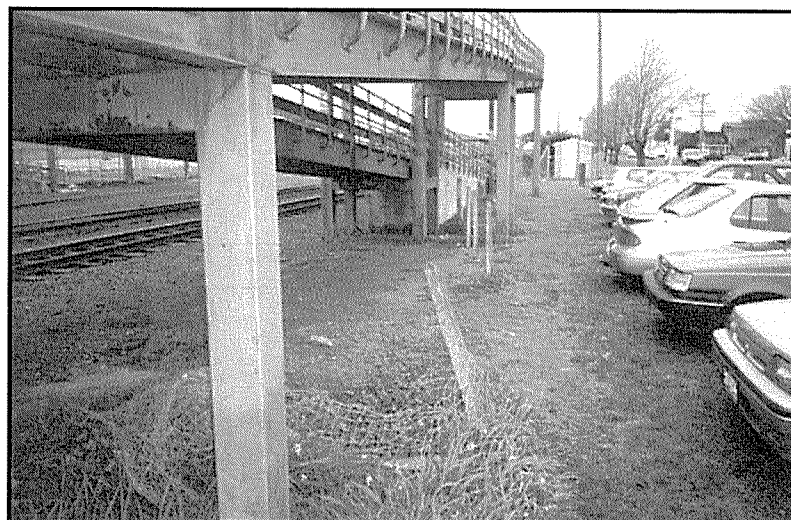
Figure 4
Foot and bicycle access to the east side of the yard

1.7.2 Fencing on the east side opposite Hickory Avenue had been broken to permit access to and from the platform, carpark and shopping area.

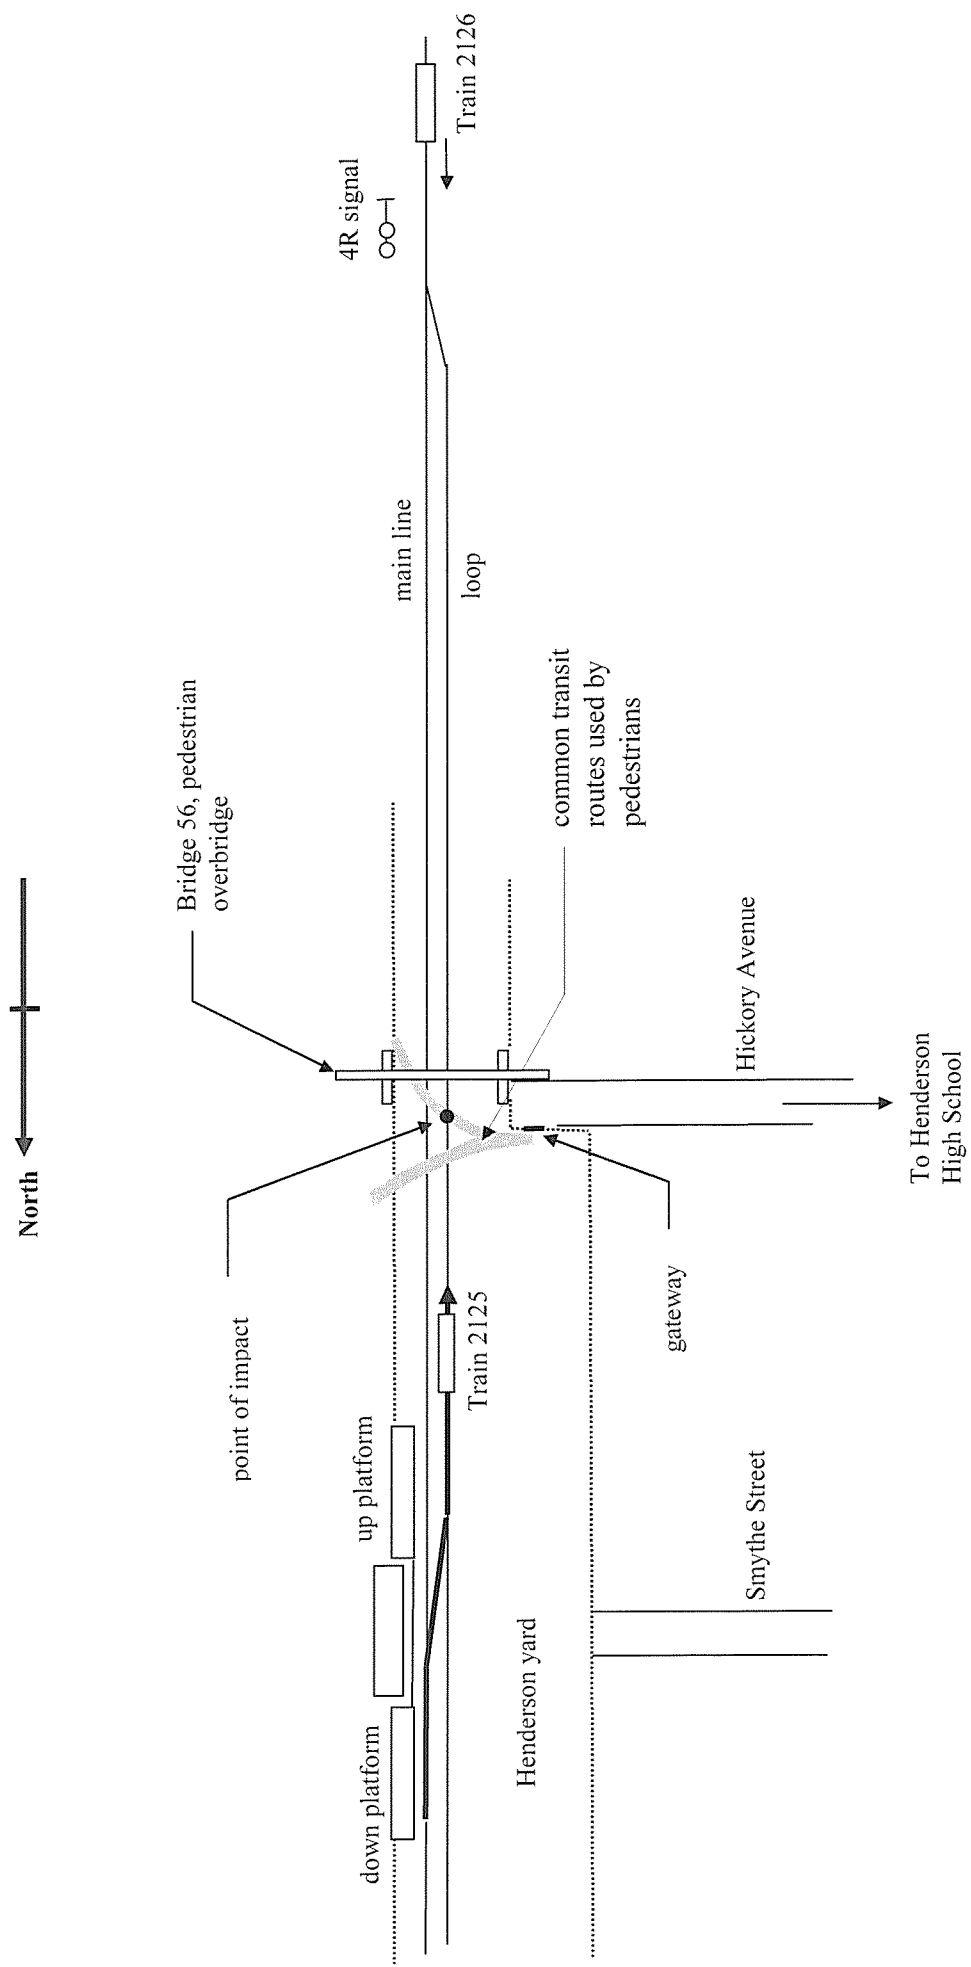
- 1.1.5 On the day of the incident Train 2126, a northbound DMU, was stopped at 4R signal waiting for Train 2125 to clear the main line and permit a proceed indication. Figure 5 shows the general arrangement and movements on the day.

Figure 5
Diagrammatic layout of Henderson yard (not to scale)
