Report 98-112

yard shunt

log fall from wagon

Rail Incident Report 98-112

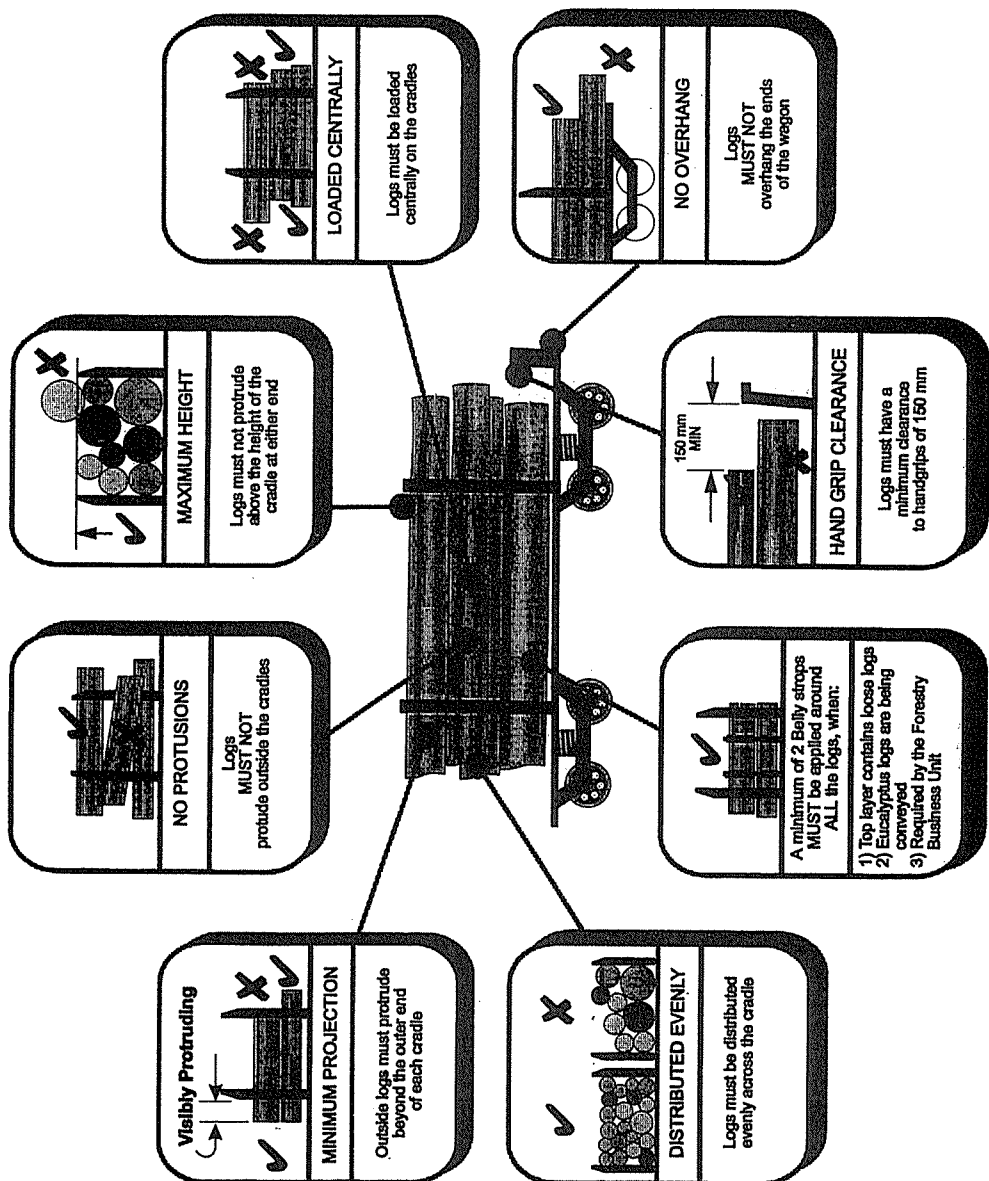
DIAGRAM 16.1

- 1.4.4 The code included the maximum height to which logs could be loaded with respect to the top level of the wagon cradles and the required overhang of the logs with respect to the cradles. Diagram 16.1 of the code permitted the logs to be loaded up to the top of the cradle (prior to the Tokoroa incident the code allowed that one third of the diameter of the log, but never more than 200 mm, could protrude above the cradle). The logs must also “visibly project” beyond each cradle (previously they had to project by at least 150 mm).

Diagram 16.1 of the Tranz Rail Log Operating Rules also required that the outside logs must protrude beyond the outer end of each cradle. The accompanying diagram showed that the “Minimum Projection” should be “Visibly Protruding”.
