Report 98-116

Train 9282

derailment

15 October 1998

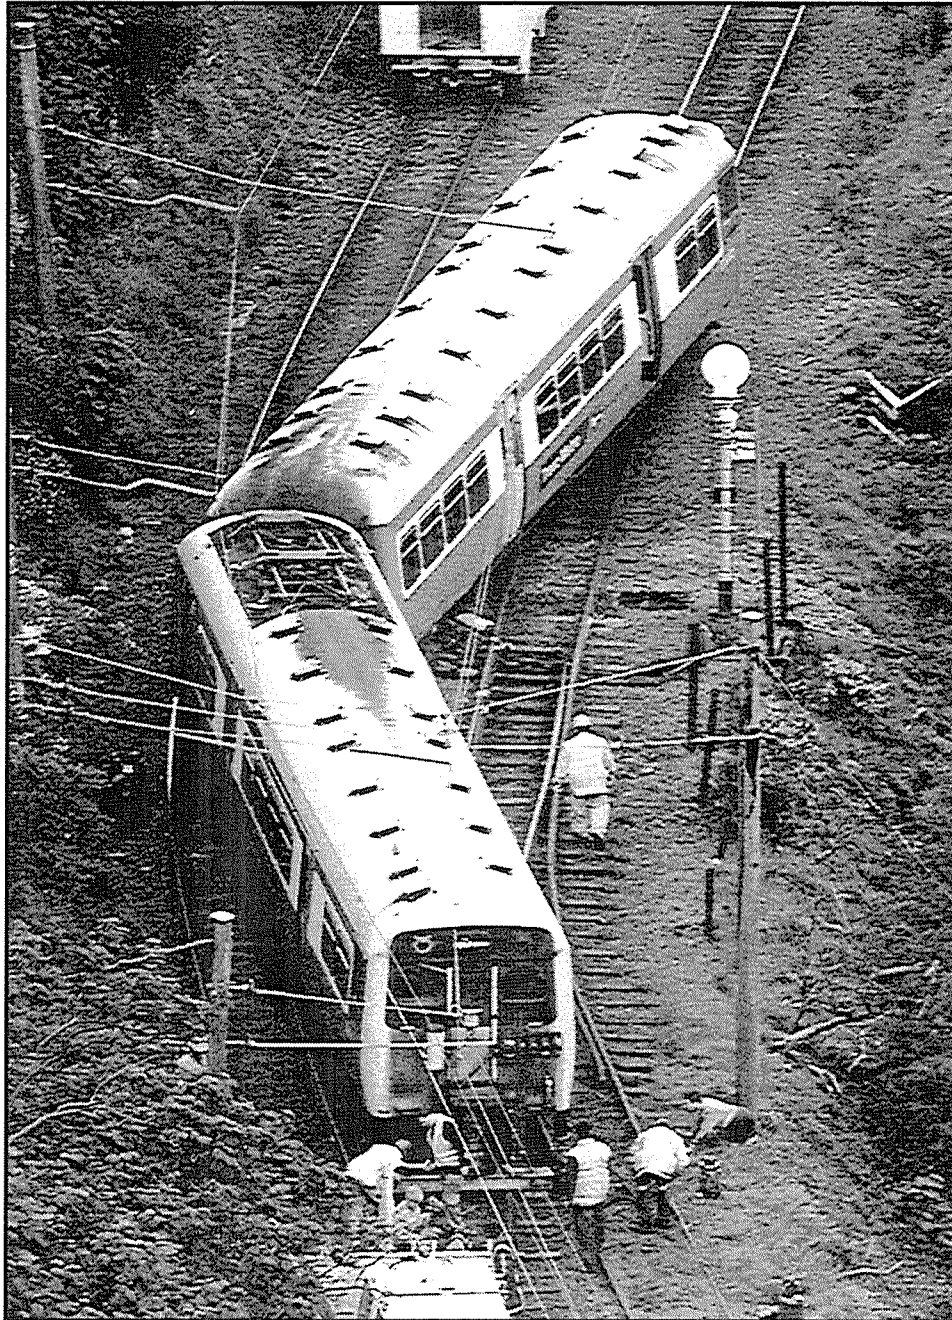
Figure 1

- 1.1.6 Shortly after passing over the points he felt rough riding and shaking and realised his train had derailed. He applied emergency braking some 28 m past the points and the train came to a stop 59 m beyond the points. The trailing bogie of the leading car and the leading and trailing bogies of the second car were derailed and came to rest as shown in Figure 1.

The 2 leading cars following the derailment (the 2 trailingcars which were at the bottom of the picture were not derailed and have been pulled clear). The view is looking to Johnsonville with the up main on the left and the down main on the right

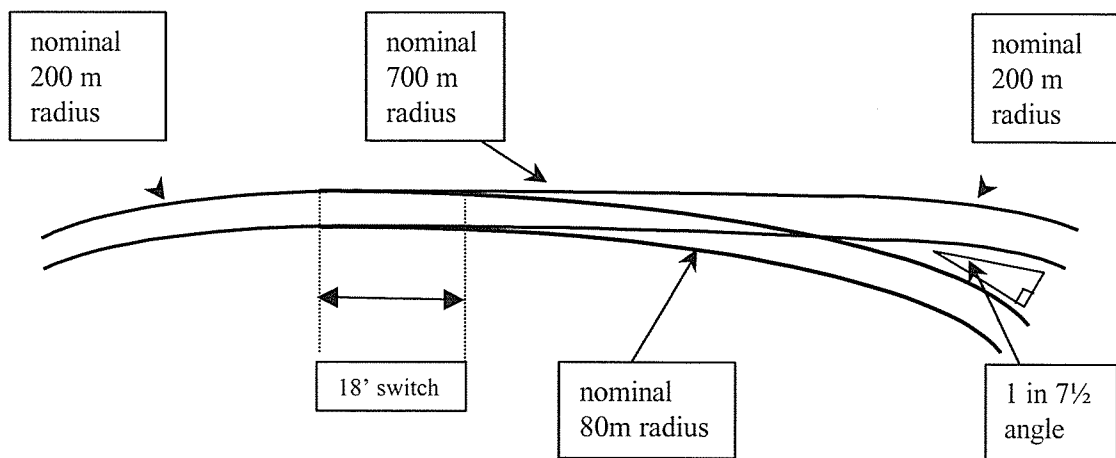
Figure 2
Layout of Turnout 1

1.3.2 Turnout 1 was a 91 lb/yard 1 in 7½ turnout with an 18 foot switch, and had been installed in 1981. Figure 2 shows the layout. It had been programmed for replacement for some years and the renewal was to be carried out over the weekend following the derailment.

1.3.3 It is normal for sidewear to occur on the curved leg of a turnout due to lateral forces associated with the curve radius. This curve wear is significantly increased when negotiating an 80m radius curve instead of the 109 m radius curve for such a turnout off straight track.

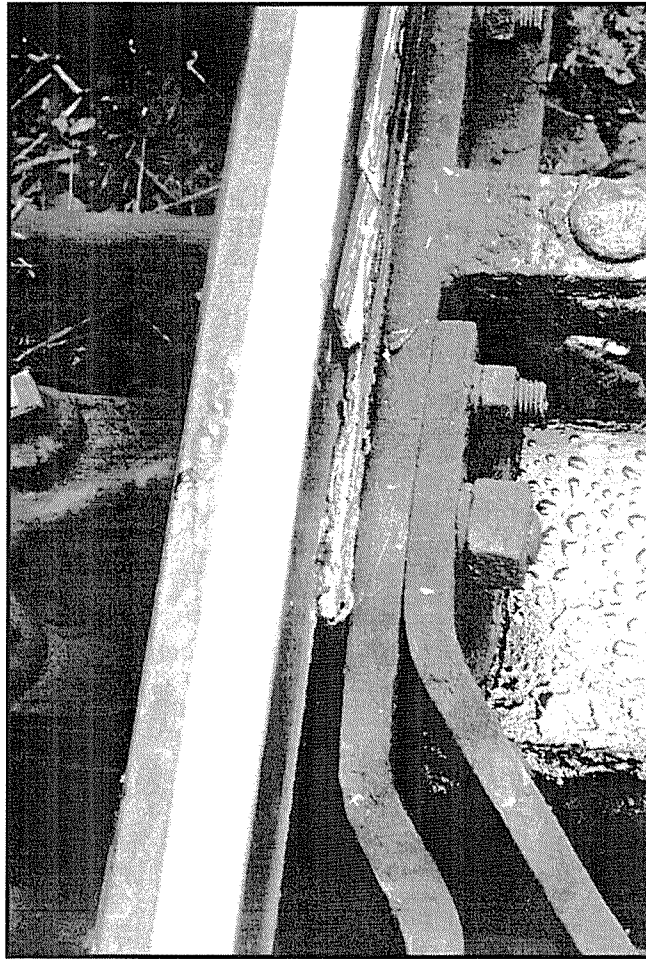
Figure 3
The worn left-hand switch on Turnout 1

1.3.4 Site investigation following the derailment showed Turnout 1 was set for the intended movement to the down main. However, the left-hand switch controlling the movement of Train 9282 to the down main was chipped and worn, with an approximate 80 mm x 20 mm portion of the switch fractured and resting on the stock rail (see Figure 3). For comparative purposes the relatively unworn left-hand switch on the north end turnout at Wadestown is shown in Figure 4.

- 2.2.2 Because of its tight curvature, Turnout 1 at Wadestown was subjected to unusually high lateral forces causing severe and rapid wear over the first 200 to 300 mm of the switch. The ganger’s experience with yard turnouts had been to use a non-standard practice (heating and bending) as a technique to extend switch life under the unusual wear conditions. His adoption of such a practice may have been due in part to the difficulty in interpreting and applying the code requirements to the Wadestown installation and the lack of instructions regarding grinding. Track management staff were unaware of this non-standard practice despite its regular use in this gang area.

- 3.3 The failure was initiated by wheel loading associated with the changed traffic pattern to suit operational demand.
- 3.4 The switch wear prior to the brittle failure had resulted in the nose of the switch being twice the permissible maximum width.

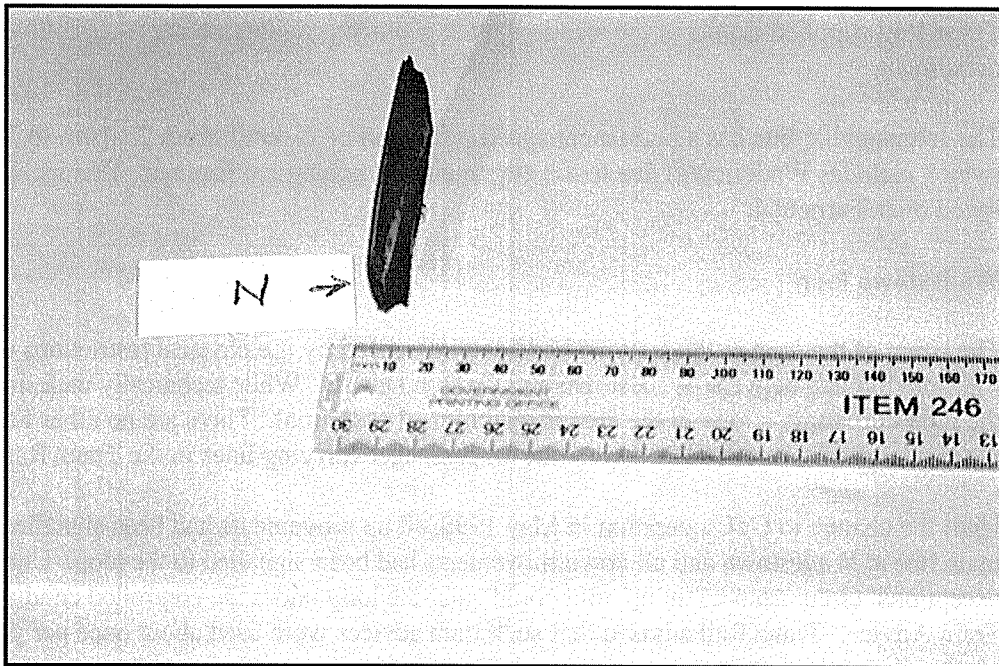
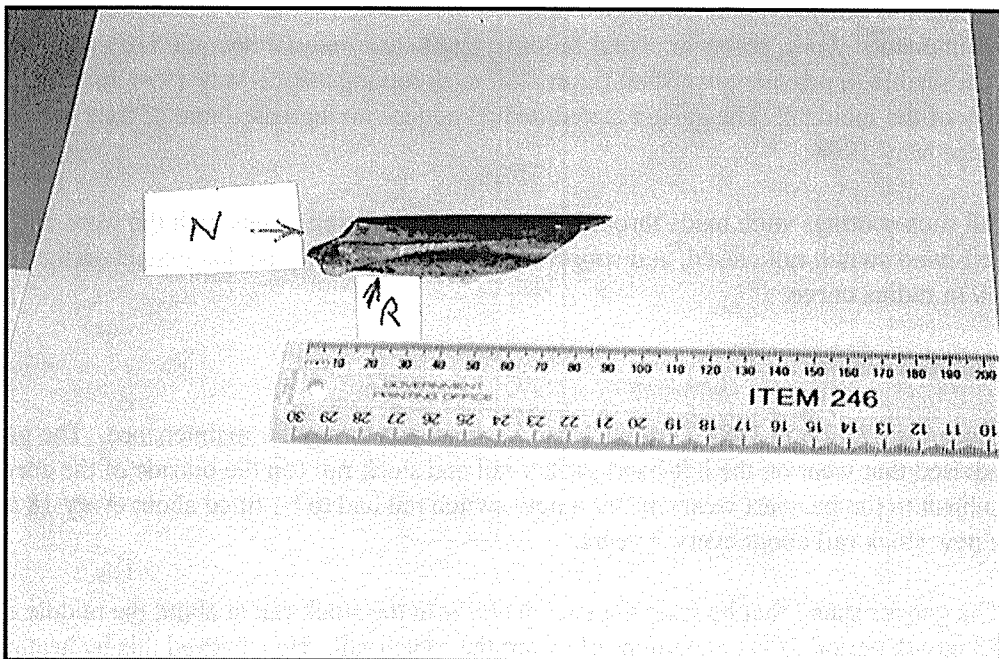
1.3.5 The fracture patterns of the switch showed no rust except at the leading face (nose) of the switch. The width of the rusted leading face was approximately 4 mm (see Figures 5 and 6).

The fractured portion of the switch found in position following the derailment.

The 4 mm wide rusted switch nose is marked N.

The ramp which caused the derailment is marked R

- 2.1.3 The broken portion of the switch blade was the cause of the ramping, and probably failed under the train.
- 2.1.4 Although the train event recorder extraction time was not recorded, by using the train departure time as a datum a difference of one hour was established, which is consistent with the standard correlation allowing for daylight saving. The short log was analysed on this basis and showed a speed of 27 km/h at the POD. The LE's report indicated that he applied the brakes approximately 28 m beyond the POD and the log indicated a stopping distance of 30 m. This was consistent with the position at which the train came to rest.

- 2.2.3 The brittle fracture of the failed portion of the switch in place after the derailment was consistent with overload. The normal hardness indicated that the undesirable practice of heating and bending the switch was unlikely to have been a factor in this failure. The failure was initiated by shock wheel loadings created by the 4 mm blunt nose arising from earlier wear.

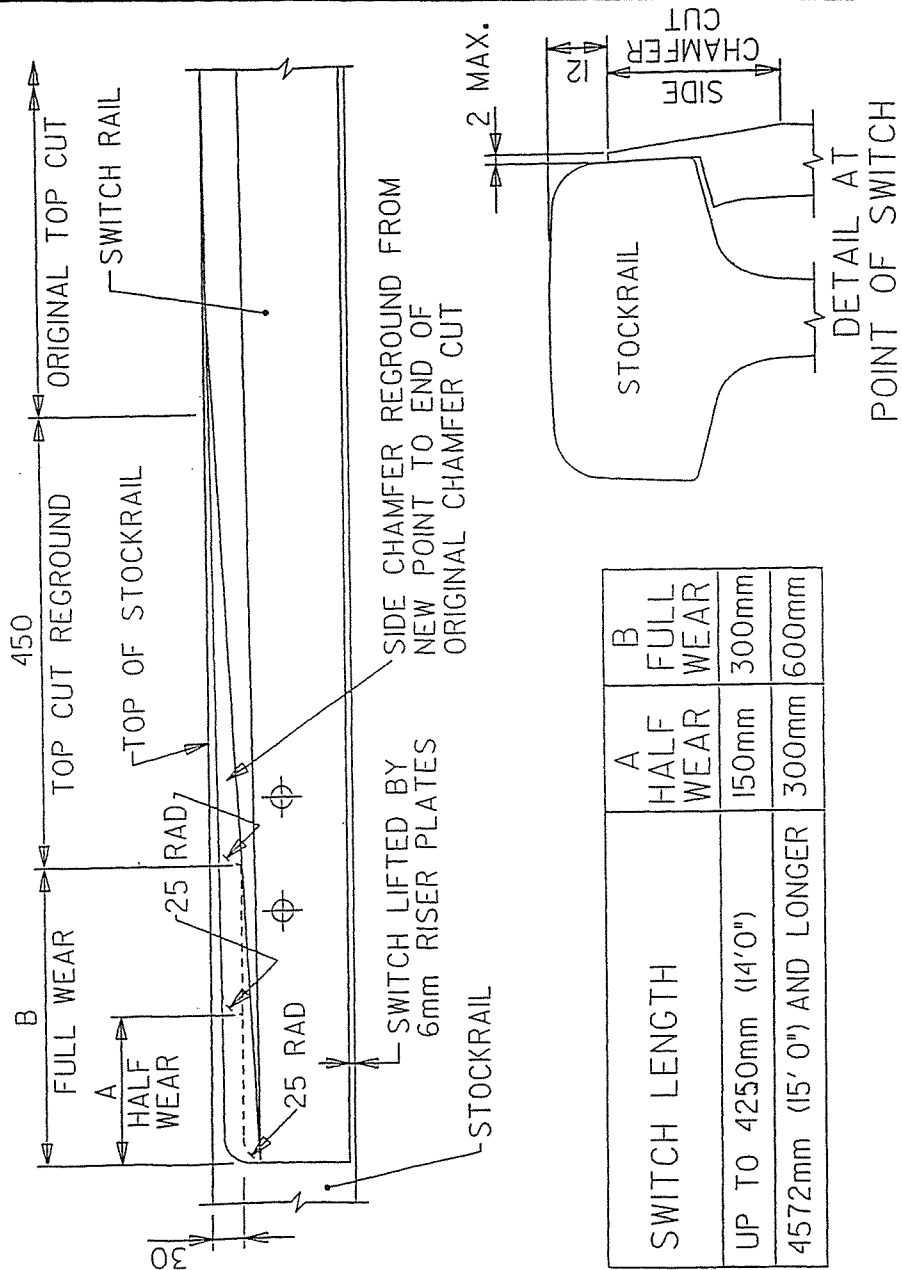
FIG 3

- (a) Frogs and wing-rails: CSP/51 refers to procedures to follow (by certified staff).
- (b) Switch points: Maximum allowable wear for all lengths of switch is shown on Fig 3. When full wear is reached the switch must be renewed. If the stock rail is so worn that the new switch will not close neatly without any gap, it must also be replaced.

1. On inspections, check that switches are not worn or broken beyond the standard as shown in the Track Code Supplement CSP/63.
2. If switches are suitable for welding, advise Ganger/T&S Manager
3. If a replacement switch is required, arrange for a switch of the same length and weight to be on site.
