Report 98-117

Train 700

collision with No. 2 shunt

Rangiora

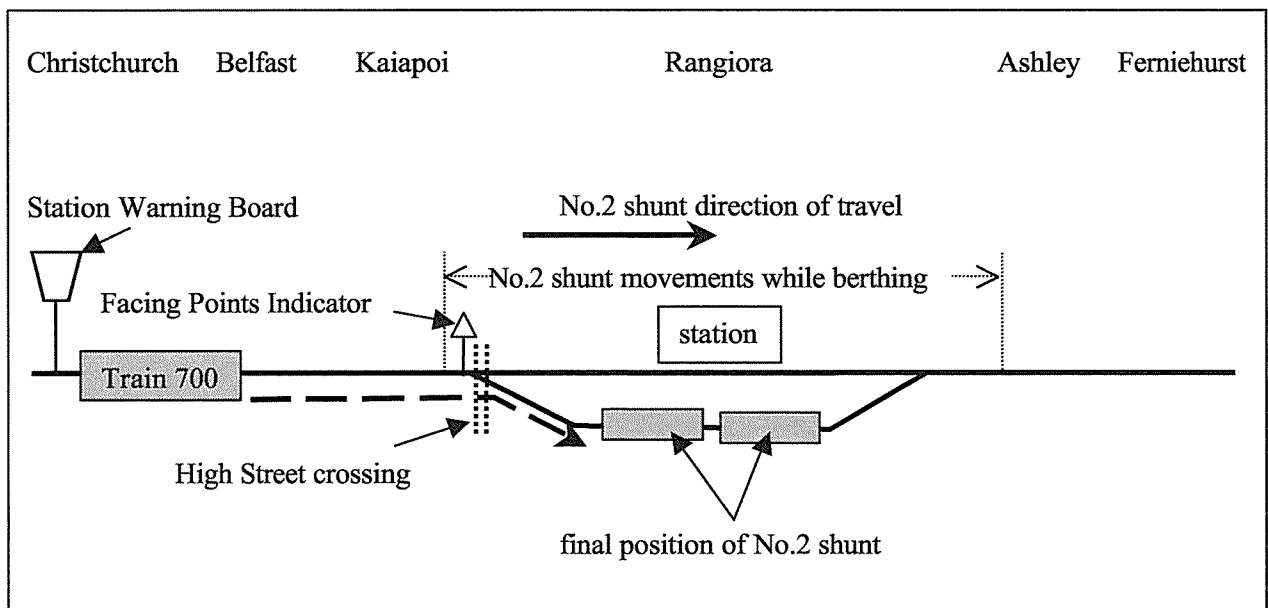
Figure 1
Train movements

- 1.2.2 The Signalling and Interlocking arrangements for Rangiora are shown on the copy of Circular S and I No. 2437, Sheet 2 of 2, attached as Appendix 1. The relationship of the localities referred to in the report and the train movements are shown in Figure 1.

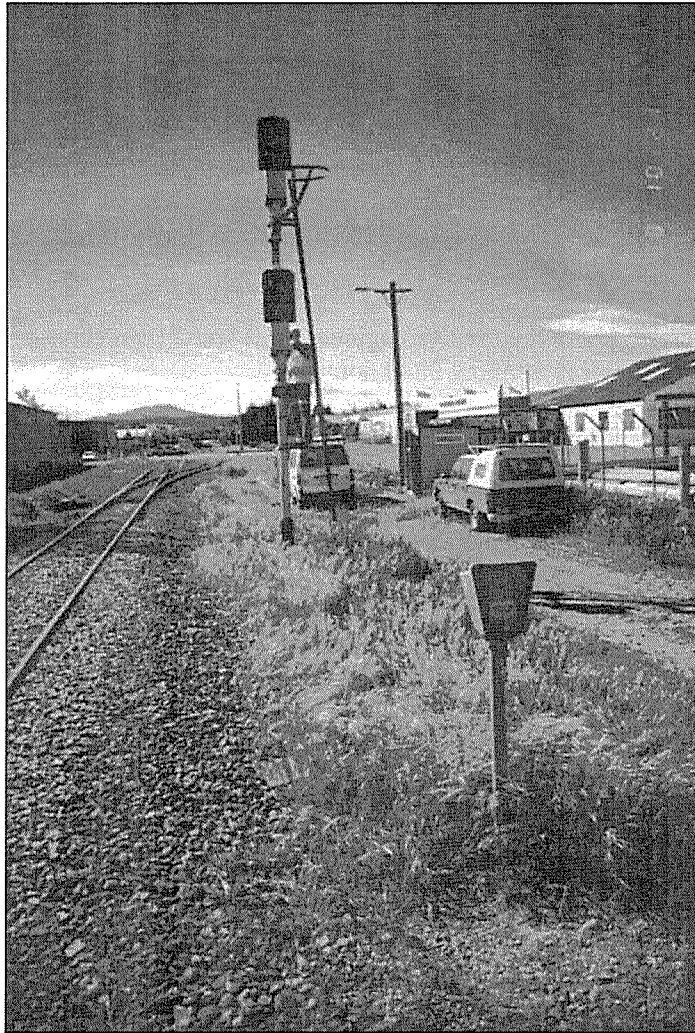
Figure 2
Facing Points Indicator 3FI

- 1.2.4 Figure 2 shows 3FI, the Up Facing Points Indicator, at the south end of Rangiora with High Street level crossing and Rangiora station in the background and the loop diverging to the right.
- 1.2.5 Figure 3 is a view looking north from High Street level crossing showing the main line on the left and the loop on which the collision occurred on the right, with Rangiora station in the background.

- 1.6.2 Tests following the incident showed that from the 3FI trip the purple over red main line points indication was clearly visible about 500 m ahead. However, the red over purple loop points indication was not visible on the purple light. The purple light on the bottom started to be visible at 300 m from 3FI.

- the range of visibility of the bulbs used for the purple loop light. A halogen bulb would have been visible approximately 200 m earlier and may have provided the necessary total indication (red over purple) in time for the LE to observe, evaluate and act before the added complication of the possible Rangiora stop took his attention
