Report 98-120

Train 700

dragging brake gear

Hapuku (near Kaikoura)

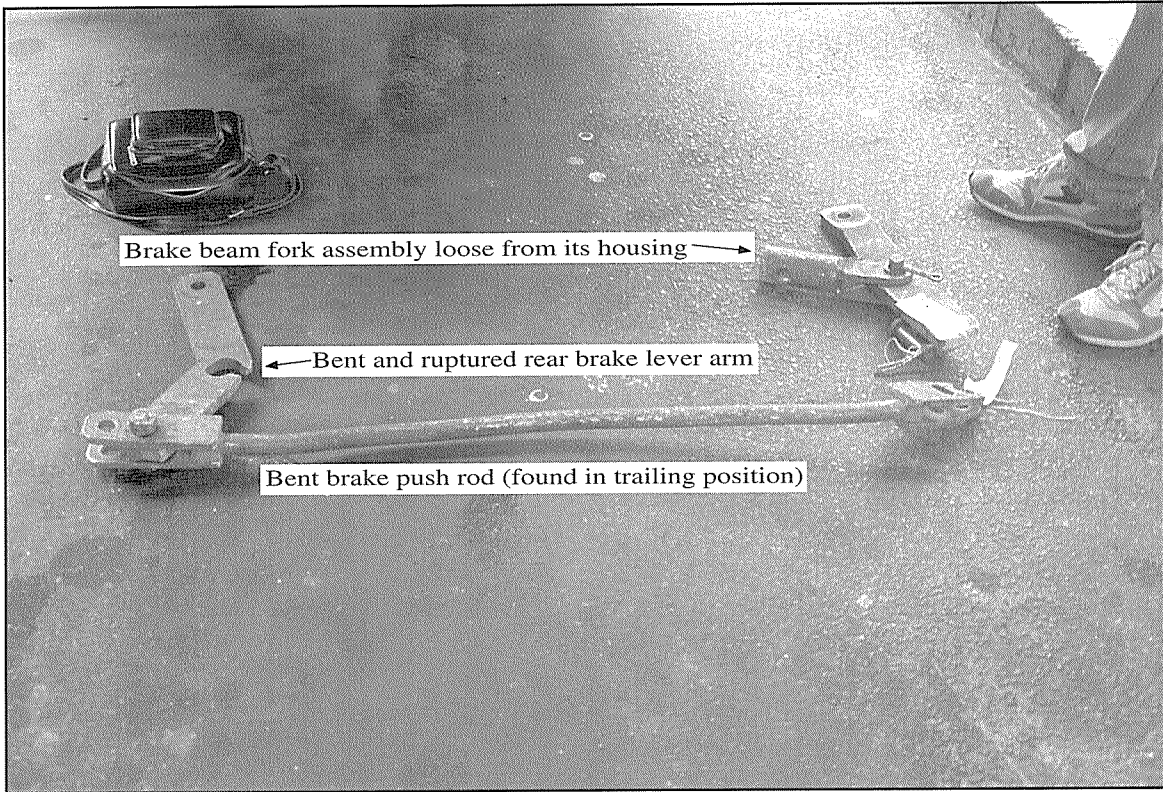
Figure 1
Recovered hand brake components

- 1.1.5 The LE's inspection found that the clevis² bolt intended to fix the front of the brake rod to the front brake lever arm was missing and the rod disconnected. The rod had been bent and displaced into a trailing position but was still fixed to the rear brake lever arm. This lever arm had been bent backwards about the brake beam fork assembly pivot and had fractured, allowing the arm to come free of the assembly and be attached only by the top arm fixing. Figure 1 shows the recovered components

- 1.1.8 The LE withdrew the two top clevis pins to each of the brake lever arms. The withdrawal of the rear pin allowed the removal of the bent rear lever arm which was still attached to the brake rod. The withdrawal of the front pin allowed the removal of the front brake lever arm from the brake pull rod and the lever arm came away with the brake beam assembly pivot attached to the centre of the lever arm (see Figure 1).

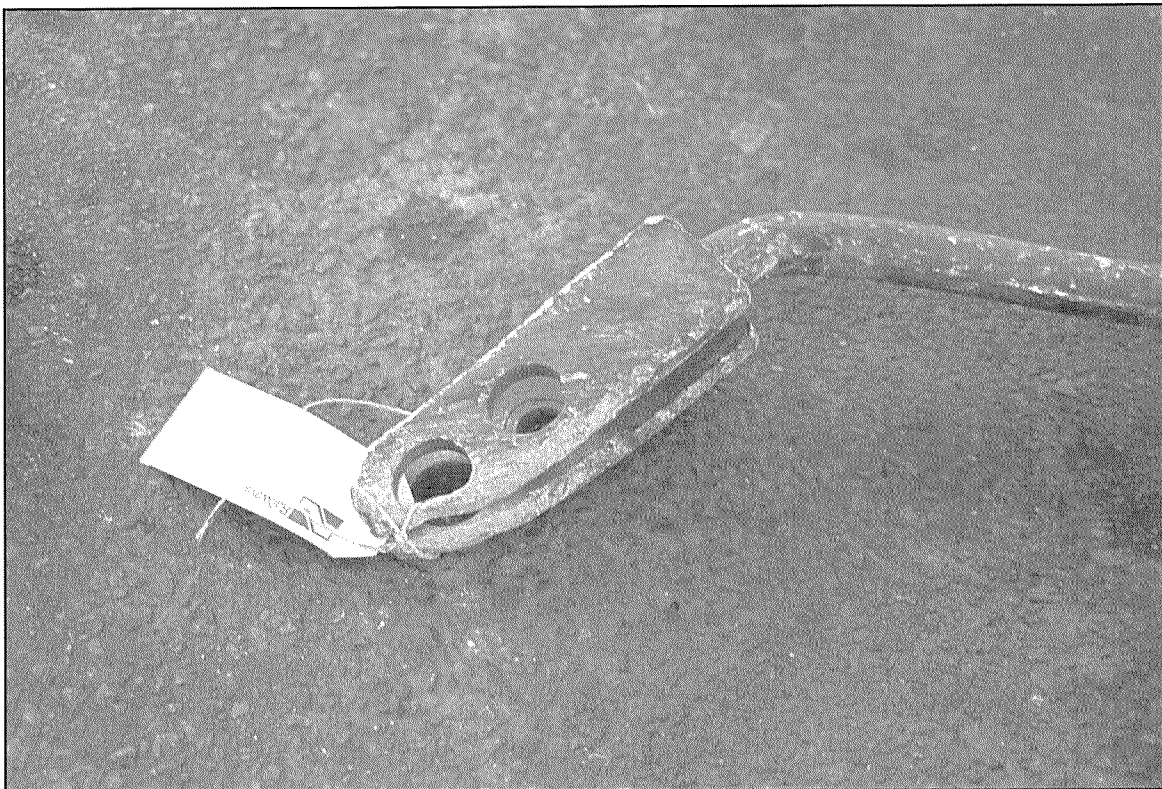
- 1.1.6 The edges of the front brake rod clevis had become worn away where it had trailed over the track ballast (see Figure 2). The clevis bolt fixing the rear brake rod clevis to the rear lever arm had been gas cut off flush with the outside of the nut (see Figure 3).

Figure 2
Front brake rod clevis (note wear resulting from trailing over ballast)

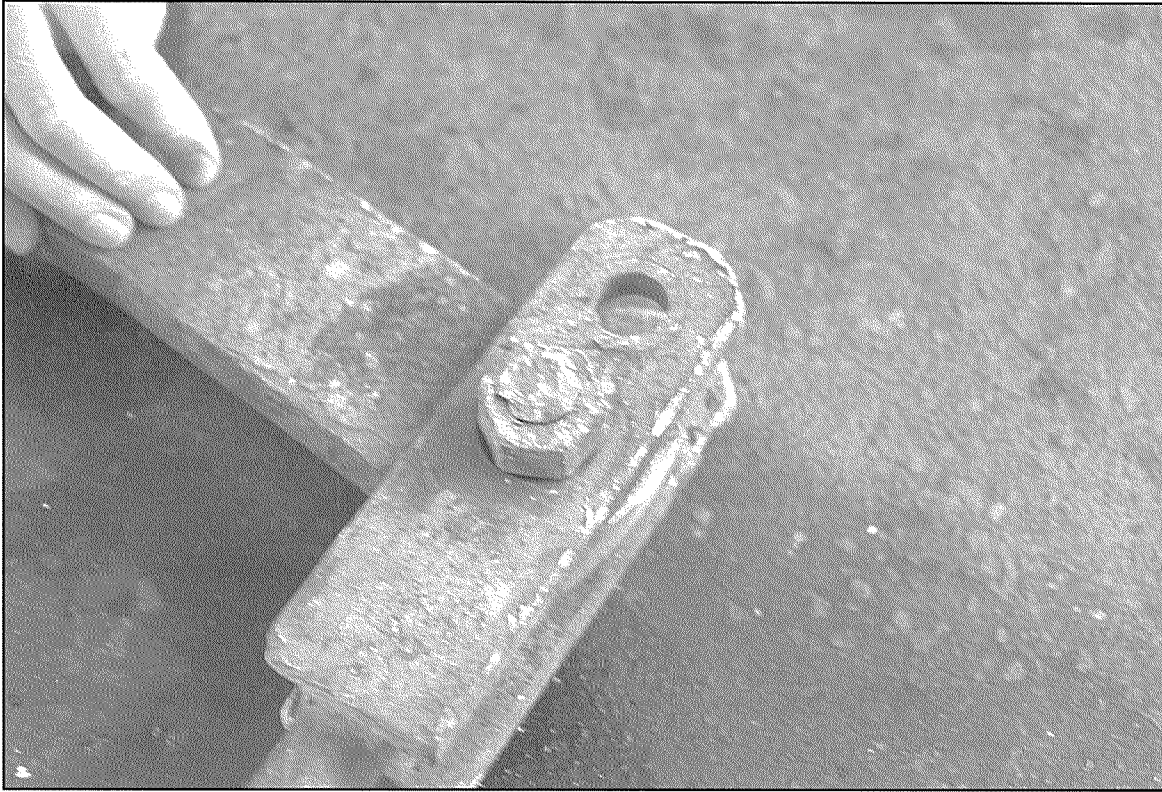
Figure 3
Rear brake rod clevis (note the gas cut marks on the end of the bolt)

- 1.3.9 The front clevis bolt to the brake rod was missing at the time the defective brake gear was removed from the wagon by the LE and a search of the track leading up to Hapuku failed to find it. The rear clevis bolt was in place but the thread had been gas-cut off flush with the head of the nut. The nut was able to be rotated slightly by hand but was held from coming undone by burrs on the thread caused by the gas cutting (see Figure 3).

- 2.3 The gas-cut removal of the bolt end on the trailing clevis was likely to have been done to remove weld fixing, although no evidence of the weld fixing remained.

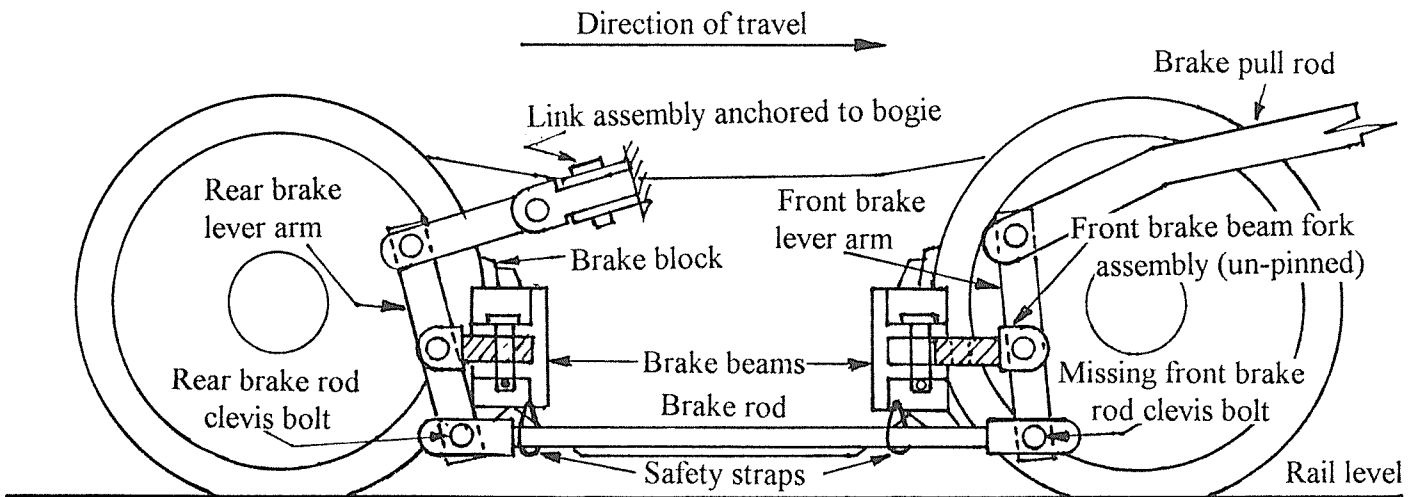
- 1.1.7 The front brake lever arm had not been located by the brake beam fork assembly and the brake pull rod had dropped down so that it was bearing on the leading axle of the bogie causing heat blueing (see Figure 4).

Figure 4
Diagrammatic section of the rear bogie showing hand brake gear (the front brake beam fork assembly is shown un-pinned in the housing)

- 1.3.4 As indicated in Figure 4, the front brake beam fork assembly on HKP74 was only partially located in the brake beam housing. The 140 mm long by 25.6 mm diameter locating pin was in position in the brake beam but not locking in the fork assembly (see Figure 5). The bottom split pin was missing from the locating pin.

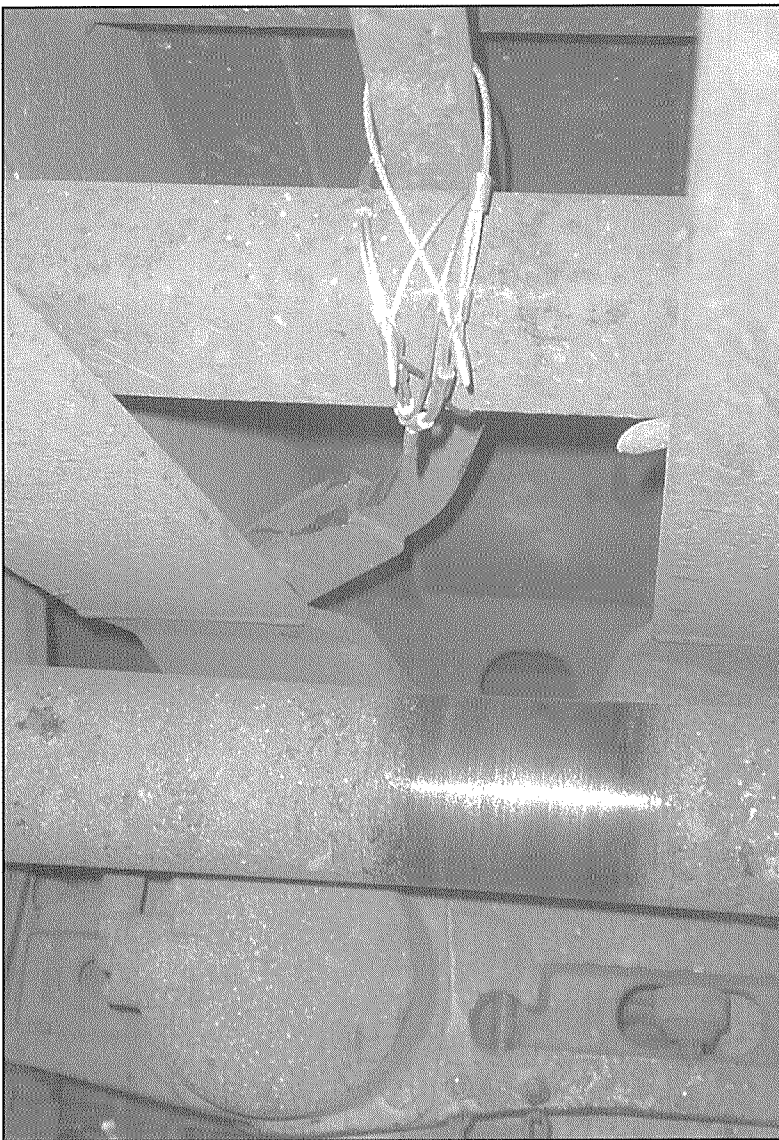
Figure 5
Axle and brake beam

- 1.1.9 The LE stated that he did not touch the pin that located the front brake beam fork assembly into the brake beam. He noted that this pin was still in place although the split pin at the bottom was missing. Figure 5 shows the pin still in the brake beam housing as it was described by the LE.

**blueing marks on the axle where
the brake pull rod was making
contact**

**the housing in the brake beam to
take the fork assembly with the
locating pin still in position (as
found)**

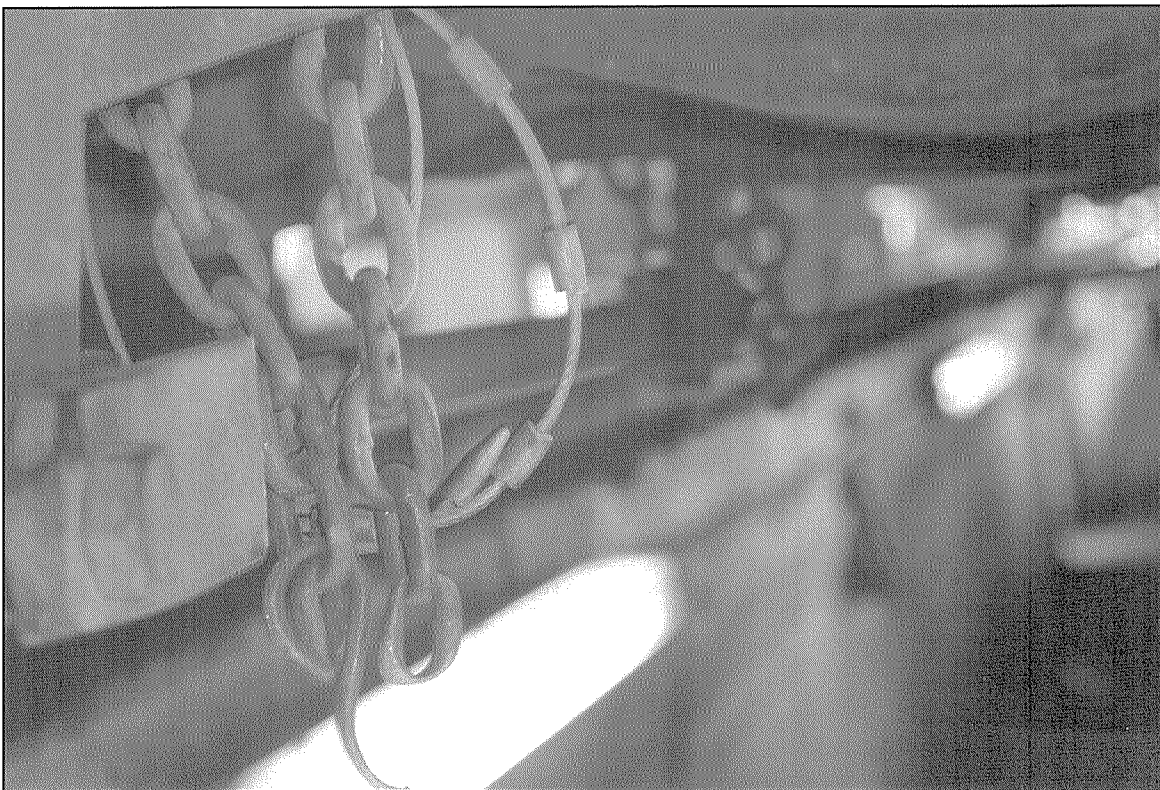
Figure 6
Safety strap

(note the previously used safety chain with worn links)

- 1.3.6 Tranz Rail recognised the potential for the brake rods to cause significant damage should they come loose and provided safety straps on all rodding. Chain links were originally used but because of the friction wear on the bottom links, safety straps had been introduced some two years ago. A safety strap was found adjacent to each of the turnouts at Hapuku. The straps consisted of a pair of 3.4 mm diameter woven stainless steel cables crimped together at 55 mm spacing and capable of being adjusted in length to loop around the brake push rod and be fixed through a pair of holes in the underside of the brake beam. Figure 6 shows a similar safety strap fitted to the brake rod on the leading bogie of HKP74. Also visible is the disconnected chain system that had been used, together with evidence of friction wear to the bottom links.
