Report 98-202

harbour tug *Purau*

restricted-limit ferry *Ngatiki*

collision

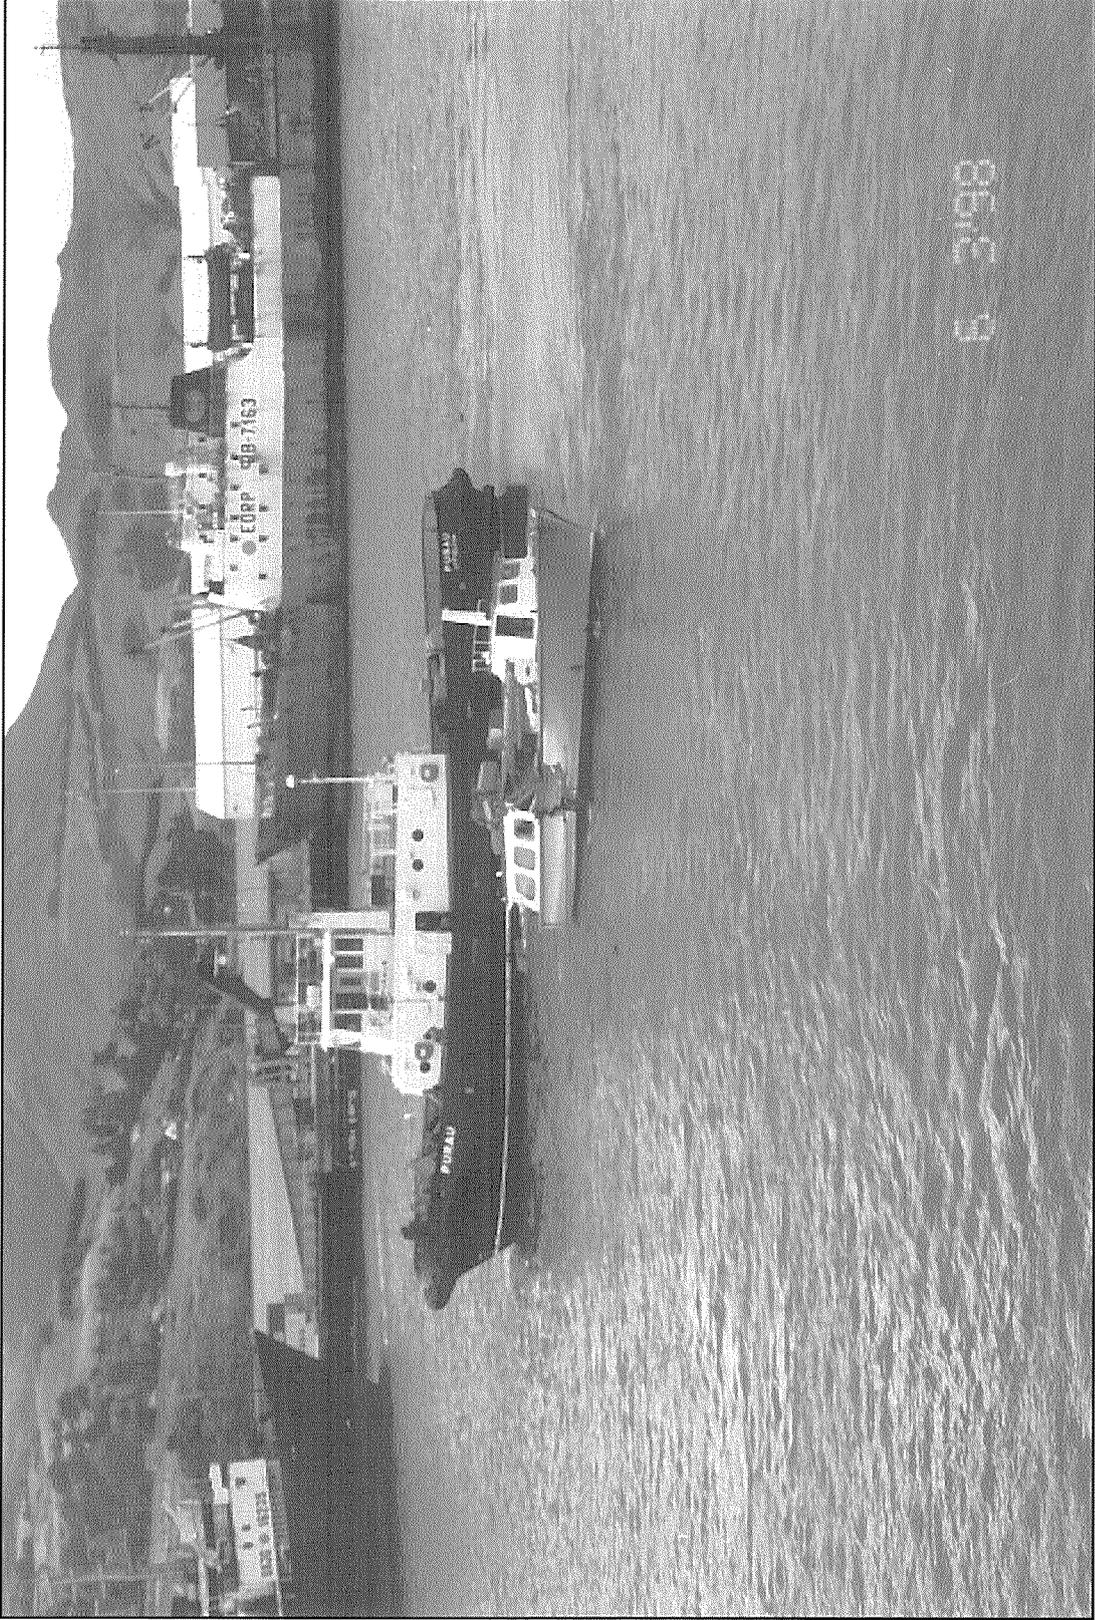
Figure 1
Purau and Ngatiki shortly after collision

- 1.1.16 Some of the way came off the *Purau* due to the full astern manoeuvre, but the simultaneous course alterations of the two vessels resulted in the *Purau* hitting the *Ngatiki* amidships on its starboard side. The impact caused the *Ngatiki* to heel violently over to port. The skipper later estimated the heel to be about 80 degrees. The large heel caused an inrush of water into the port side of the *Ngatiki*. The *Ngatiki* was holed on its starboard side and superstructure.

- 1.1.17 The *Purau* remained embedded in the starboard side of *Ngatiki* for a short period and the two vessels swung around together as a result of the collision. As the astern power took effect, *Purau* pulled free of *Ngatiki* but the vessel continued to swing and it passed down the port side of *Ngatiki*. The skipper of *Ngatiki* put his vessel astern to clear the immediate area of the collision. During this confused movement of the two vessels, the starboard quarter of *Purau* came into contact with the bulbous bow of the *Green Wave*.

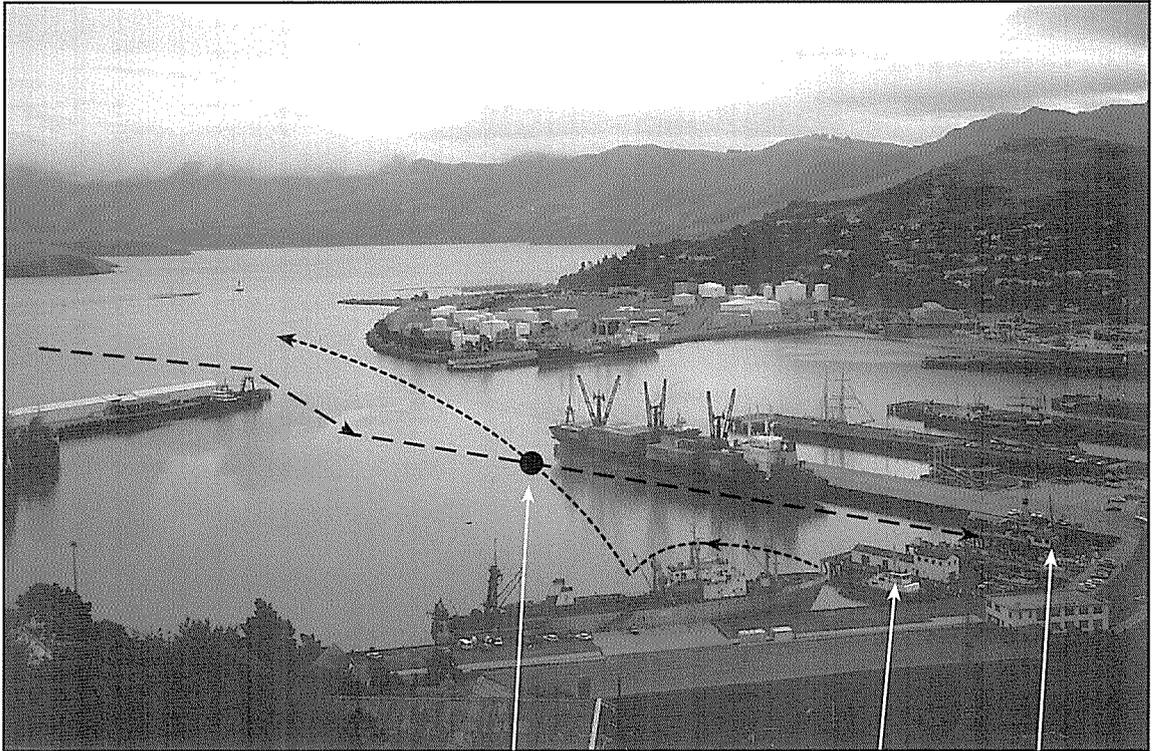
Figure 2
An overview of the Port of Lyttelton

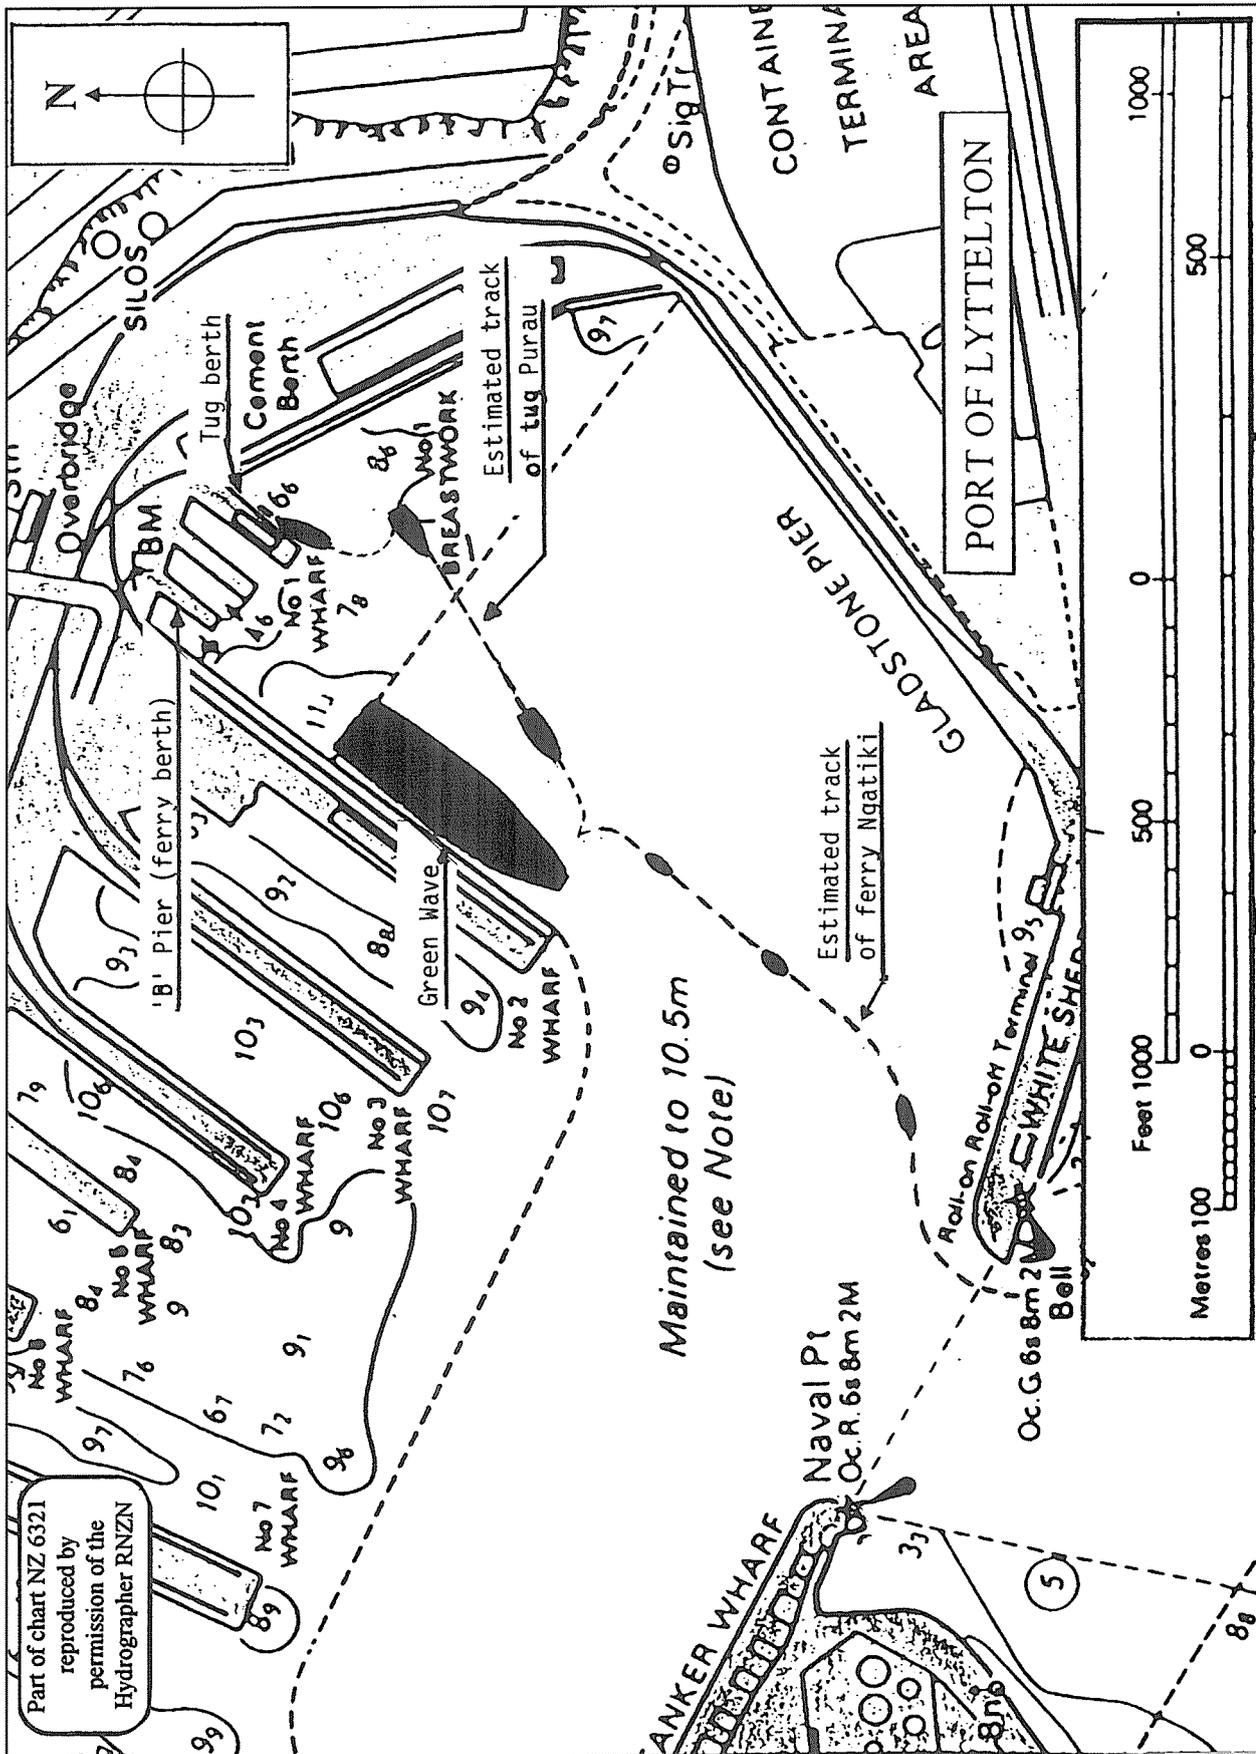
Figure 3
Part of Chart NZ 6321 showing estimated tracks of Purau and Ngatiki

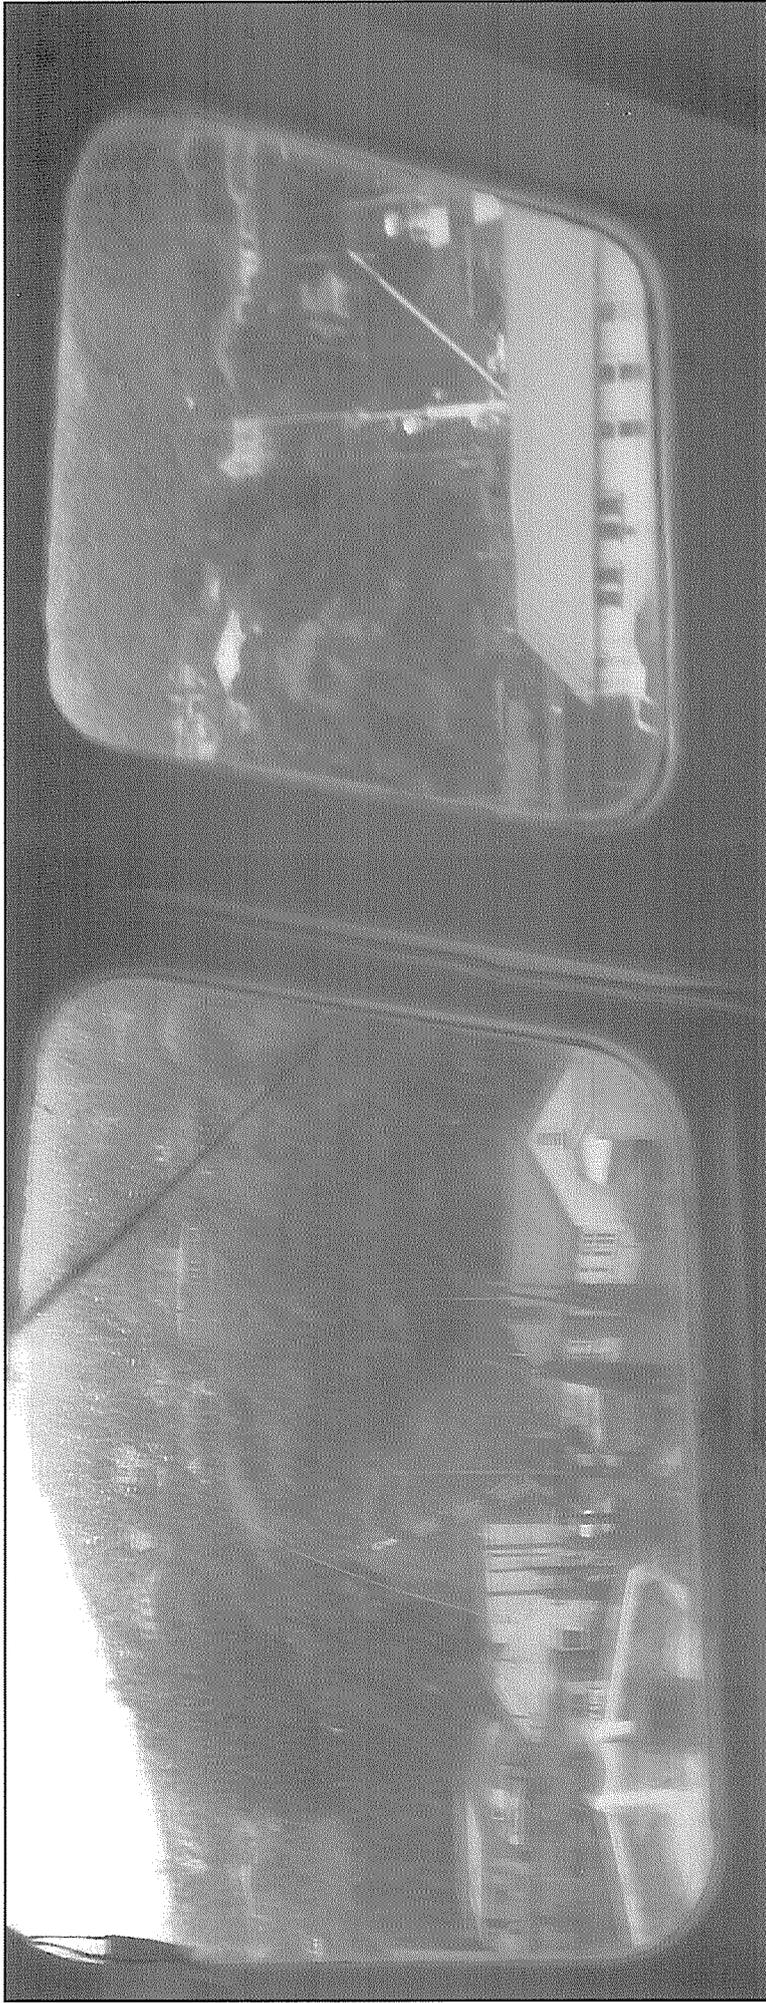
Figure 4
View from steering position of *Ngatiki*

- 1.5.4 The wheelhouse was fitted with three forward windows. The central athwartships window was the largest. The windows on either side were smaller and angled slightly towards aft. The width of the mullion between the windows was about 20 cm, (see Figure 4). The steering position of *Ngatiki* was in line with the mullion between the central and port side windows.
