## **Report 98-204**

### **Wave-piercing catamaran ferry *Condor 10***

#### **heavy weather damage**

#### **Wellington Harbour entrance**

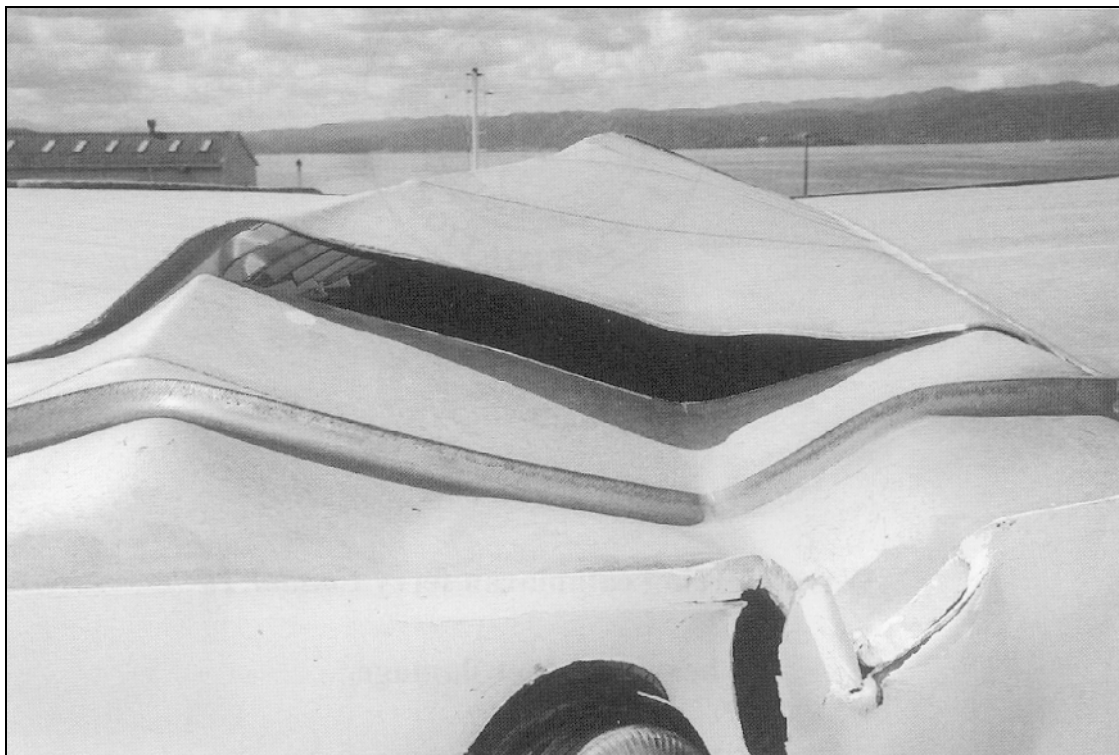
**Photograph showing an outside view of the crumpled ceiling of the car deck**

- 1.3.6 The top of the car ramp and car deck ceiling was compressed, causing the car ramp supports to fracture and, as there was little horizontal bracing between the car ramp supports and surrounding hull structure, the car deck ceiling crumpled.

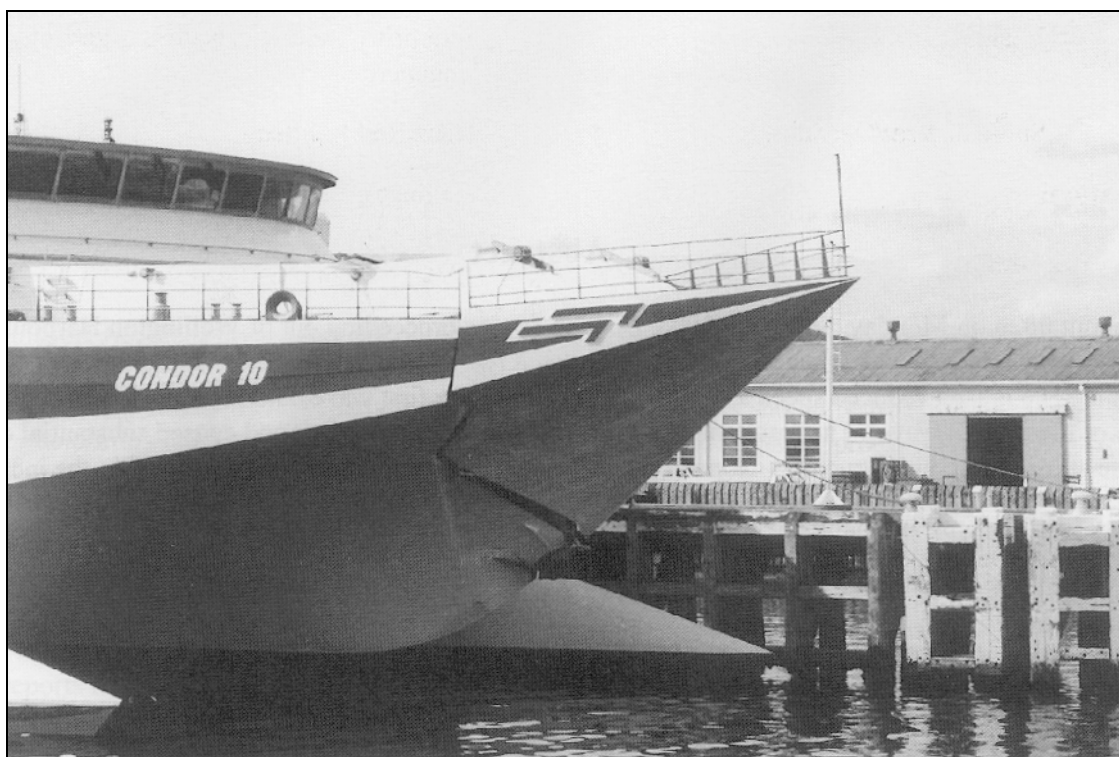
**Photograph showing the displaced bow visor on *Condor 10* shortly after the incident**

**Nature of damage:** Bow visor displaced, causing significant  
damage to the visor and surrounding hull  
structure

- 1.3.1 The impact damage to the supporting centre hull structure and visor was such that the visor remained partly open.
- 1.3.2 Some of the internal T-section frames running along the hull plating of the centre bow were twisted, and torn away from the plating. Tubular struts between the floor and upper decks were distorted and some had been torn away at one end. The hull plating under the flare of the centre bow was set up between the frames on the starboard side only.

- 1.3.3 The starboard locking device and its surrounding structure had failed in overload. The socket was torn away from the visor in a direction both upwards and to port while it was still engaged on its wedge pin. The pin had been pulled out from its housing. There was a large degree of deformation associated with each failure.

- 1.3.4 The port locking device had failed in a similar way to the starboard one.
- 1.3.5 The damage would have occurred almost instantaneously, and was consistent with the centre bow impacting a wave with a bias on the starboard side.

- 2.1.19 The damage to the centre bow was not caused by the failure of the two securing devices. If the securing devices alone had failed, then the bow visor would have been relatively free to pivot about its top hinges. With only its hydraulic rams to hinder such movement, damage to the structure behind it would have been minimal. The fact that the structure behind the visor also sustained significant damage, indicates that the whole centre bow was subjected to forces beyond its design parameters, rather than just the bow visor itself. If the securing devices had not failed, then the damage to the main structure of the centre bow could have been worse.

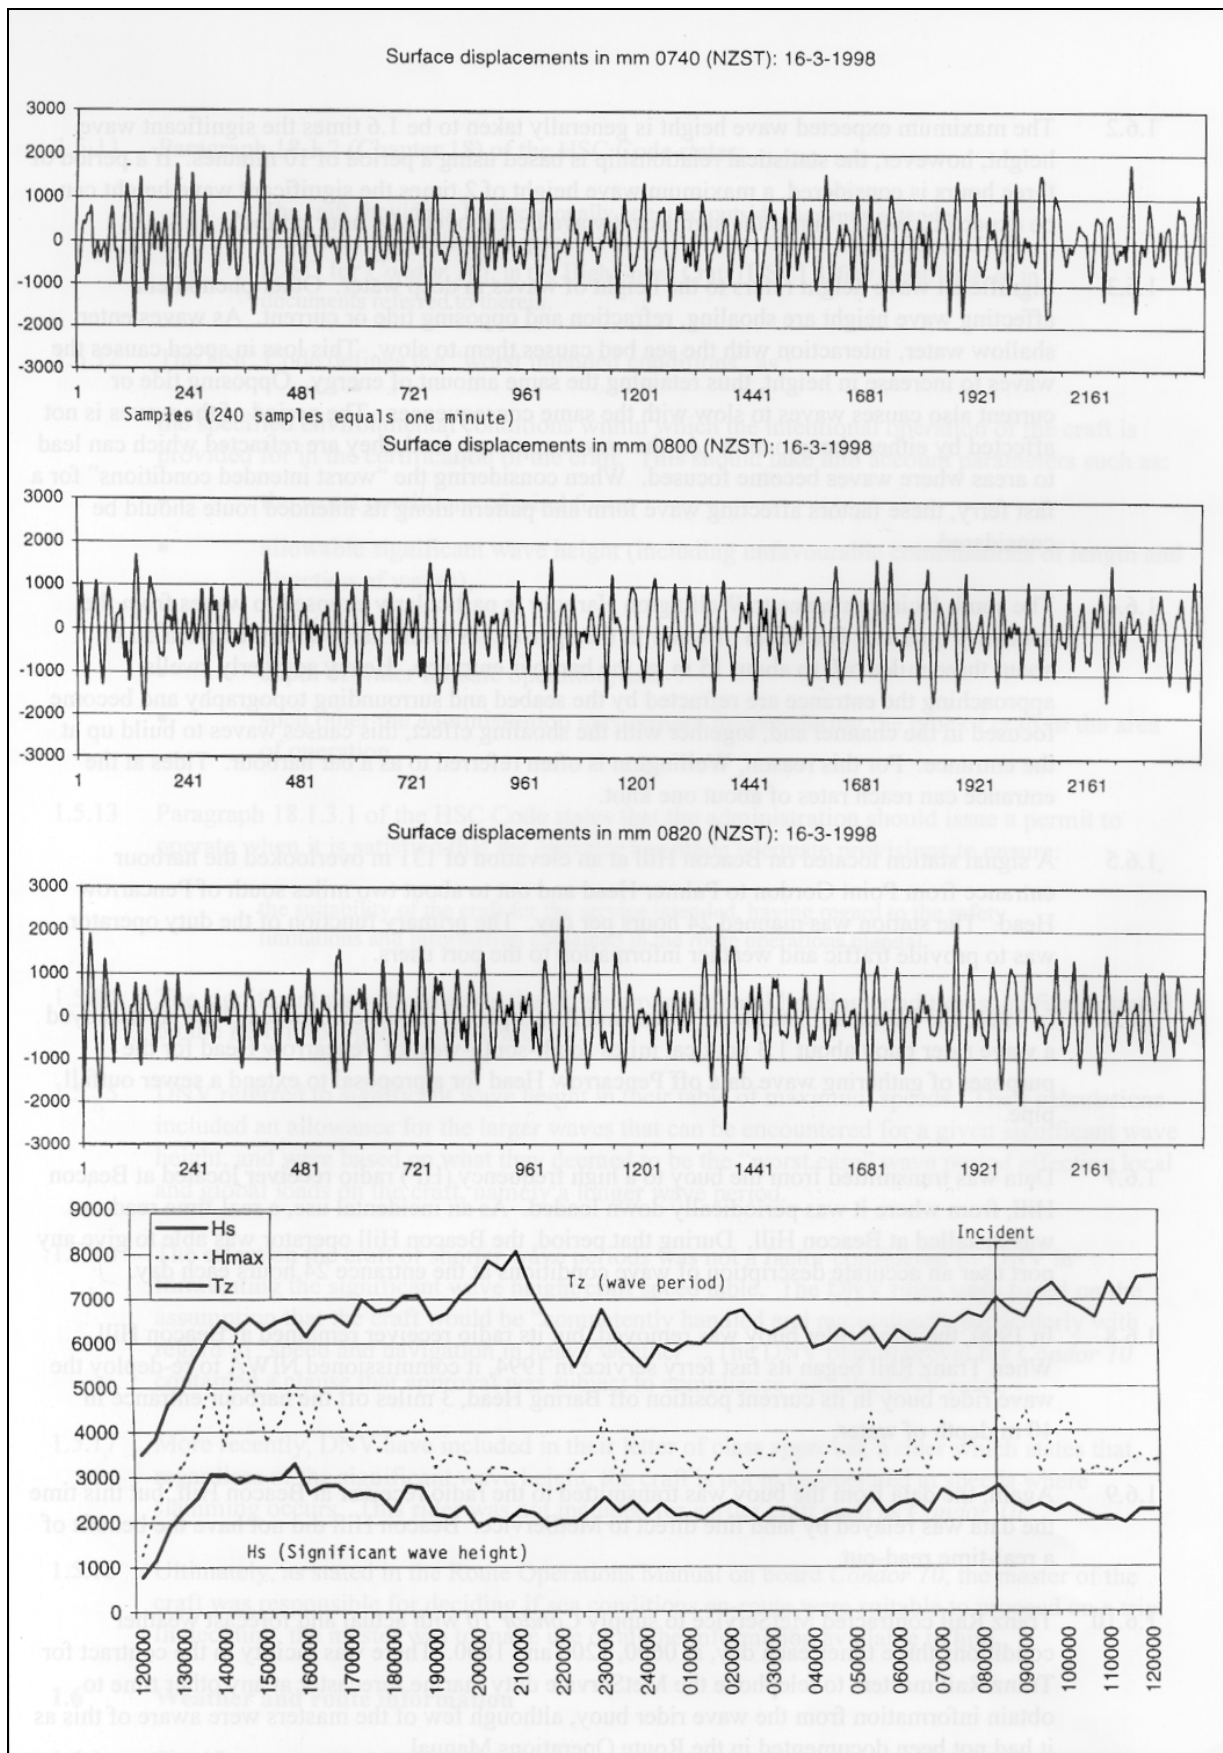
**Figure 2**  
**Graphs showing the surface displacements, significant wave height and period, and maximum wave heights over the period the incident occurred**

- 1.6.20 Note that from 0740 to 0800, about the time the Beacon Hill operator observed and reported to the master of *Condor 10* the swell conditions at the entrance, the wave pattern was relatively uniform at about 2.5 m significant height. The Beacon Hill operator's assessment was probably a little low, but from his position up on the hill, was fair.
