## Report 98-208

### Ro-Ro cargo vessel *Union Rotoma*

#### shift and loss of cargo

29 July 1998

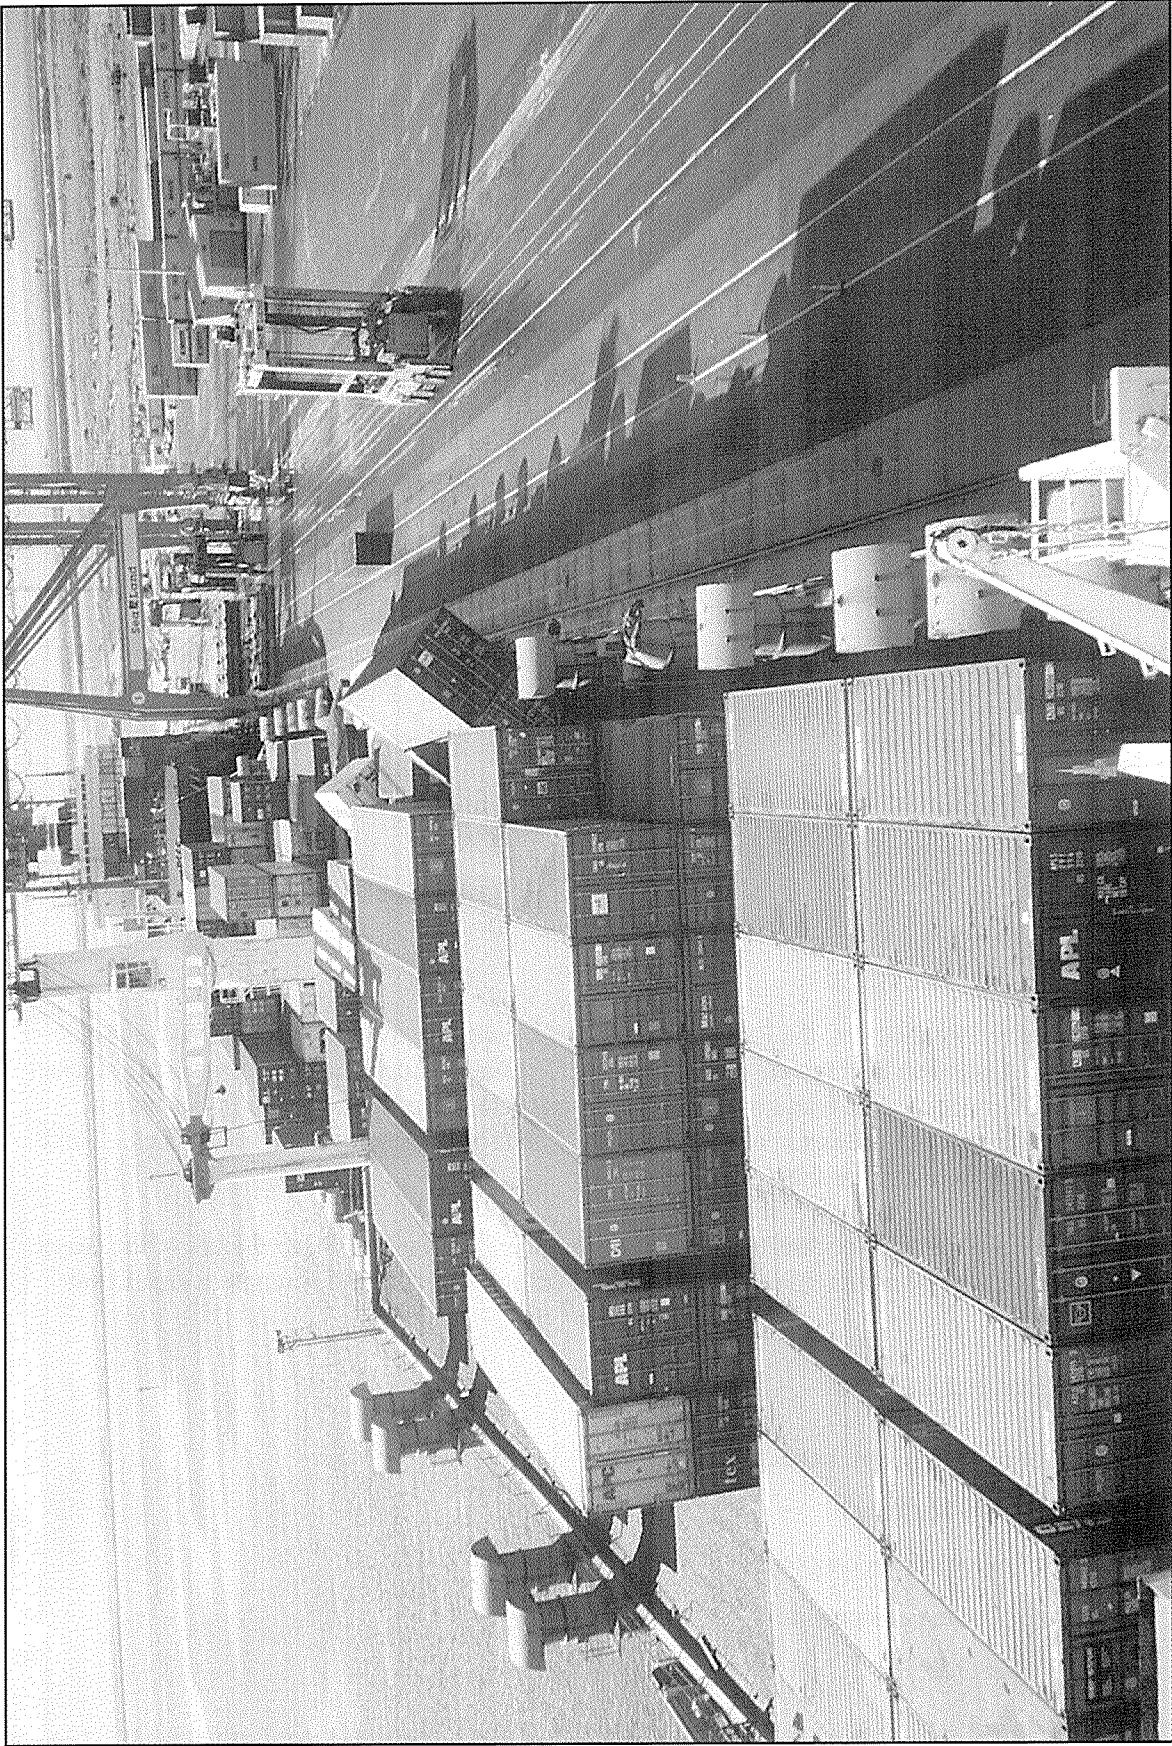
The foredeck of *Union Rotoma*, on arrival at Adelaide

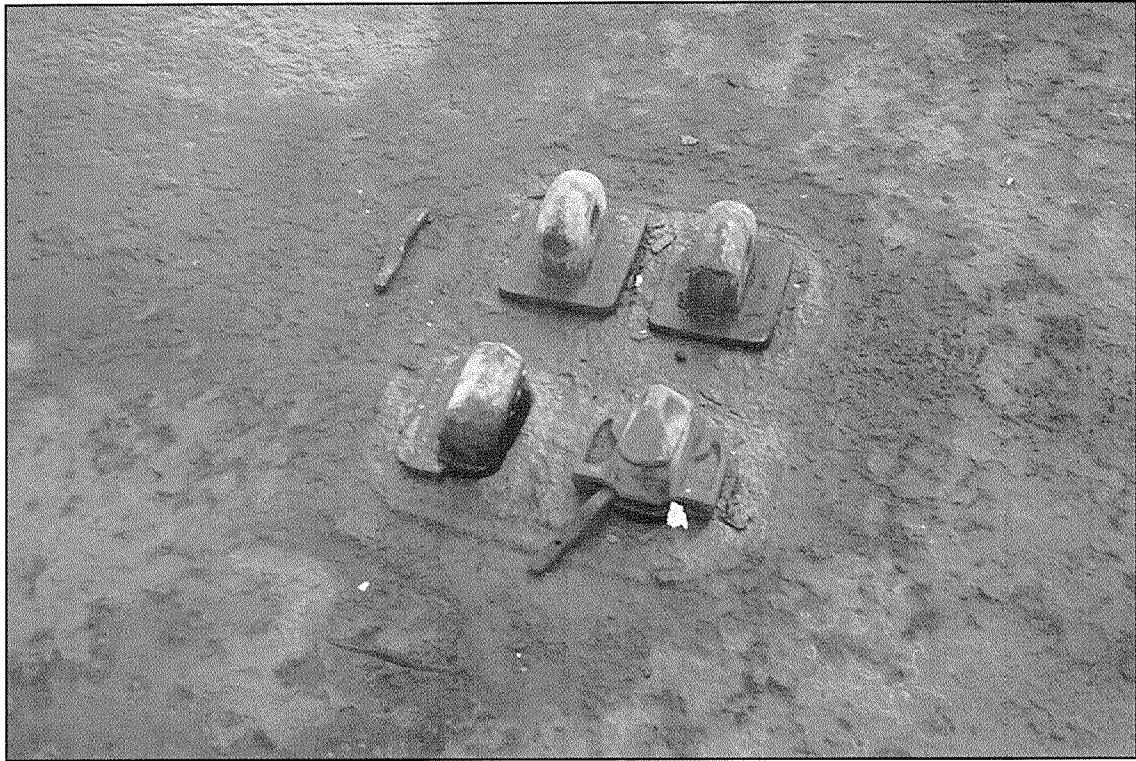
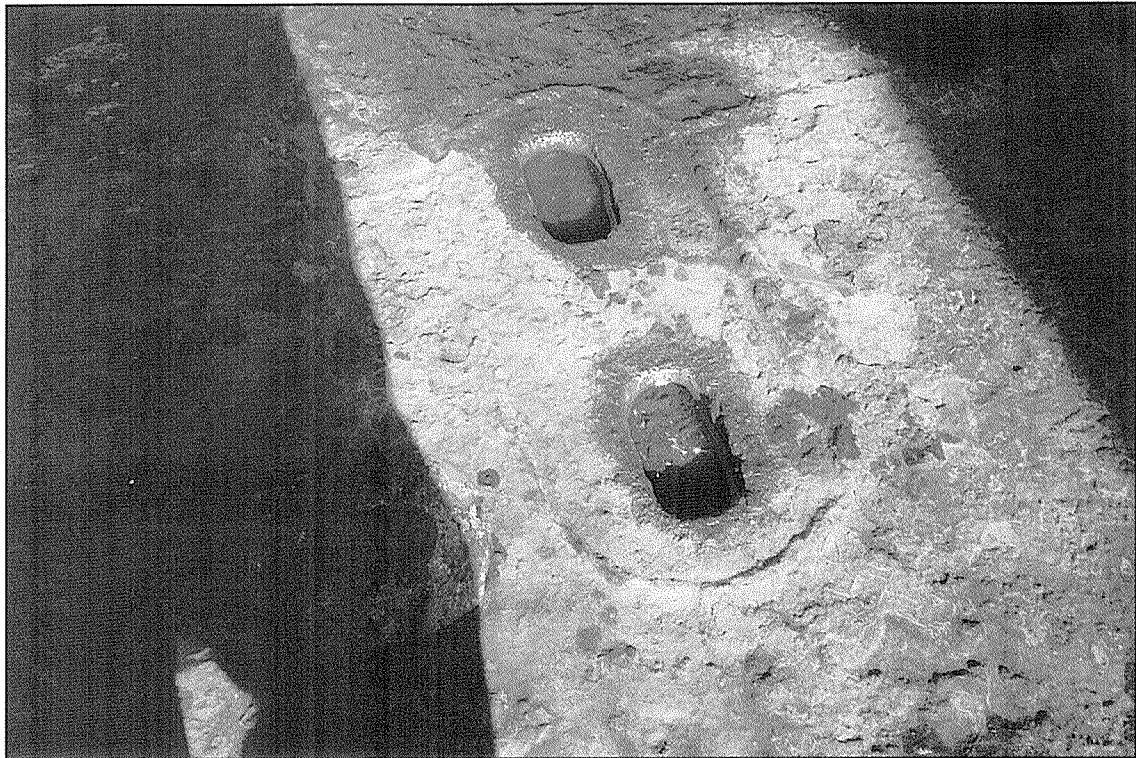
**Figure 2**  
Photographs showing enlarged openings in the deck sockets caused by a combination of corrosion and stacking cones being pulled out under load (bottom photograph), and incorrect use of twistlock (top photograph {note half the load bearing plate missing from the bottom left stacking cone causing it to sit on an angle})

- some container sockets recessed into the deck had been deformed by a base stacking cone pulling out under load (some of these deformities appeared to be recent, others appeared to have been existing before the accident; see Figure 2)

- 2.4.6 Container fittings are only as good as the permanent fixture to which they are attached. Some of the recessed sockets in deck 5 of *Union Rotoma* had become enlarged through corrosion which resulted in a reduced holding potential. There was evidence that some sockets had been damaged prior to the accident, probably by containers being lifted with a pin still inserted through a stacking cone.

5.1.2 surveys the fixed container lashing points and makes repairs as necessary. (113/98)

5.2.2 We shall be repairing container lashing points as necessary whilst the ship is in service and expect to carry out a detailed survey/repair at the next scheduled docking (January 2000).

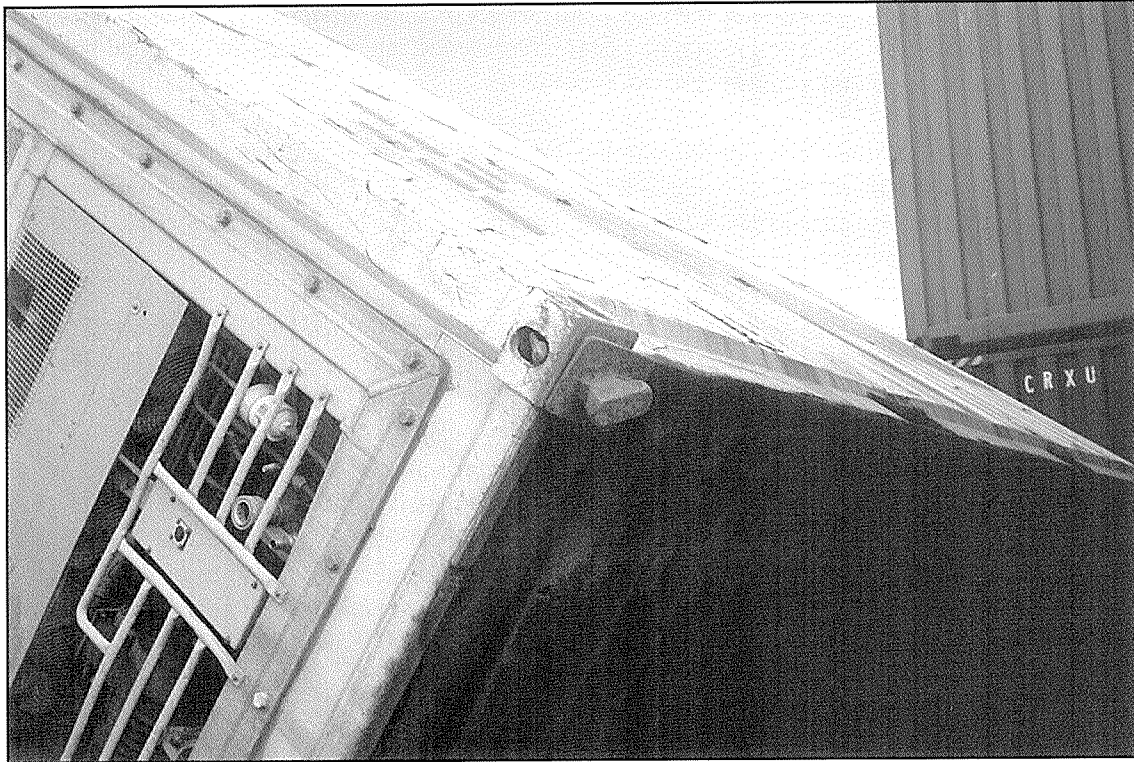
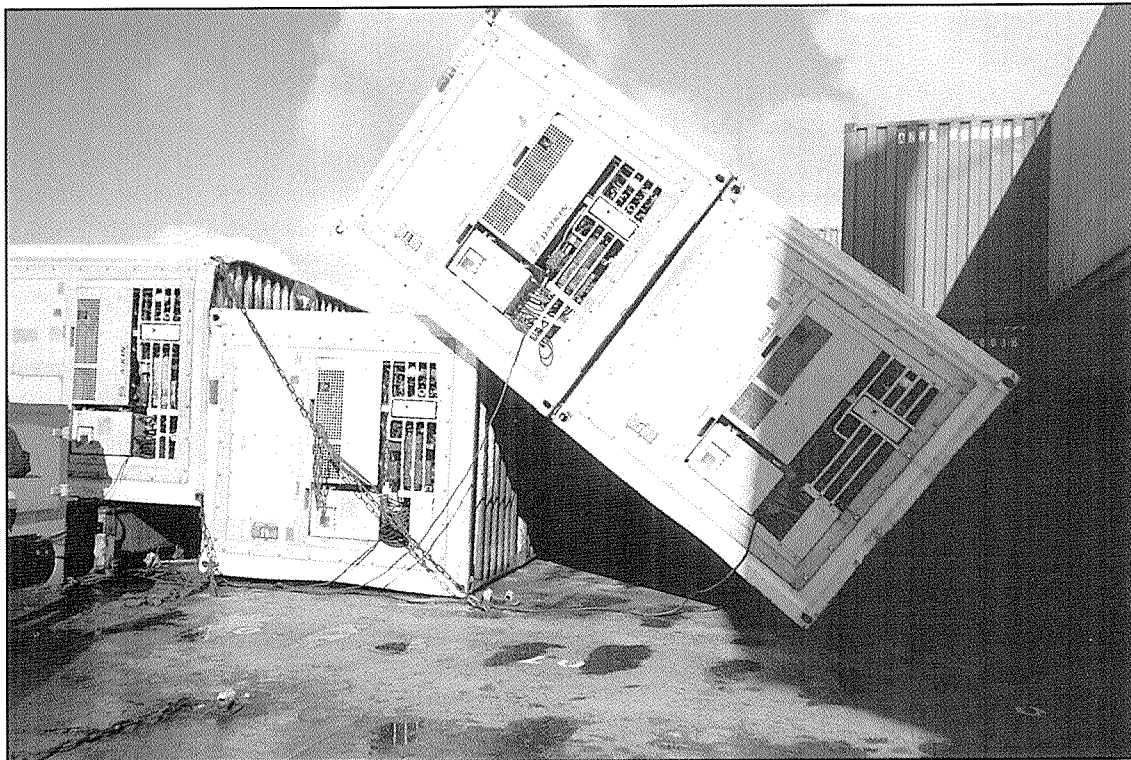
**Figure 3**

**Photographs showing toppled reefer containers in Bay 21; note the stacking cone still pinned to the bottom corner casting in the top photograph; the cone was torn from the deck socket. The two bottom containers weighed about 17.5 t each; the one far left (top stow) weighed about 21.5 t. Two containers, one TEU and one FEU, stowed outboard of the containers shown were lost overboard**
