Report 98-209

fishing trawler *San Rakaia*

grounding

Ninepin Rock

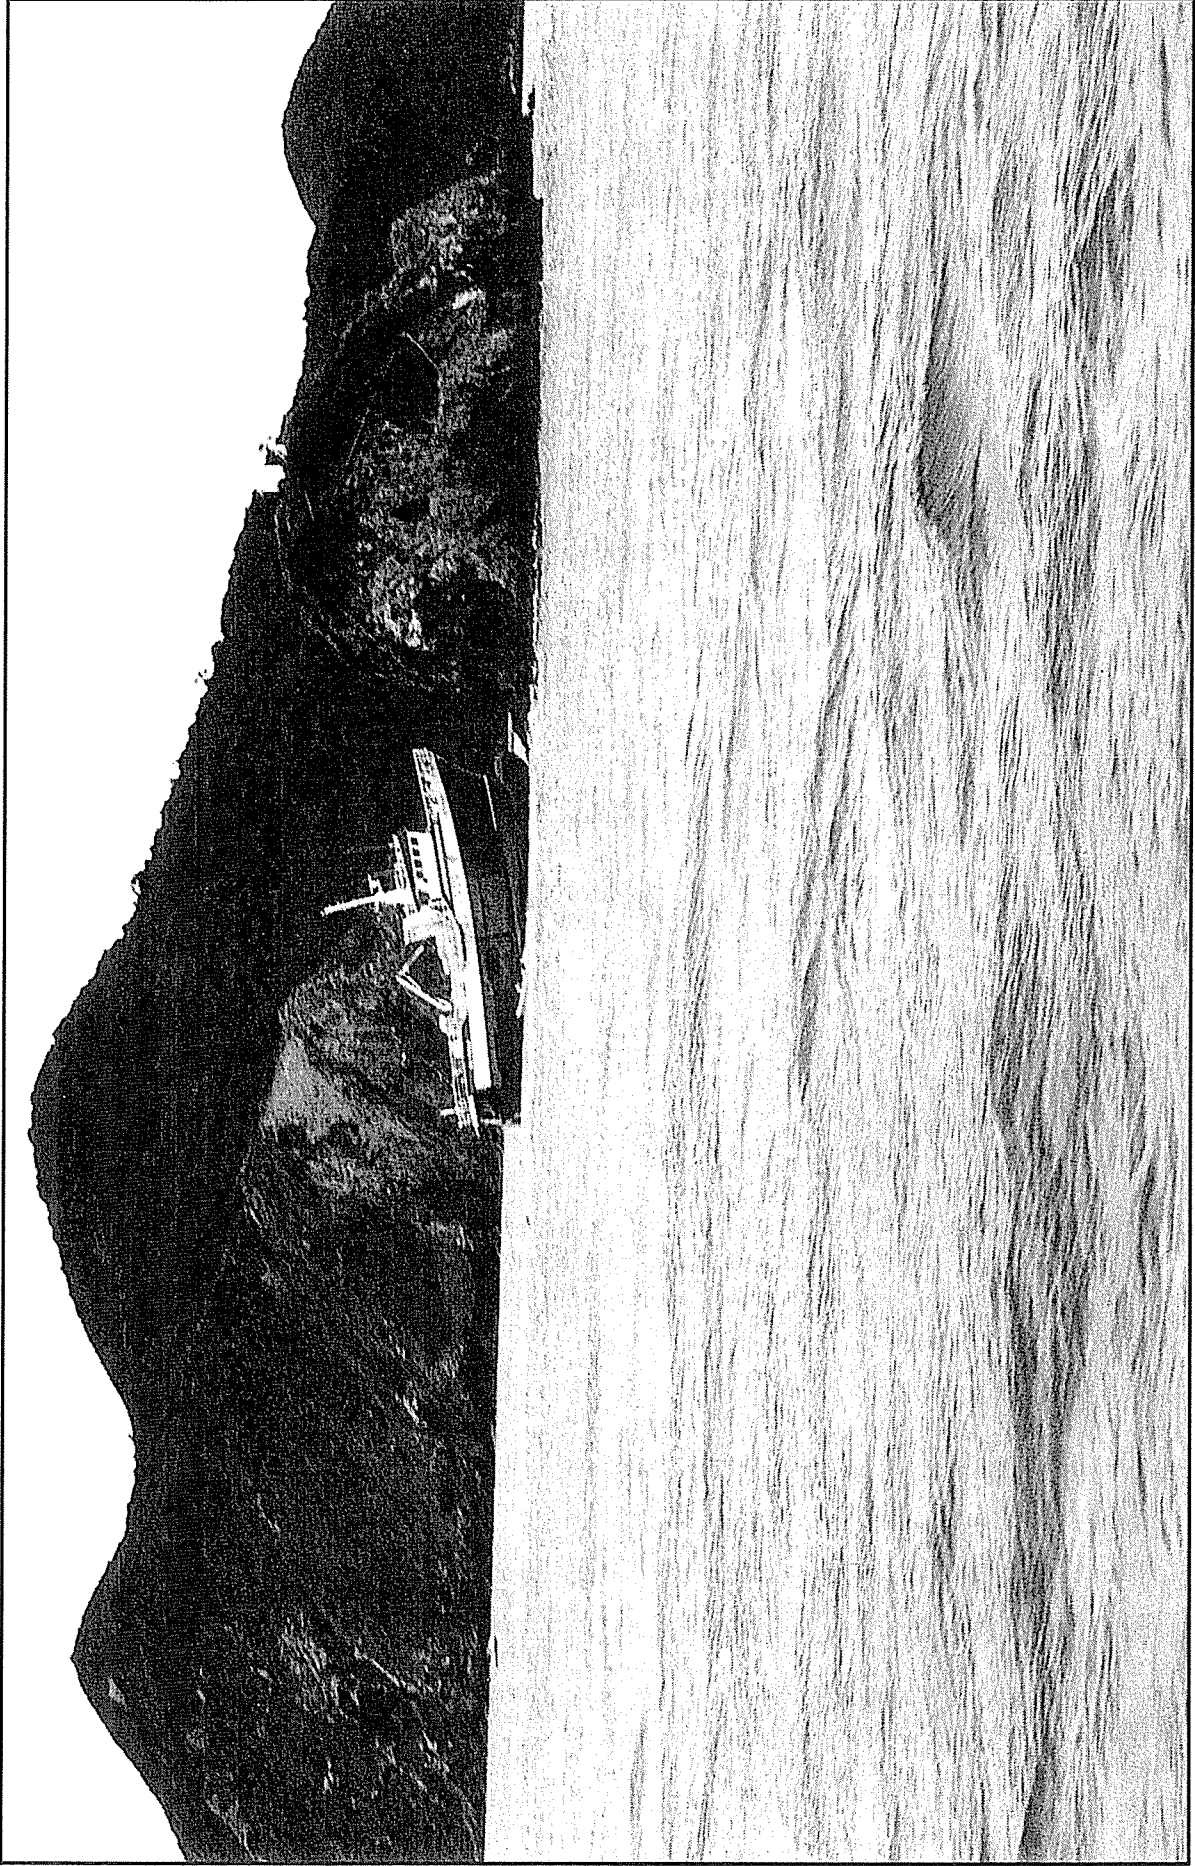
San Rakaia aground on Ninepin Rock

Nature of damage: Forward 4 m section of box keel heavily indented and cracked. Echo sounder pod distorted

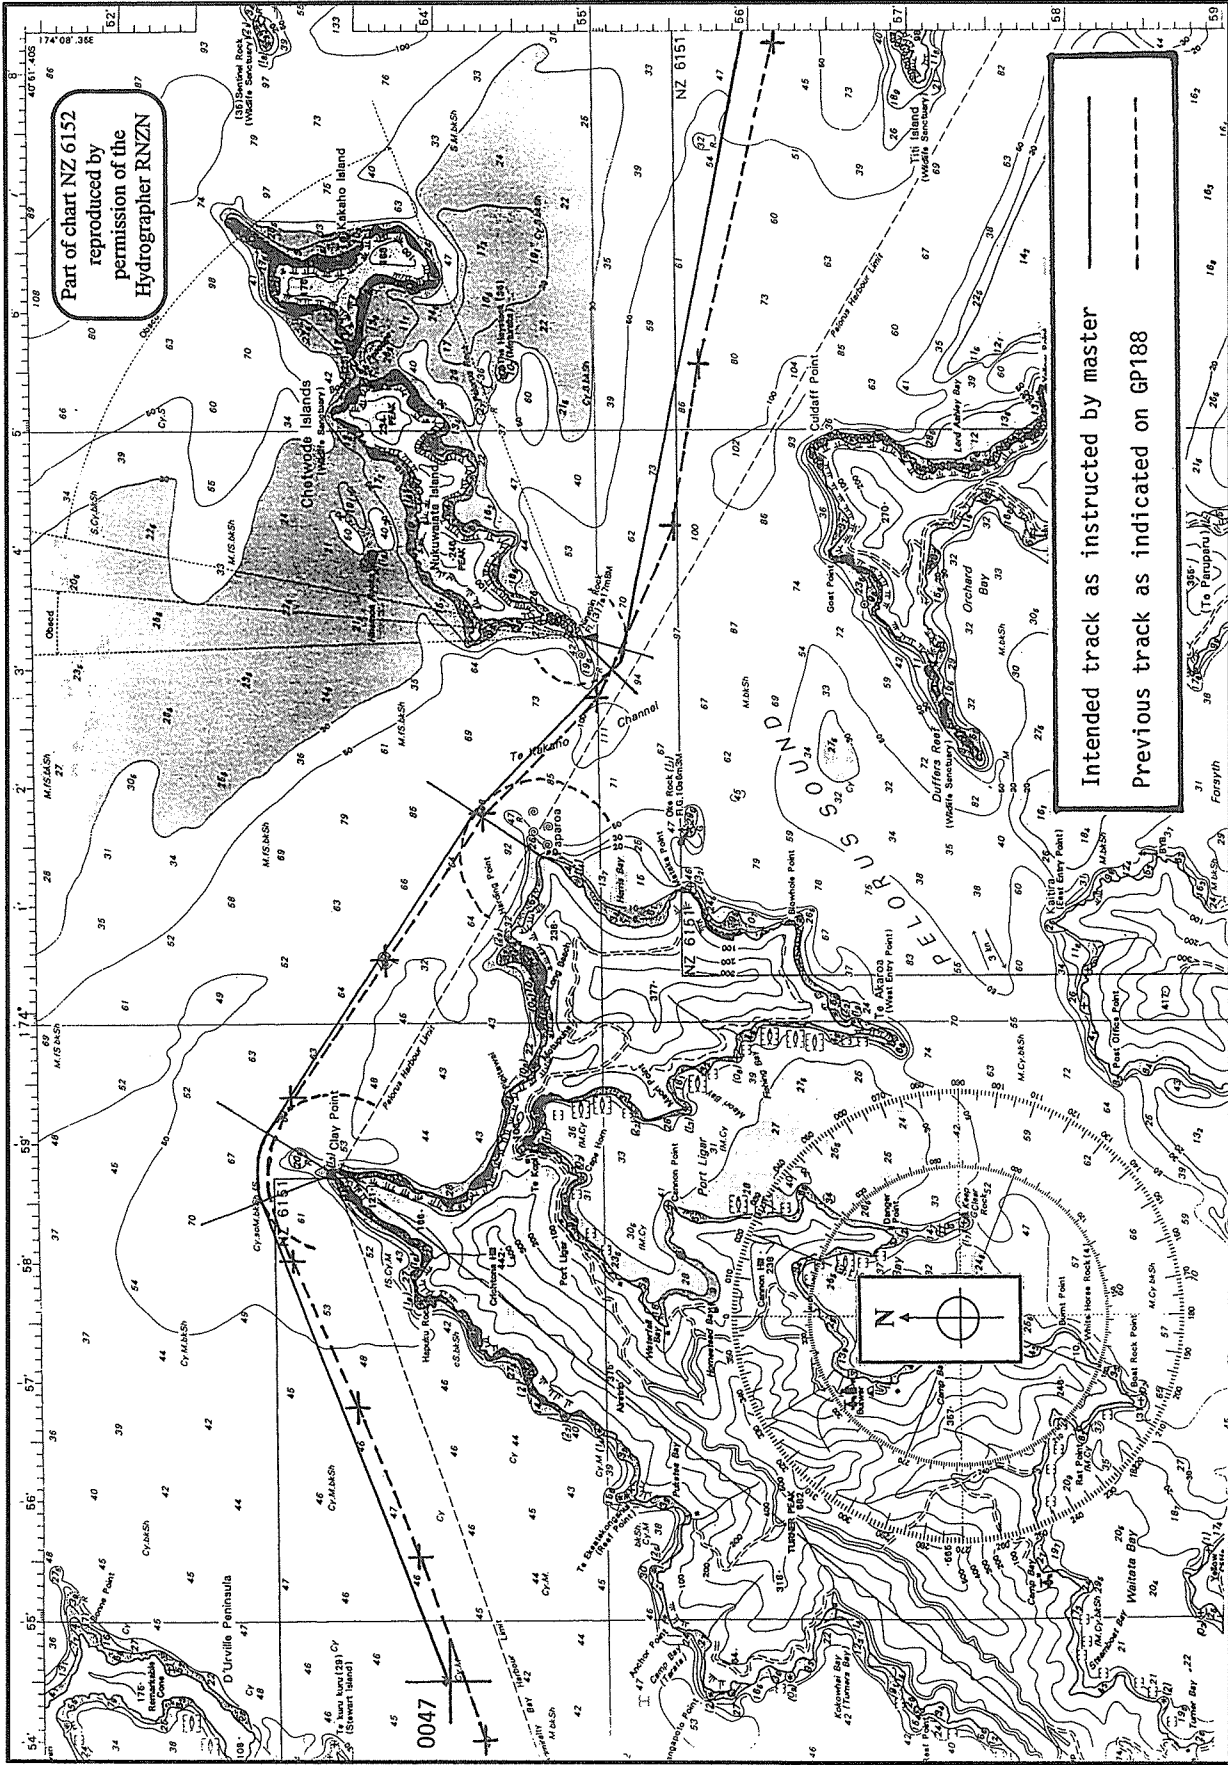
Figure 1
 Extract of chart NZ 6152 showing intended route

- 1.1.8 The intended track on which the master briefed the deckhand was that he should go around Clay Point keeping at least 0.5 nautical mile off, then pass Harding Point abeam to starboard keeping at least 0.5 nautical mile off and then pass Ninepin Rock abeam to port keeping at least 0.3 nautical mile off before proceeding onwards to Titi Island, Cape Jackson and the Brothers. (See Figures 1 and 2.)

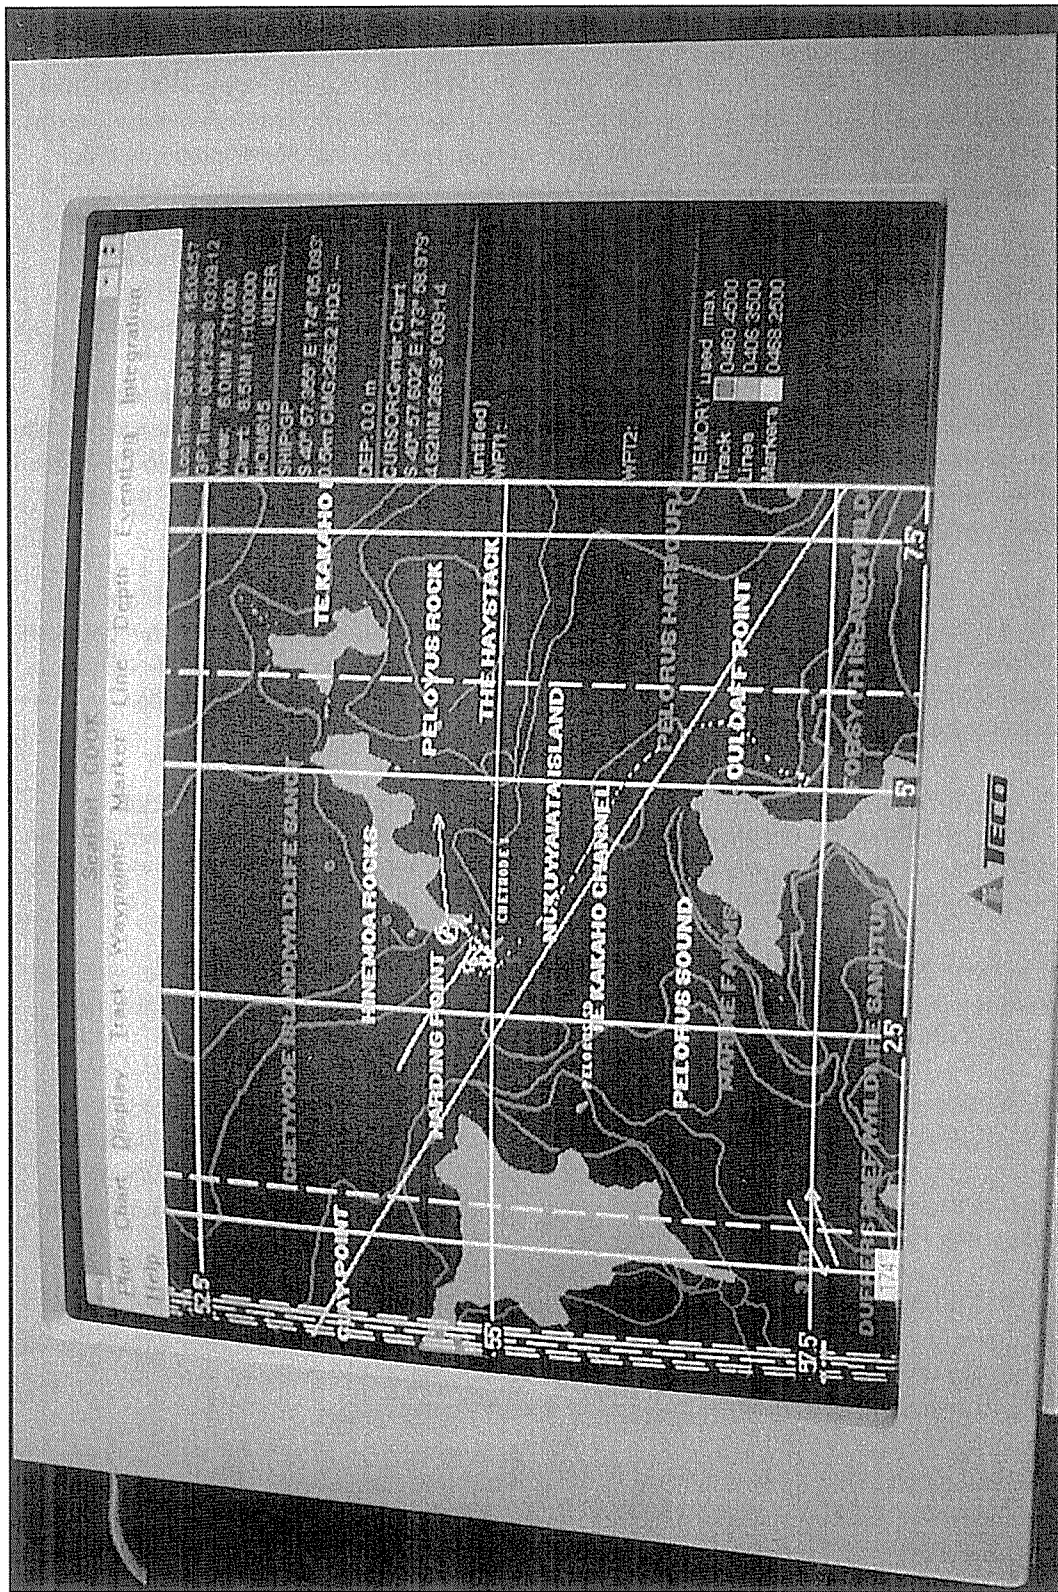
Figure 3
 Past track history as depicted on Seaplot Chart Monitor

- 1.1.17 He said he remembers observing an indication on the GP188 that there was a distance to go to the alteration position of 0.3 nautical mile. He also remembers centring the Seaplot display "at some stage". The past track history depicted on the Seaplot, indicated that this centring was done at or about the intended alteration position off Paparao (see Figure 3). The deckhand does not remember altering the course.

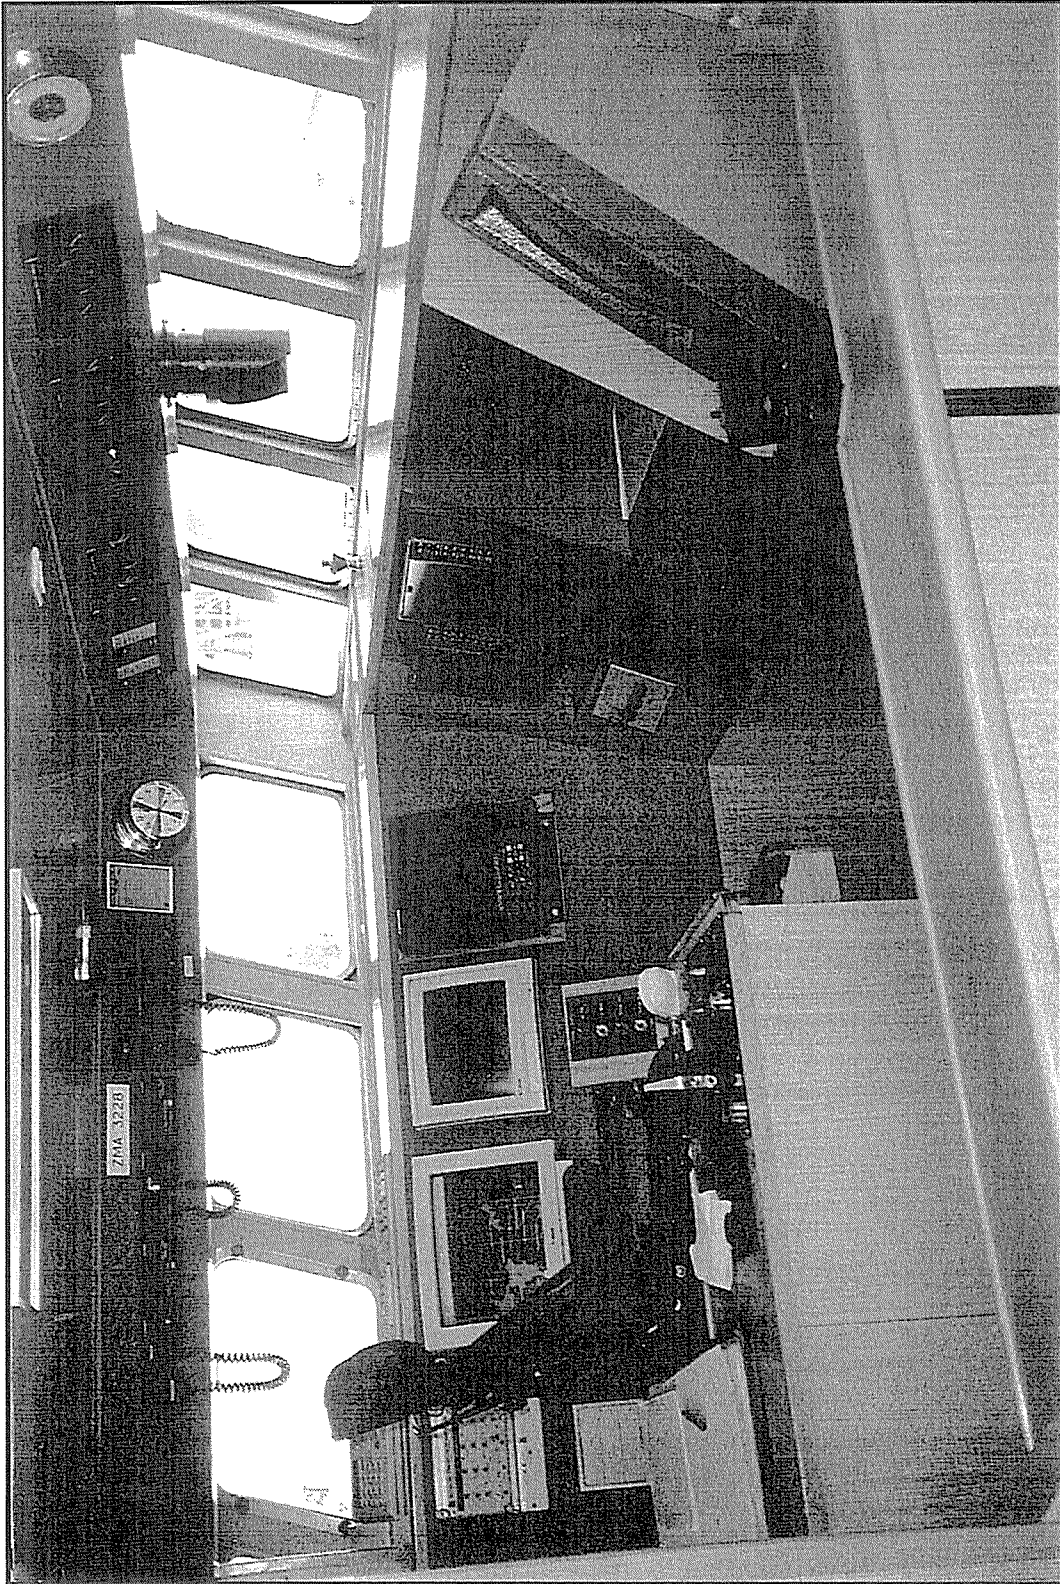
Figure 5
View of the wheelhouse of *San Rakaia*

1.6.8 The bridge was designed for one person operation, but was not fitted with a single-handed-watchkeeper monitoring alarm system (deadman alarm). Under such a system a watchkeeper must periodically reset a timed alarm. Should the watchkeeper fail to do so, an audible alarm would sound. If that alarm was not acknowledged by the watchkeeper, the alarm would be transferred to another position to alert other personnel.

- 4.2.2 **106/99**
In regards to the fitting of Deadman Alarms to the bridges of Company vessels where these are not already fitted, Sanford Limited intends to implement this safety recommendation. Currently we have invited suppliers to tender for the supply of Deadman Alarm units, we would anticipate the process being completed by 7th May 1999 and a supplier being awarded the contract by 21st May 1999.

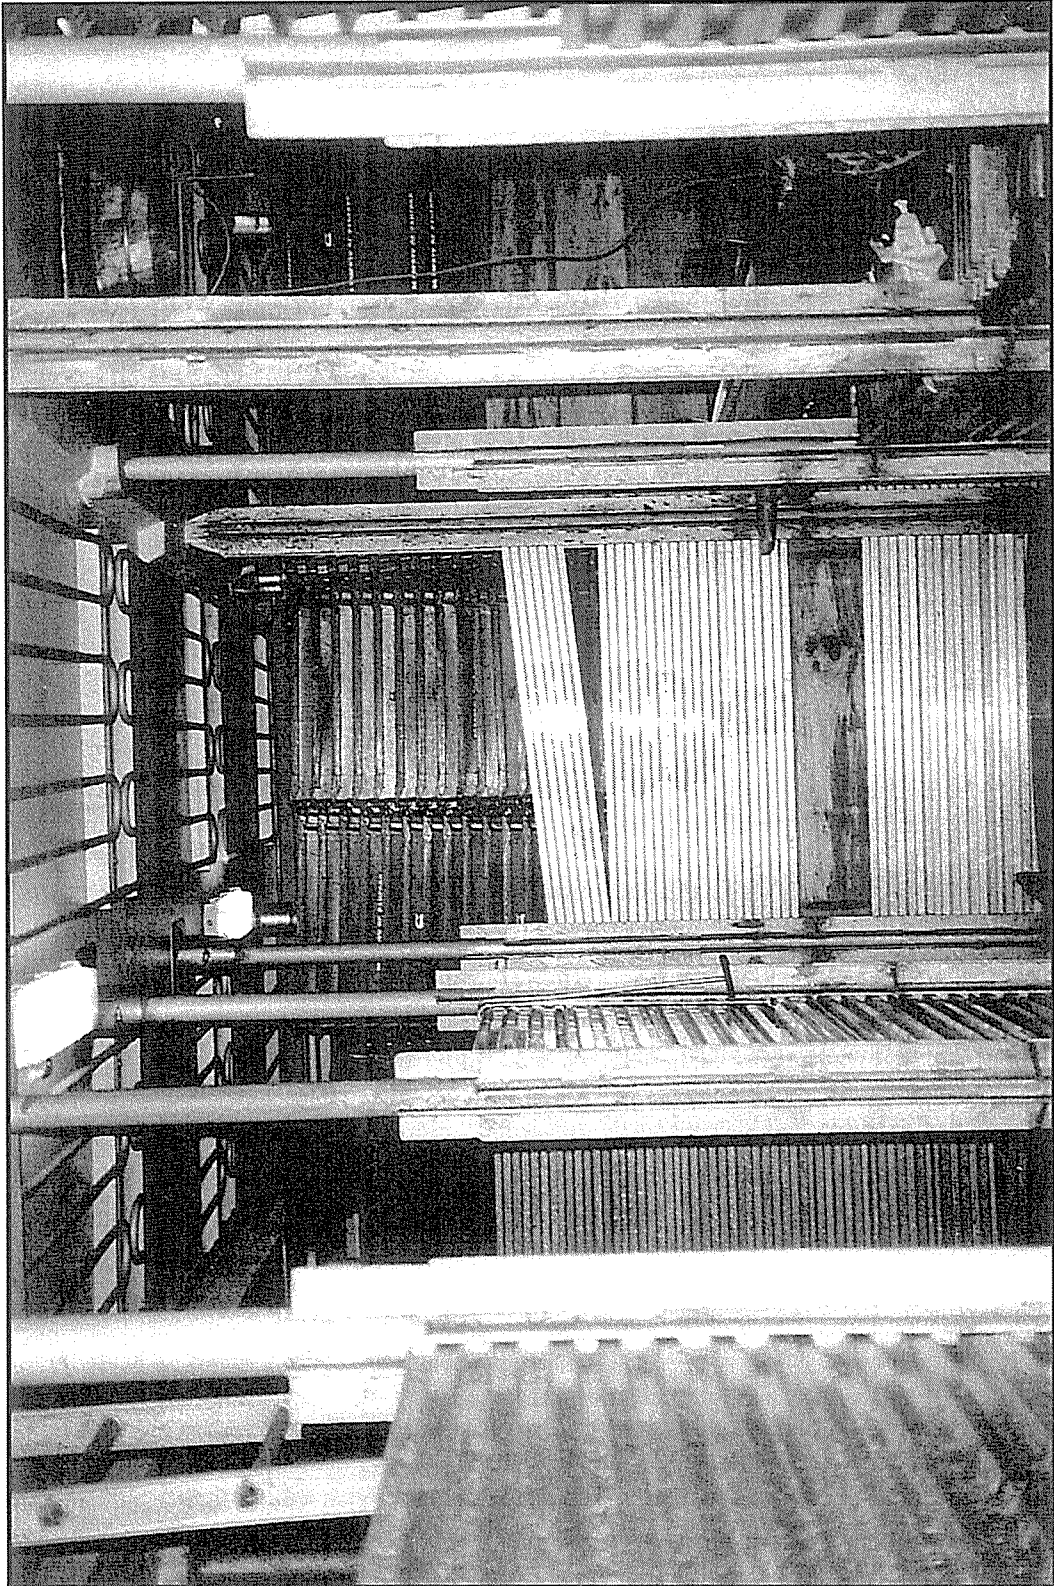
Figure 6
View of fish hold of San Rakaia

1.4.4 The filled bins, each holding 27 to 28 kilos of fish, had to be manhandled throughout the fish hold and stacked between retaining pond boards. The hold was 12 m long, 9.5 m wide and 3.25 m deep, making the stowing of the catch a physically demanding task. There was no mechanical assistance available in the fish hold to reduce the workload. At the time of the grounding a conveyor system for *San Rakaia* was at the design and discussion stage.

1.6.2 The fish hold of *San Rakaia* was of simple design, being a basically square hold with pond board divisions to secure the stowed catch. Depending on the species targeted, the catch was stowed either in bulk with a mixture of fish and ice retained behind the pond boards or in bins between the pond board divisions. Hoki was required to be stowed in bins, which were shifted around the hold by hand as there was no mechanical assistance in the form of a conveyor system. The crew were able to stow the catch a rate of about 3 tonnes per hour. (See Figures 4 and 6.)

- 4.2.3 **107/98**
In regards to the safety recommendation to consider the provision of conveyor systems in the fish holds of the Company vessels where these are not already fitted and where the dimensions and layout of the hold are such that fitting is practicable, it is our view that we have fitted conveyor systems in the Company vessels that are practicable and we do not intend to adopt this safety recommendation for other vessels in our fleet.

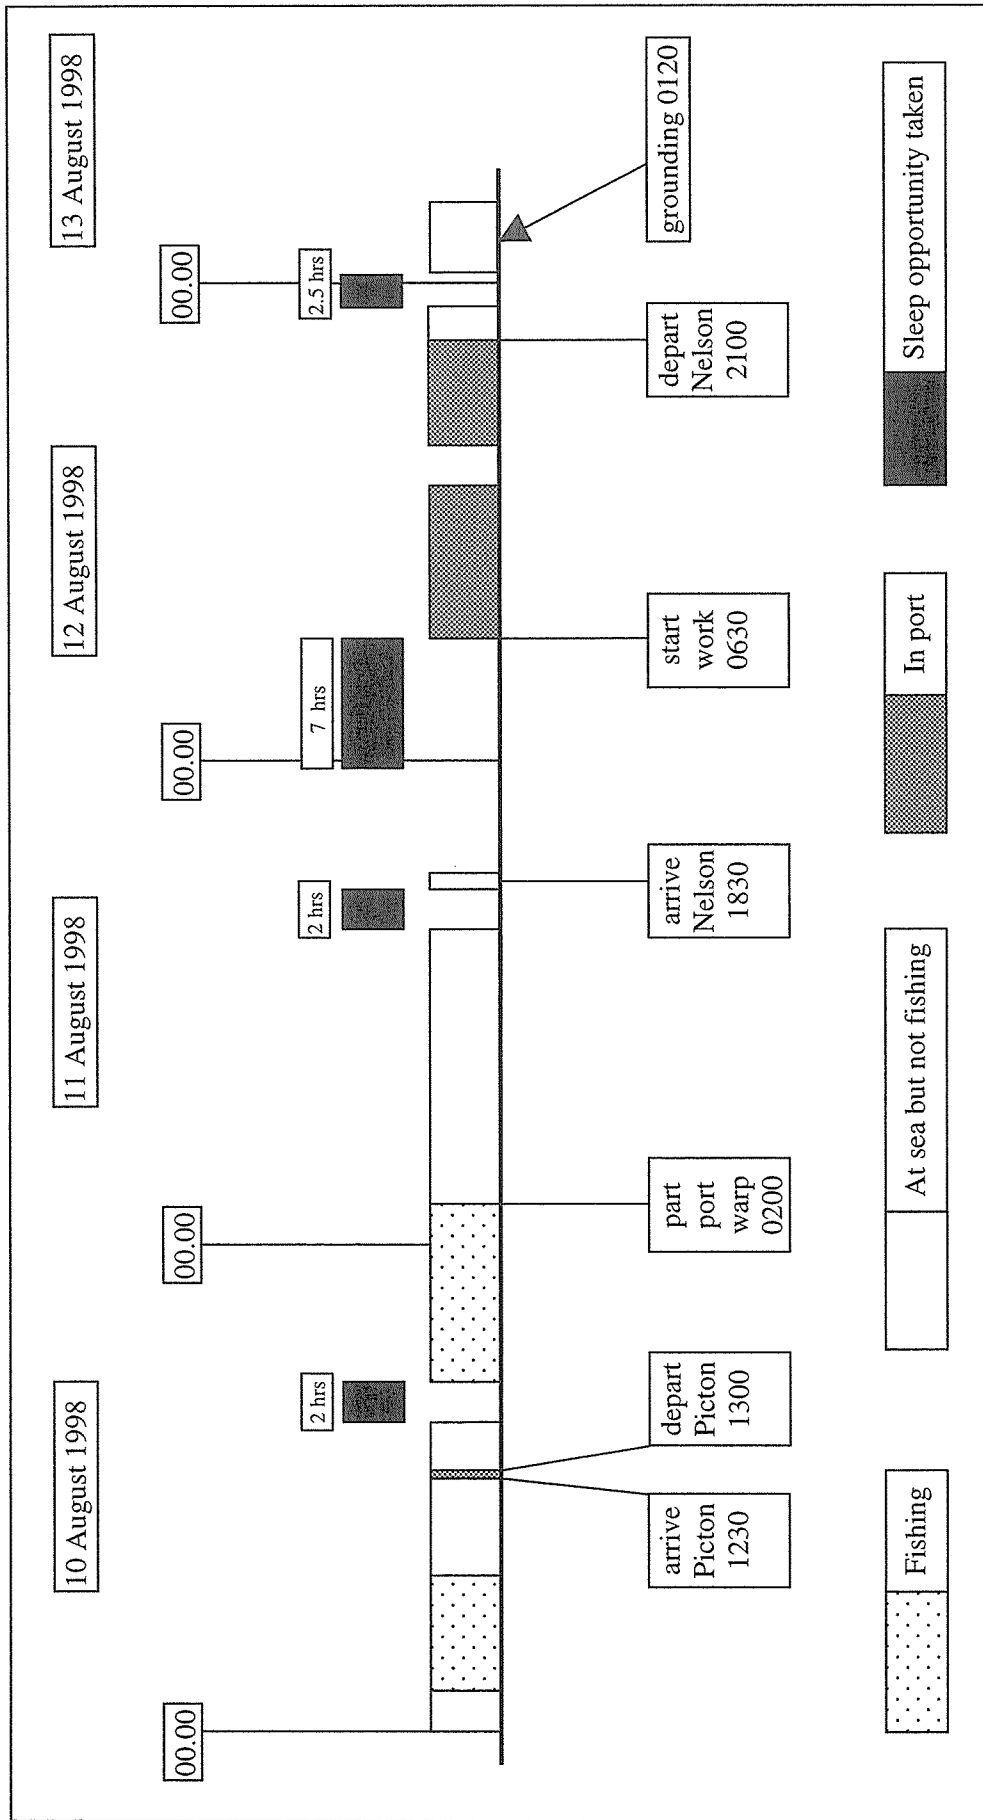
Figure 7
Deckhand's duty history for the 72-hour period before the grounding

- 1.7.11 Figure 7 shows a duty history for the deckhand during the 72-hour period before the grounding. Working times are indicated by shaded blocks showing times of various tasks. Times of fishing are indicated separately. The periods when the vessel was at sea but not fishing include tasks such as watchkeeping, stowing the catch, retrieving the damaged trawl, clearing and cleaning decks, and food preparation. Gaps in the block diagram indicate where off-duty periods were granted but the sleep opportunities taken within those periods are shown above the baseline.

- “I can only conclude that I must have been more tired than [I was] aware, and I must have dozed off for a few minutes, which I can only put down to lack of sleep over the previous three days and the strenuous work involved in casing hoki in the fish hold and the repair of our damaged fishing gear.”

- 4.1 On 26 March 1999 it was recommended to the Group Fleet Manager of Sanford Limited that he:
 - 4.1.1 formulate a company policy on the management of fatigue to give guidance and advice to masters and crew on the causes, recognition and prevention of fatigue among sea staff. (105/98)
