Report 98-210

Restricted-limit passenger and freight ferry *Stella*

loss of steering in heavy weather

18 August 1998

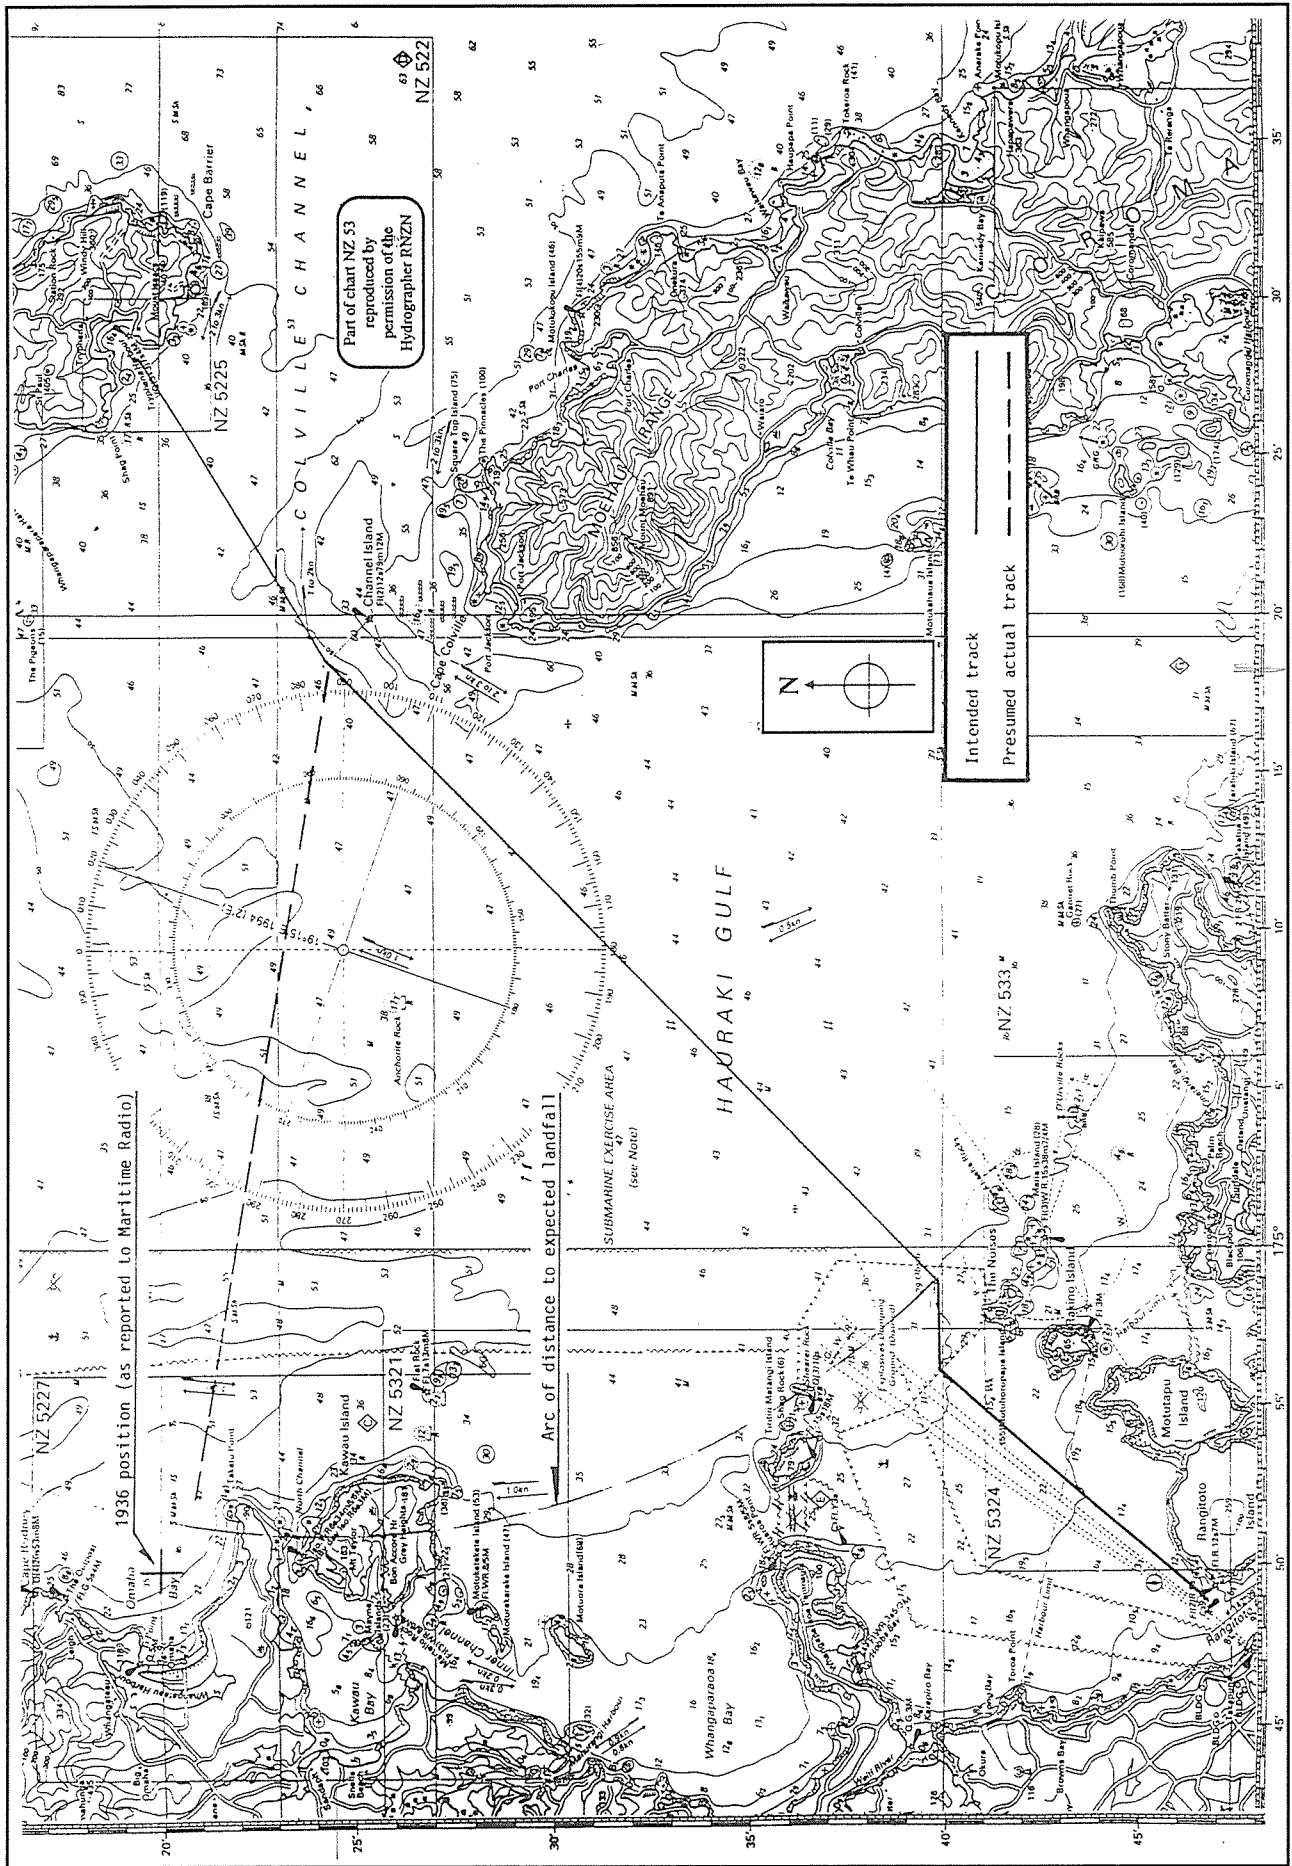
Figure 2
 Extract of Chart NZ 53 showing intended and presumed actual tracks

- 1.4.1 Subsequent to the incident, the master has made a self-critical analysis of his actions on the day . He has come to the assumption that in setting the autopilot when passing Channel Island he had entered the wrong required course into the unit. His intended initial course from Channel Island had been 220 degrees magnetic. He believes that he probably set the required course as 270 degrees magnetic.

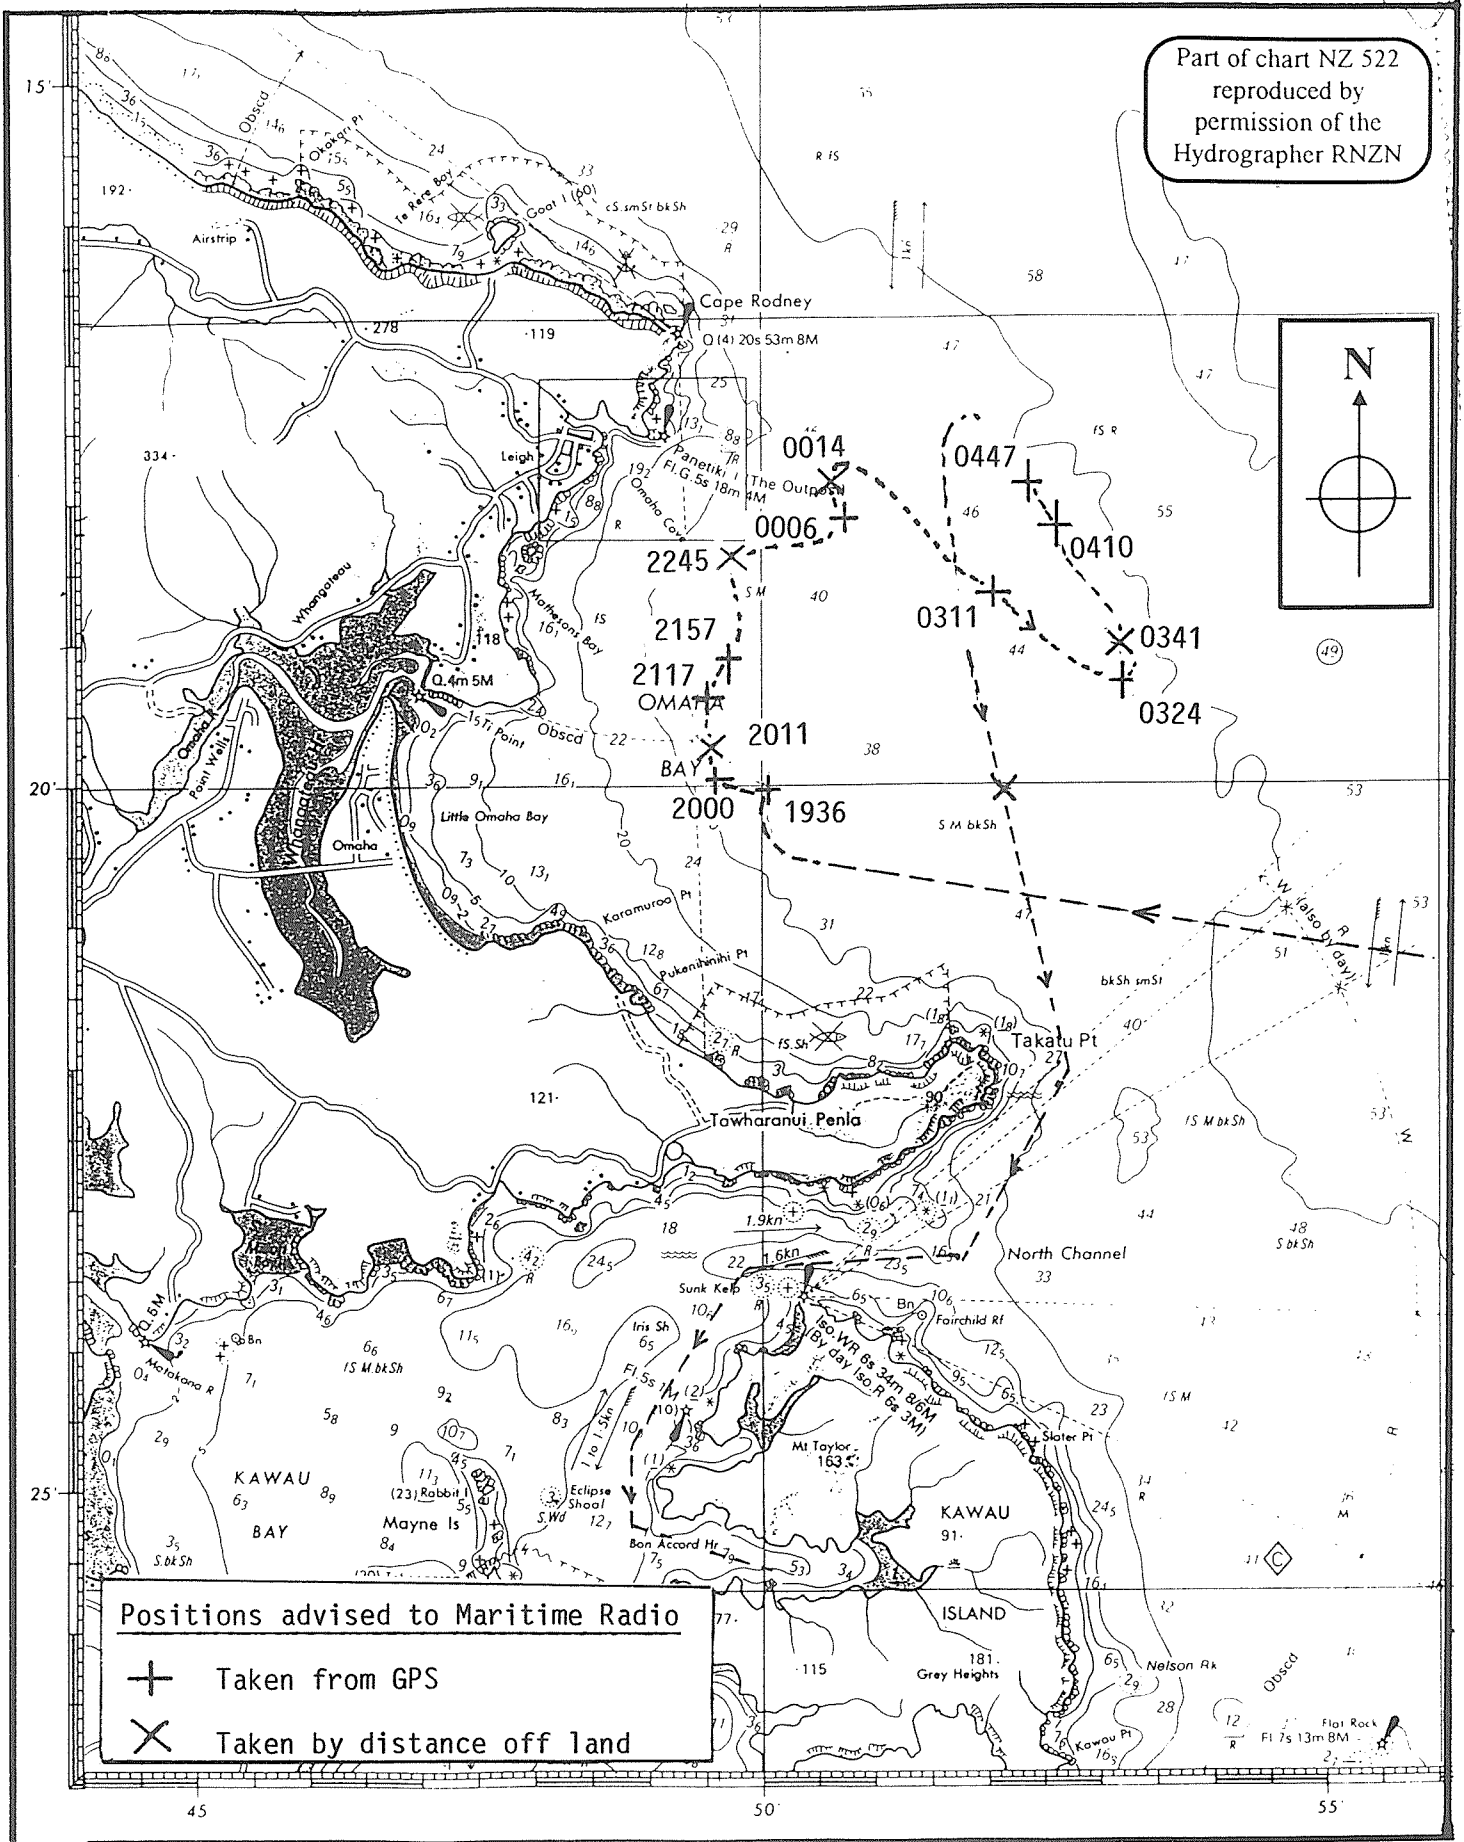
Figure 3
Extract of Chart NZ 522 showing positions of the Stella in Omaha Bay

- 1.1.12 The master brought the vessel head to the sea using a combination of helm hard over and various engine speeds. He decided to anchor the vessel and further appraise his situation. At this stage he checked the GPS and found that the vessel was actually in Omaha Bay. The land that had been on the port bow was not The Noises but Takatu Point instead.

- 1.1.16 In the initial call the master stated that he thought the vessel had struck an underwater object causing the loss of steering. He gave the vessels position, taken from the GPS, as 36°20.04' South 174°50.07' East .
