Report 98-211

Passenger sailing vessel *Phantom of the Straits*

electrical fire in engine enclosure

5 September 1998

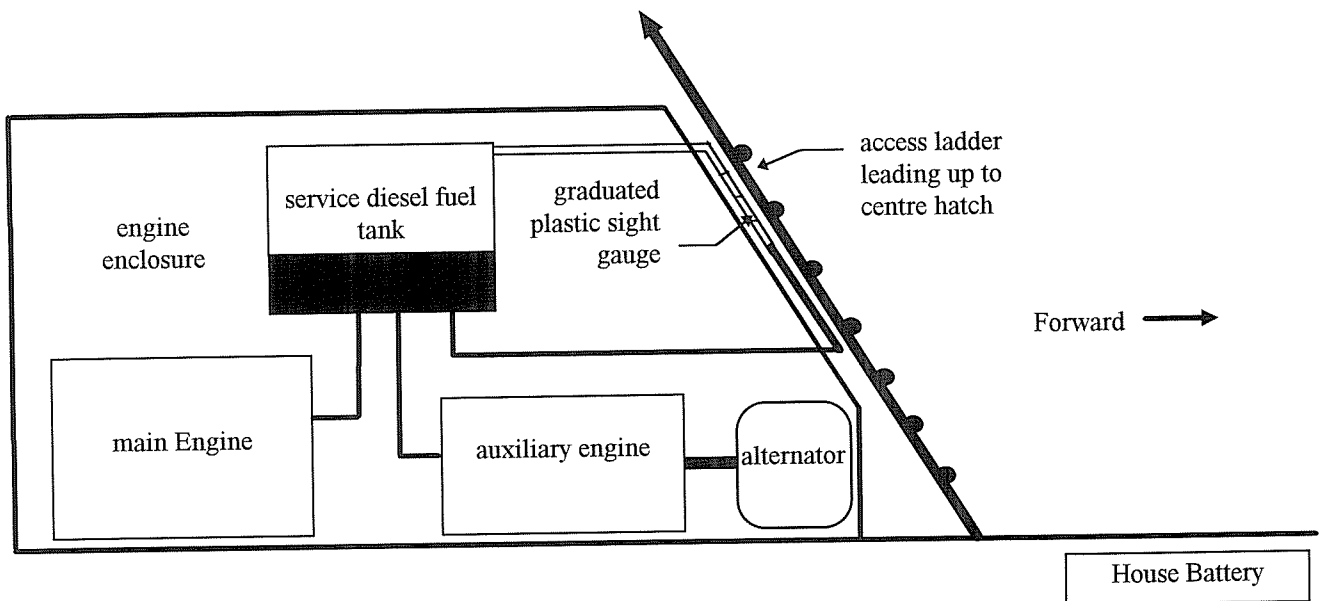
Figure 2
Engine enclosure arrangement, profile looking from starboard side
(Diagram not to scale)

- 1.4.10 A cable loom of individually Polyvinyl Chloride (PVC) sheathed control wires had been run up inside the engine enclosure near its front starboard corner, and then run aft at half enclosure height. The loom split between the two engines, one branch running up and over to the port side of the generator; the other continued aft and eventually up to the main engine starter control panel.

- 1.4.11 A similar cable route, but with larger PVC insulated cables, had been run on the port side of the engine enclosure. The two heavy horizontal cables (about 35 mm²) connecting the main engine alternator to the main engine starting battery had been loomed together and run along the length of the port side engine enclosure. These high current cables were loosely supported along their route, but were unsupported for about 1000 mm past the main engine. At one point they were resting on the main engine air intake duct. A current shunt had been installed in the positive conductor of this cable pair to provide an instrument reading representative of the main engine charging current. The shunt had been installed within the cable loom with no apparent additional support, and with a poorly crimped lug.

2.3.1 The one cable in the starboard cable loom that had been heated by excessive electrical fault current was not protected by a fuse. The heat generated by this cable, which was sufficient to melt through the house battery casing, illustrates the importance of cable protection. The unprotected cable was an example of non-compliance with the regulations.

2.3.2 On the port side of the engine enclosure, where the heavy cables between the main engine alternator and battery passed over the engine air intake, it appeared that heat from the adjacent main engine exhaust manifold had heated the cable insulation to plastic flow temperature, allowing gravity and vibration to gradually expose the conductors. The maximum safe operating surface temperature limit of the PVC cable insulation is approximately 75 degrees Celsius, which would have been exceeded at this point. These cables were not adequately supported or protected from external heat radiation as required by the applicable code.

2.3.3 The current shunt installed in the positive of the two cables had a poorly crimped lug. This relatively high resistance joint might have become hot while the shunt was conducting current, or heat from the generator might have softened the insulation at some stage. As the cables were unsupported, the sharp corners of the hot cable shunt might have melted into the insulation of the adjacent negative cable, which would have eventually caused a short circuit directly across the engine battery. Such a fault would explain the observed rapid electrical fault separation of both cables in this area. The shunt should have been mounted on an insulated frame and the cables should have been protected from heat and adequately supported. The shunt was a possible source of ignition for the fire.
