Report 99-101

Express freight Train 230

derailment

25 February 1999

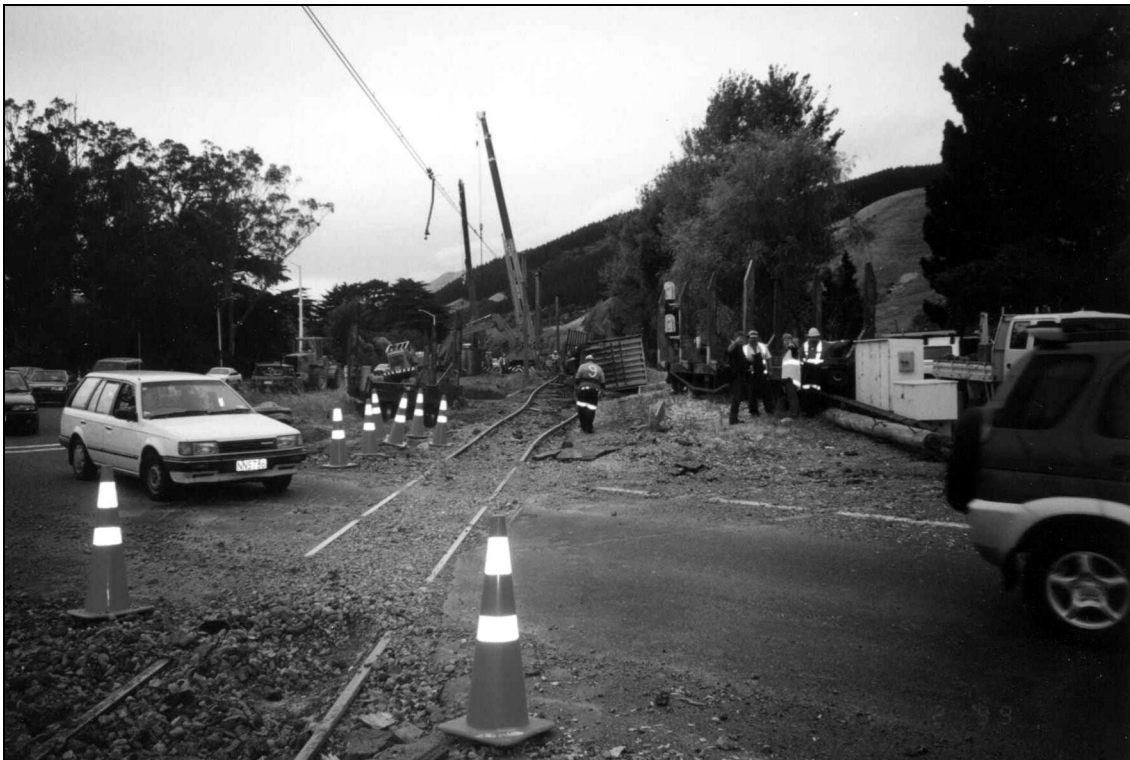
- 1.1.3 The gap between the stock rail and the dislodged switch blade allowed the wheels of the following wagons to take 2 roads simultaneously, resulting in 19 wagons becoming derailed. Some of the derailed wagons sideswiped overhead traction support poles, which brought down the 1500V lines. Derailed wagons were strewn over the McKays level crossing, blocking State Highway 1 for approximately 2 to 3 hours before a lane for one way traffic was cleared. Figure 1 shows a general view of the site following the derailment and road clearance.

Figure 1
General view of the site

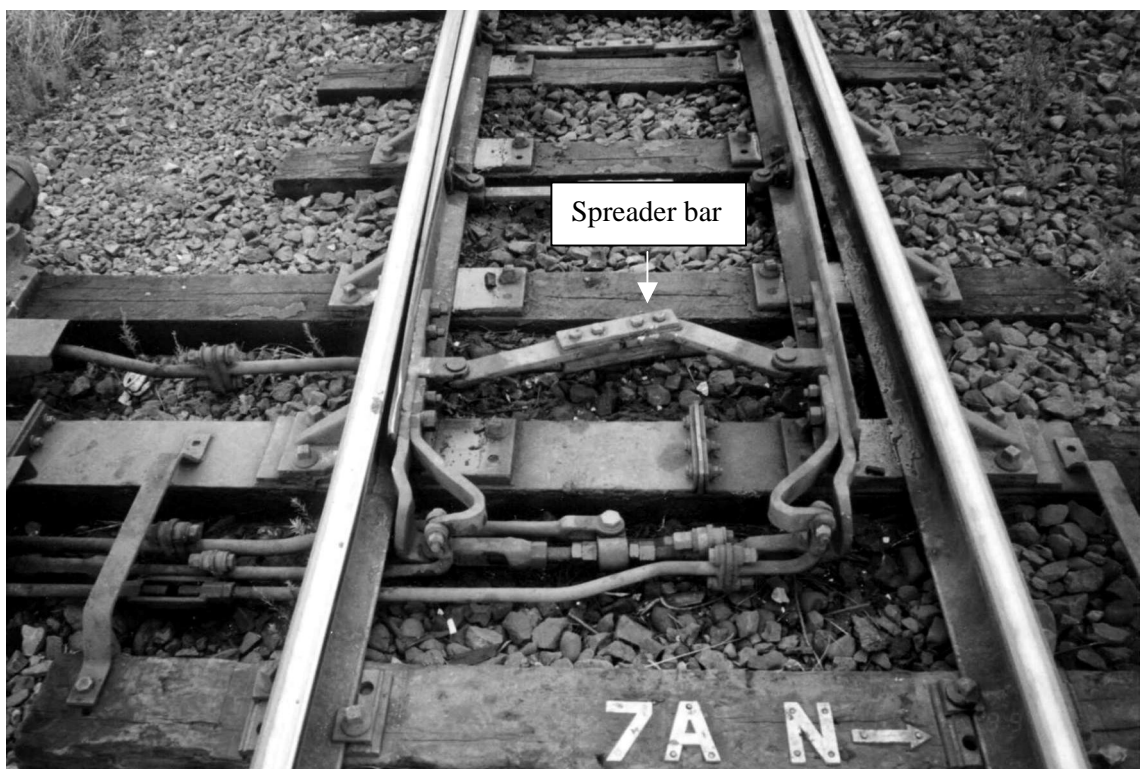
approximate kilometrage	description of damage
22.5 km	first indication of scrape marks on sleepers near Mana
22.8km	brake block piece and spear found in centre of track
23.4 km	intermittent score marks
24.9 km	score marks in Plimmerton Road level crossing
32.0 km	signal cables torn out mid track from 8R signal location
32.1 km	spreader bar to south junction turnout 7B hit and bent 25 mm
35.3 km	left hand side switchblade horn scraped on turnout B9
38.5 km	left hand side switchblade horn scraped on turnout 3A
38.9 km	spreader bar at Paekakariki crossing turnout 5A bent 25 mm
41.63 (POD)	spreader bar at McKays Crossing turnout 7A hit and bent back 140 mm. Figure 2 below shows the extent of damage.

Figure 2
Damage to turnout spreader bar caused by dragging brake gear

- 2.1.6 The impact on the spreader bar on the safety turnout just south of McKays Crossing bent it sufficiently to pull the facing switch blade away from the stock rail and allow a gap for a wheel to follow. In this situation the right wheels were pulled away from the rail head and the derailment ensued.
- 2.1.7 The locomotive event recorder output was not available for assessment and the only estimate of speed at McKays just prior to the derailment was 65 km/hour as reported by the LE. This is below the maximum allowable line speed of 70 km/h.

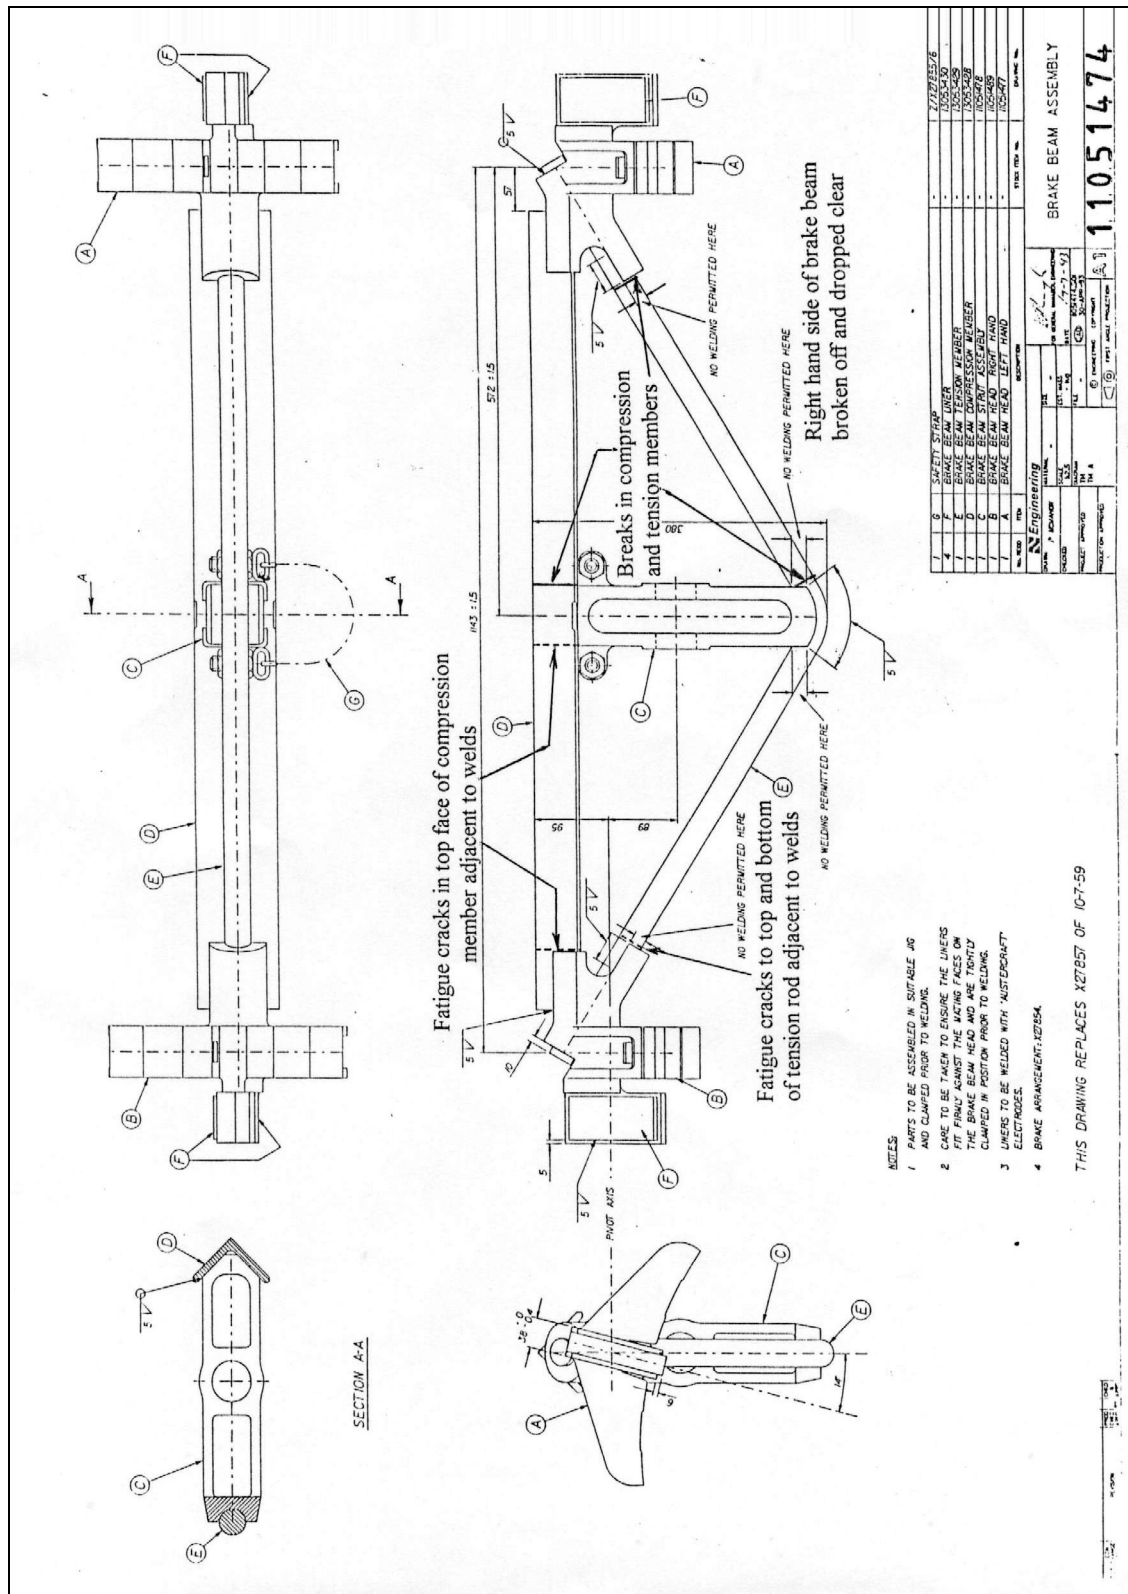
Figure 4
Tranz Rail plan 11051474A
Brake beam assembly

- 1.6.3 In addition to the break in the angle iron there were 2 cracks. One was at the brake shoe end on the top side adjacent to a weld. This crack was forced open to reveal that it had propagated 36 mm into the angle from the edge. The fracture surface was a red/black rust colour and had been polished due to fretting. The other crack was on the top, adjacent to the central strut, and on the opposite side of the failure. This crack was about 10 mm long and there was also evidence of a possible crack on the bottom side of the angle adjacent to the weld. The position of these cracks are shown on Figure 4.

- 4.2 As a result of the metal fatigue cracks found in the tension members adjacent to welding on the fabricated brake beams, Tranz Rail amended the welding detail on their plan to exclude any welding on the side of the rod and limit it to the ends of the rod only. Welding size was also increased from 5 mm to 8 mm fillets. A Job Breakdown Sheet has been formalised by Tranz Rail based on the revised plan for the fabrication of brake beams to ensure that the correct order of assembly is achieved.

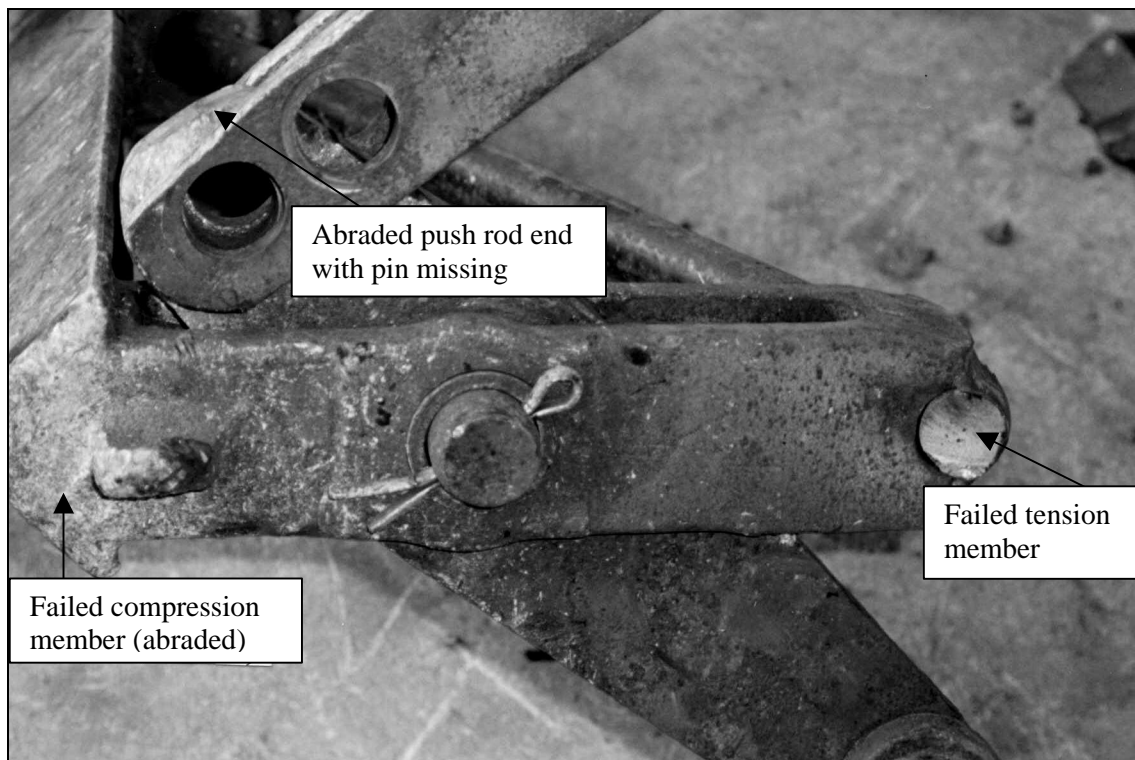
Figure 5
Broken angle compression member (abraded) and tension member on brake beam

- 1.6.2 The break in the angle iron was extensively worn as a result of having been dragged through the track ballast and no analysis of the failure mode was possible. The failure was located next to the weld adjacent to the central strut assembly.

- 2.2.1 The brake beam probably initially failed by a fatigue crack initiating and propagating through the tension member adjacent to the weld between the tension member and the right-hand head casting until it failed in overload. The cracking was similar to the cracks seen in the tension member at the left side of the brake beam in the same location, which were propagating at the same time. This was where the majority of cracks had been detected in other brake beams. Once the tension member had broken, the loading on the brake beam would have significantly changed with the angle iron being subject to bending rather than compression when the brakes were applied. This was confirmed by the slight bend in the broken end of the recovered compression member. As a result of this, fatigue cracks then initiated in the angle iron at most of the welds.

- 2.2.2 The break in the tension member resulted from 2 fatigue cracks initiated at the edges of a weld to the central strut and on opposite sides of the tension member. Two other fatigue cracks had also developed at tack welds on either side of the tension member at the left brake shoe end. Fatigue crack striations are often present on fatigue fracture surfaces and each one is caused by an incremental advancement of the crack. The number of cycles to failure was in the order of 35 000 cycles. Braking cycles over the life of the beam would have imposed a loading of about 3000 cycles assuming a brake application on average every 10 km. It can be concluded that the fatigue cracks did not develop with each application of brakes.

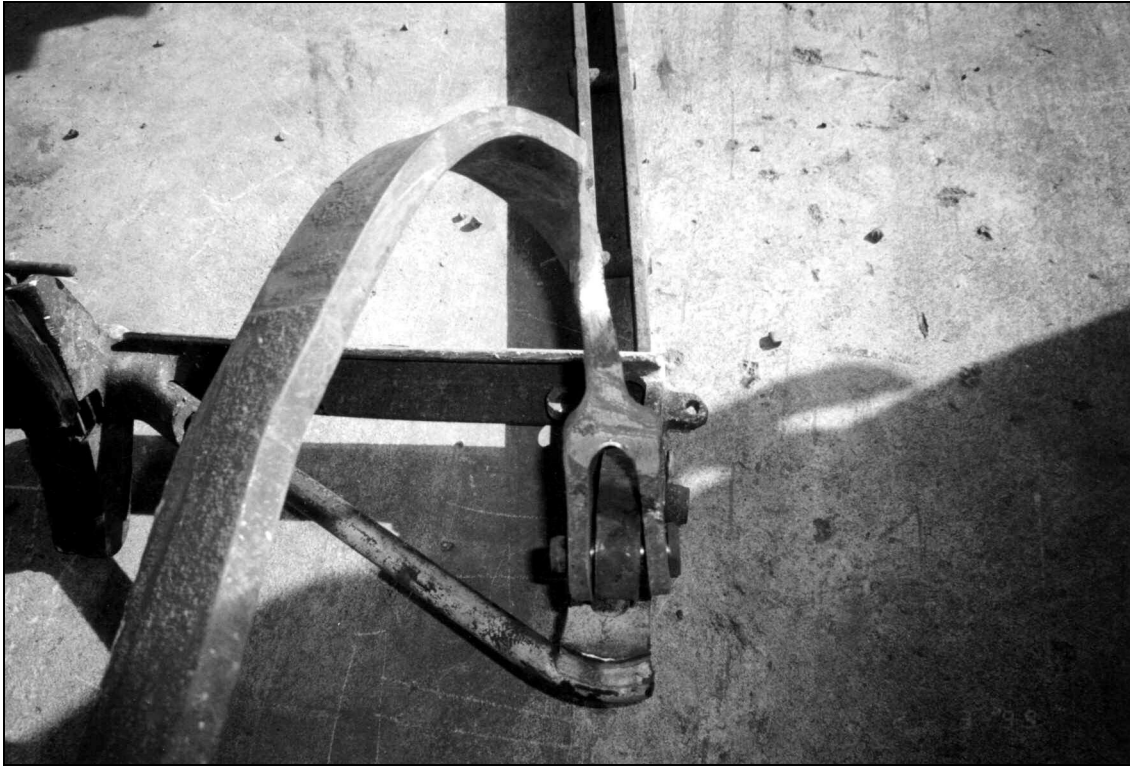
- 1.4.3 The remaining left brake block was broken and unevenly worn on the inner portion of the block, and there were wear marks on the brake beam liner indicating that it had been twisted in the sideframe guide.
- 1.4.4 The remaining left-hand section of the brake beam had come free from its guide and was attached only by the brake pull rod (through the brake lever arm), which had become wrapped around the trailing axle of the bogie. In this position the broken part of the brake beam had been dragging in contact with the track bed. Figure 6 shows the condition of the pull rod after removal from the wagon.

Figure 6
Showing bent brake pull rod

prior to the derailment (and after the pin came free) the trailing brake gear become snagged sufficient to bend the brake pull rod around the trailing axle. It was likely that it was in this position when it impacted on the spreader bar at McKays Crossing.
