Report 99-107

Shunt L55 and Train 211

collision

Southdown

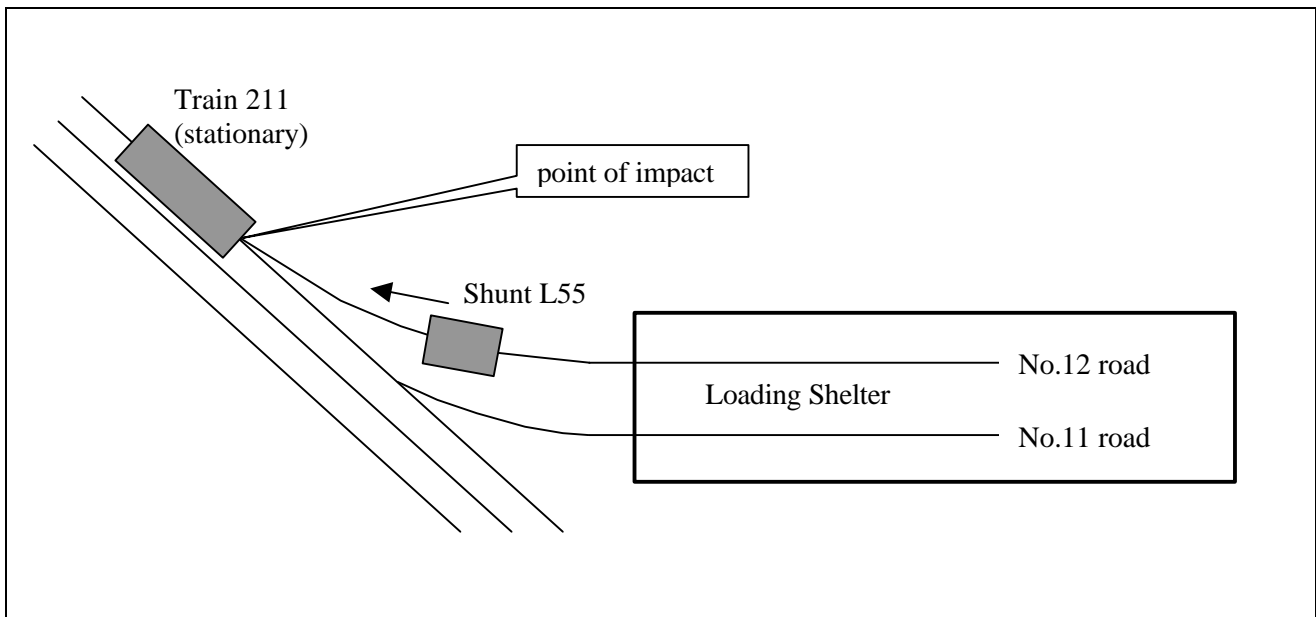
Figure 1
Site details at the Auckland Freight Centre loading shelter

- 1.1.6 Following the radio discussion TX(1) spoke directly to the remote control operator (RCO) of Shunt L55 that was working in its defined work area in the vicinity to confirm if it was all right for Train 211 to move out. The shunt was in the process of transferring tonnage to the adjacent No. 12 road within the loading shelter. The RCO was not made aware of the TEM problem and understood Train 211 was departing. He gave his approval subject to the cross-over points being reset to Train 211’s departure route. Figure 1 below gives the site details.

- 1.1.7 TX(1) reset the points and gave authority for the LE to pull out. After the last wagon had exited the terminal building it was established that there was still no response from the cab monitor and TX(1) directed the LE to stop the train so that another TEM could be fitted. The train stopped with the last wagon sitting over the turnout that gave access to the No. 12 road to place it as close as possible to the van holding the new TEM.

- 1.1.8 TX(2) had uncoupled the defective TEM from the rear of the wagon when he heard a warning shout from TX(1) to get out of the way. TX(2) quickly glanced around, saw the shunt locomotive approach from behind him and managed to jump aside just before it impacted with the wagon. TX(1) estimated that it was approximately half a minute from the time Train 211 stopped to the time of the collision.

- 1.1.10 No. 12 road had a right hand curve as it approached the ladder road and the RCO was operating the shunt from the rear left-hand refuge of the locomotive. He stated that because of the restricted view line from his position he could not see the train and was not aware of it until the collision.
