## **Report 99-111**

**yard shunt and logging truck**

**collision**

**Kinleith**

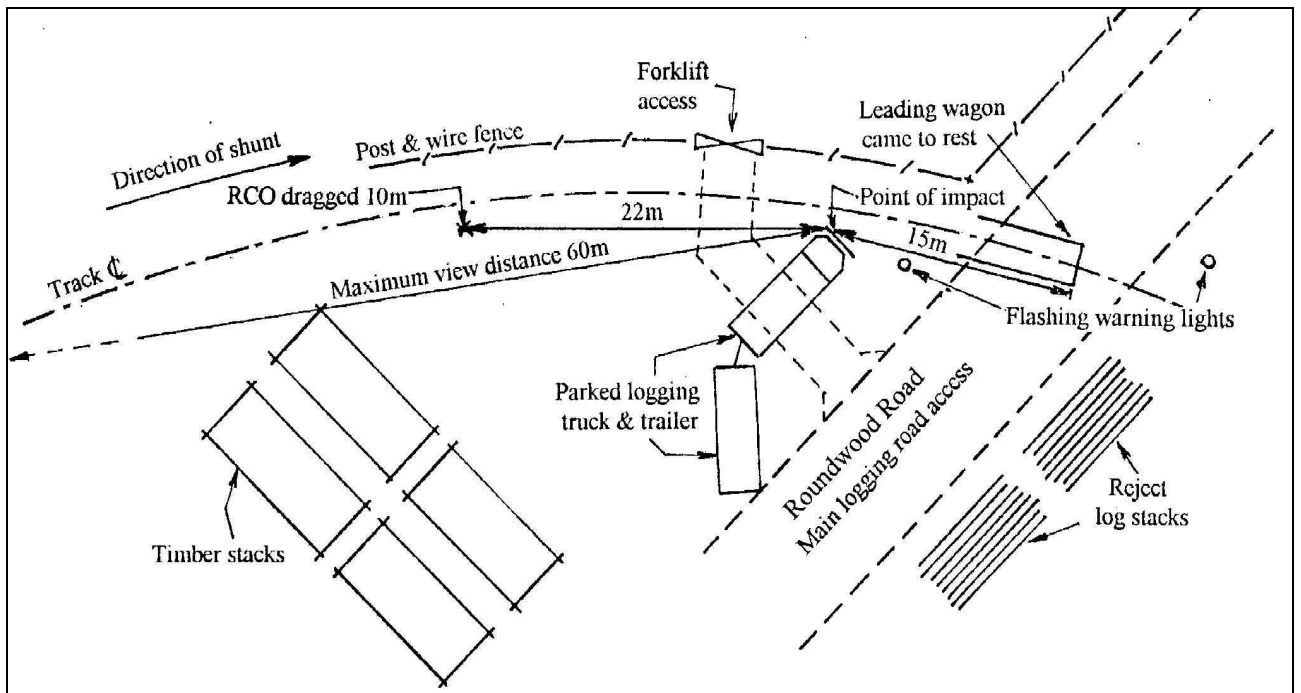
**Figure 1**  
**Site layout (not to scale)**

- 1.1.6 The RCO stated that at some distance off he noted the rear of the logging trailer on the right hand side near the main logging road level crossing, but the truck cab was hidden by stacks of timber. He did not notice the cab until he was approximately 40 m away and saw that it was parked foul of the running road. From his position on the leading wagon the maximum view distance to the obstruction was approximately 60 m but the RCO stated that his attention was concentrated on a forklift access adjacent to the running road just short of the road level crossing. Figure 2 is a photograph showing the view line at 60 m from the point of impact and the forklift access on the left hand side.

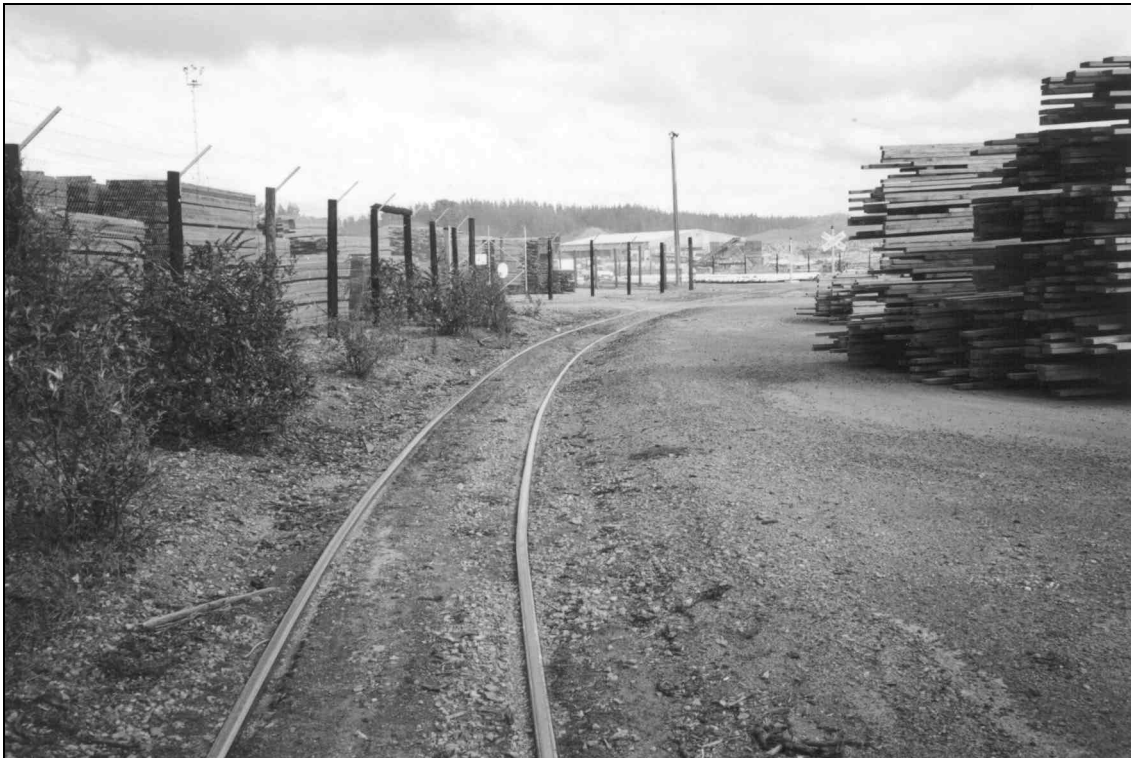
**Figure 2**  
**View line at 60 m from the point of impact**

- 2.4 The RCO lost approximately 23 m of the maximum view distance that was available to him before he observed the truck parked foul of the running road. At a shunt speed of 25 km/h this equates to about 3 seconds, which could have been accounted for by the RCO's attention being focused on the fork-lift access where problems were known to exist. Taking account of the need to be alert for the activities of integrated operations within the mill site plus a normal reaction time, the RCO did not control the shunt movement within his "range of vision". Tranz Rail's Code made reference to the various parameters that could influence an adequate "range of vision" but did not define "adequate" in this context.
