Report 99-113

Commuter EMU Train 3612, collision with cable drum

Melling Junction

13 June 1999

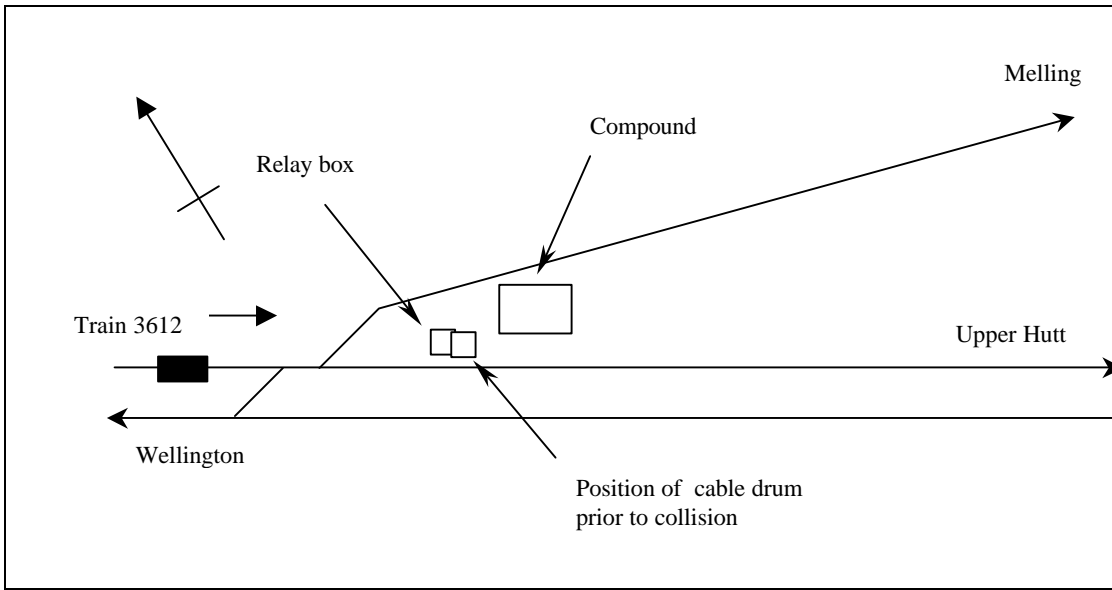
Figure 1
Site plan (not to scale)

- 1.2.1 The wooden cable drum was 1.75 m in diameter and 700 mm wide and weighed approximately 200 kg.
- 1.2.2 The empty drum had been stored in the company’s traction compound approximately 50 m away from the point of impact. A general site plan is shown in Figure 1 and the relationship of the compound to the point of impact is shown in Figure 2.
- 1.2.3 About 2 weeks before the incident the drum had been reported as lying against the relay box immediately adjacent to the point of impact by the LE of Train 630 at approximately 2100 hours on Monday, 31 May 1999. He considered there was limited room for trains to pass and reported the potential obstruction to the TCO on duty.

- 2.1 The empty cable drum weighed 200 kg and could have been rolled by 2 people. It was probably removed by persons unknown at a time when the compound gates were open and the compound unattended. It had been rolled approximately 50 m to a position where it lay between the relay hut and the track, about 2 m from track centreline.

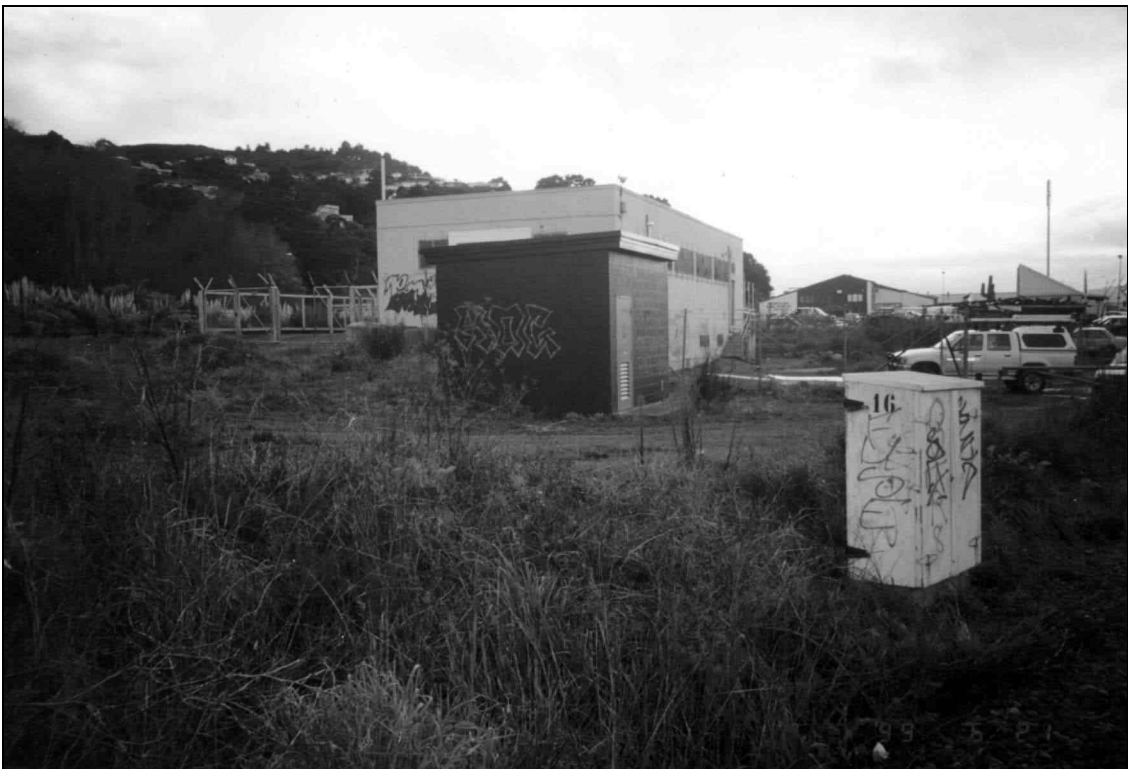
Figure 2
The compound viewed from near the point of impact

- 1.3.1 The Melling Branch leaves the Wairarapa main line at Melling Junction and the traction compound is located between both lines, about 50 m from the point of impact.
- 1.3.2 The compound was enclosed by a fence approximately 3 m high with 2 double chain mesh gates at the southern end permitting vehicular access. The majority of the fence was topped with barbed wire, as were the gates. The fence line was in good condition and the gates, although showing signs of weathering, were in good condition and showed no evidence of being forced. There was a loose hinge on one gate.
- 1.3.3 The compound was usually kept locked and was infrequently visited by Tranz Rail staff in the course of their duties.
- 1.3.4 It was common practice to secure cable drums while in the compound with chains but there was no evidence to suggest this was the case in this instance.
