**Report 99-117**

**Express freight Train 230**

**derailment**

**Paraparaumu**

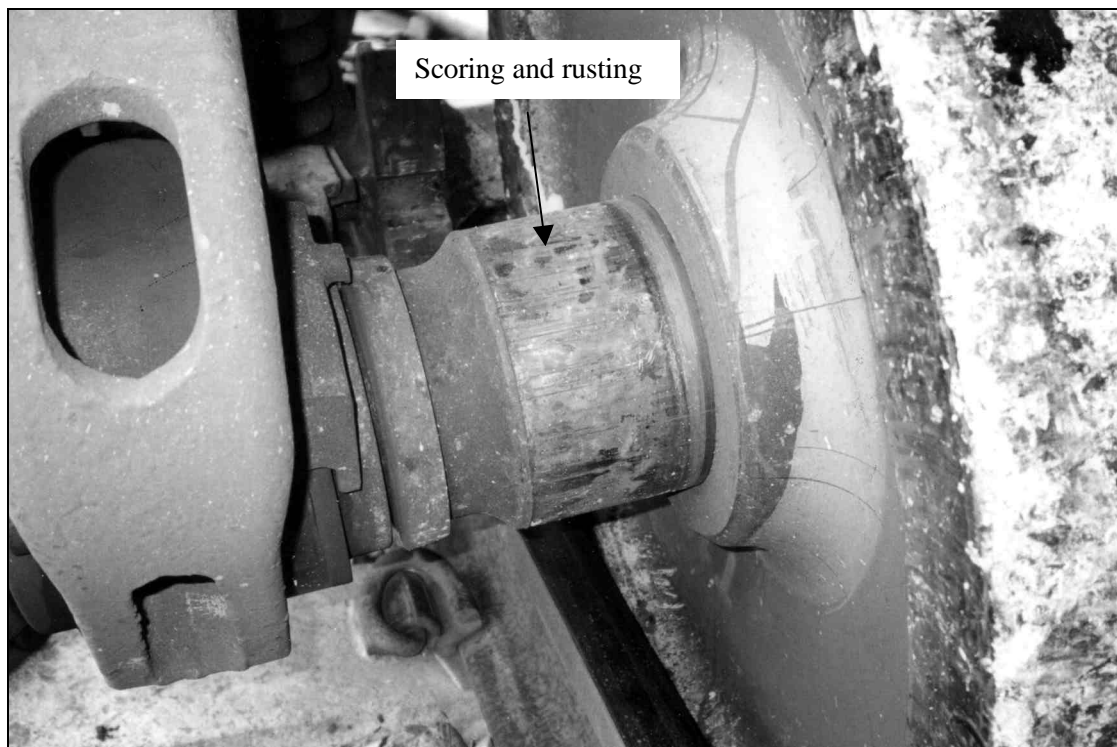
**Figure 1**  
**Wheel movement**

- 1.1.4 An examination of the train at that stage revealed that the brakes on wagon UCA170 (the 38th wagon in the train) had locked on and all the wheels were overheated. The trailing left-hand wheel of the leading bogie had moved 116 mm in on its axle and derailed to the inside of the track. Figure 1 shows the extent the wheel had moved on the axle.

- 1.3.3 The area on the axle seat where the wheel had moved showed evidence of new surface rust plus older rust in the heavy scoring. Hand grind marks were also evident on the surface. Figure 1 shows the extent of scoring and rusting.

- 2.3.4 The hand grind marks on the surface of the scored axle was probably the result of the press fit operator attempting to smooth the pick-up burrs after the wheel had been removed in preparation for a repress. The use of a hand grinder to attempt the required fit, and the re-use of the heavily scored axle, showed a lack of adherence to documented procedures and a lack of tradesman expertise in this operation.

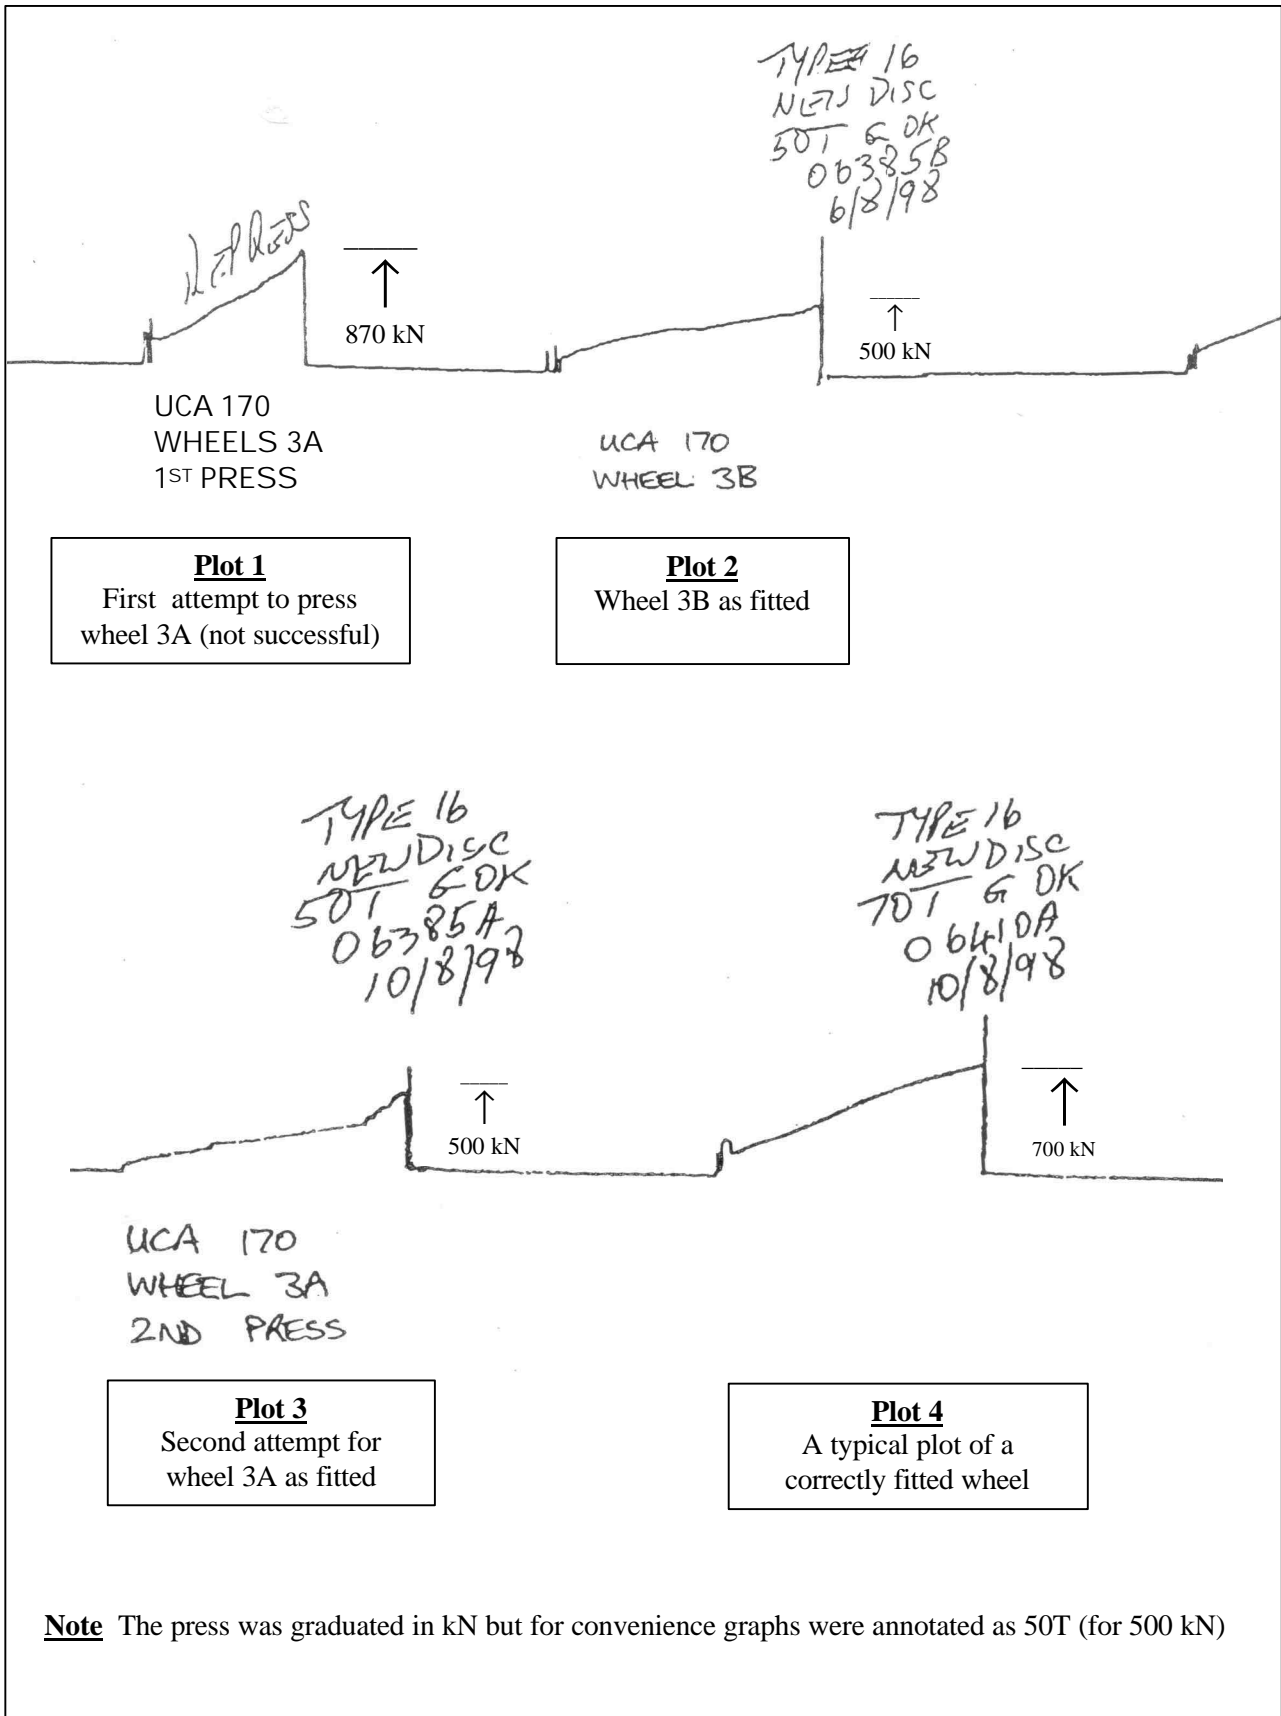
**Figure 2**  
Wheel pressing graphs

- 1.4.1 The wheels on the number 3 axle were originally assembled in Tranz Rail's Hutt workshops in August 1998. Graphical recordings of the axial force required to press each wheel onto the axle were made. Figure 2 is a copy of the original graphs for each wheel showing the increase in axial force as the wheels were pressed onto the axle. The horizontal axis represents the distance the wheel is pressed onto the axle and the vertical axis represents the axial force being applied as the wheel was pressed on.

- 1.4.2 There was no record of the axial force for the first press fit of wheel 3A to the axle, and the graphs had not been calibrated. However by scaling it could be established that with the wheel only about 63% on, the axial force was approximately 870 kN. Extrapolating the first press curve to a full press situation would equate to approximately 1220 kN.

- 2.3.2 A comparison of the press fit graphs in Figure 2 with those in Appendix 1 shows that while the general profile of the graph for wheel 3B fits the “No. 1 – Ideal”, wheel 3A clearly fits the “Unacceptable” force fit diagrams. The significance of the force fit diagram for wheel 3A was that there was not a linear build-up of force as the wheel was pressed on and it was only over the last 25 mm of travel (of a total of 194 mm) that the maximum force was achieved.

- 2.3.3 The interference force fit of wheels on axles is not an exact science, with a number of factors influencing the actual force that is required to achieve the press fit. While the extent of the interference fit is the governing feature, this can be influenced by the type of lubricant used, the smoothness of the mating surfaces, and whether there is any pick-up of surface steel during the press. The 3A end of the axle showed heavy score marks which indicated that there had been considerable pick-up of metal during the first pressing resulting in a final high press load of approximately 870 kN with only 63% of the travel (Figure 2, plot 1).
