## **Report 99-119**

### **Train 281**

### **fall from cab**

### **Owhango (near Taumarunui)**

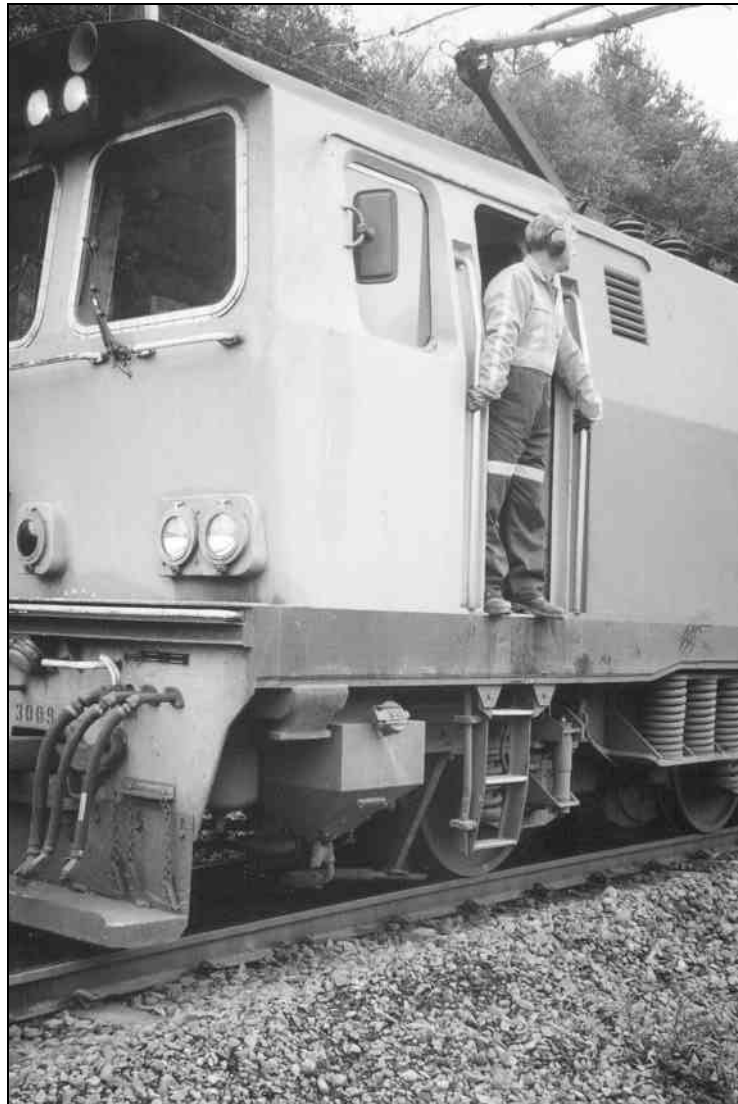
- 1.1.21 The LE then exited the cab of the DX locomotive and made his way forward to the head of the train. As he did so he noted that the train seemed to be responding well and was picking up speed. On reaching the EF locomotive, at that time moving at about 15 km/h, he jumped onto the steps giving access to the cab, climbed to the top and turned around to view the rear of the train. In turning around he lost his footing on the door sill and fell off the train onto the track formation. Figure 1 gives an indication of the likely position of the LE when he slipped. The height from the door sill to the ballast formation was 1.5 m. The LE scrambled to grab the locomotive as it went past and in so doing was struck on the forehead by part of the under frame near the rear of the locomotive and was rolled away from the track. In the process he also injured his back.

**Figure 1**  
**Likely position of LE in relation to the locomotive before falling**

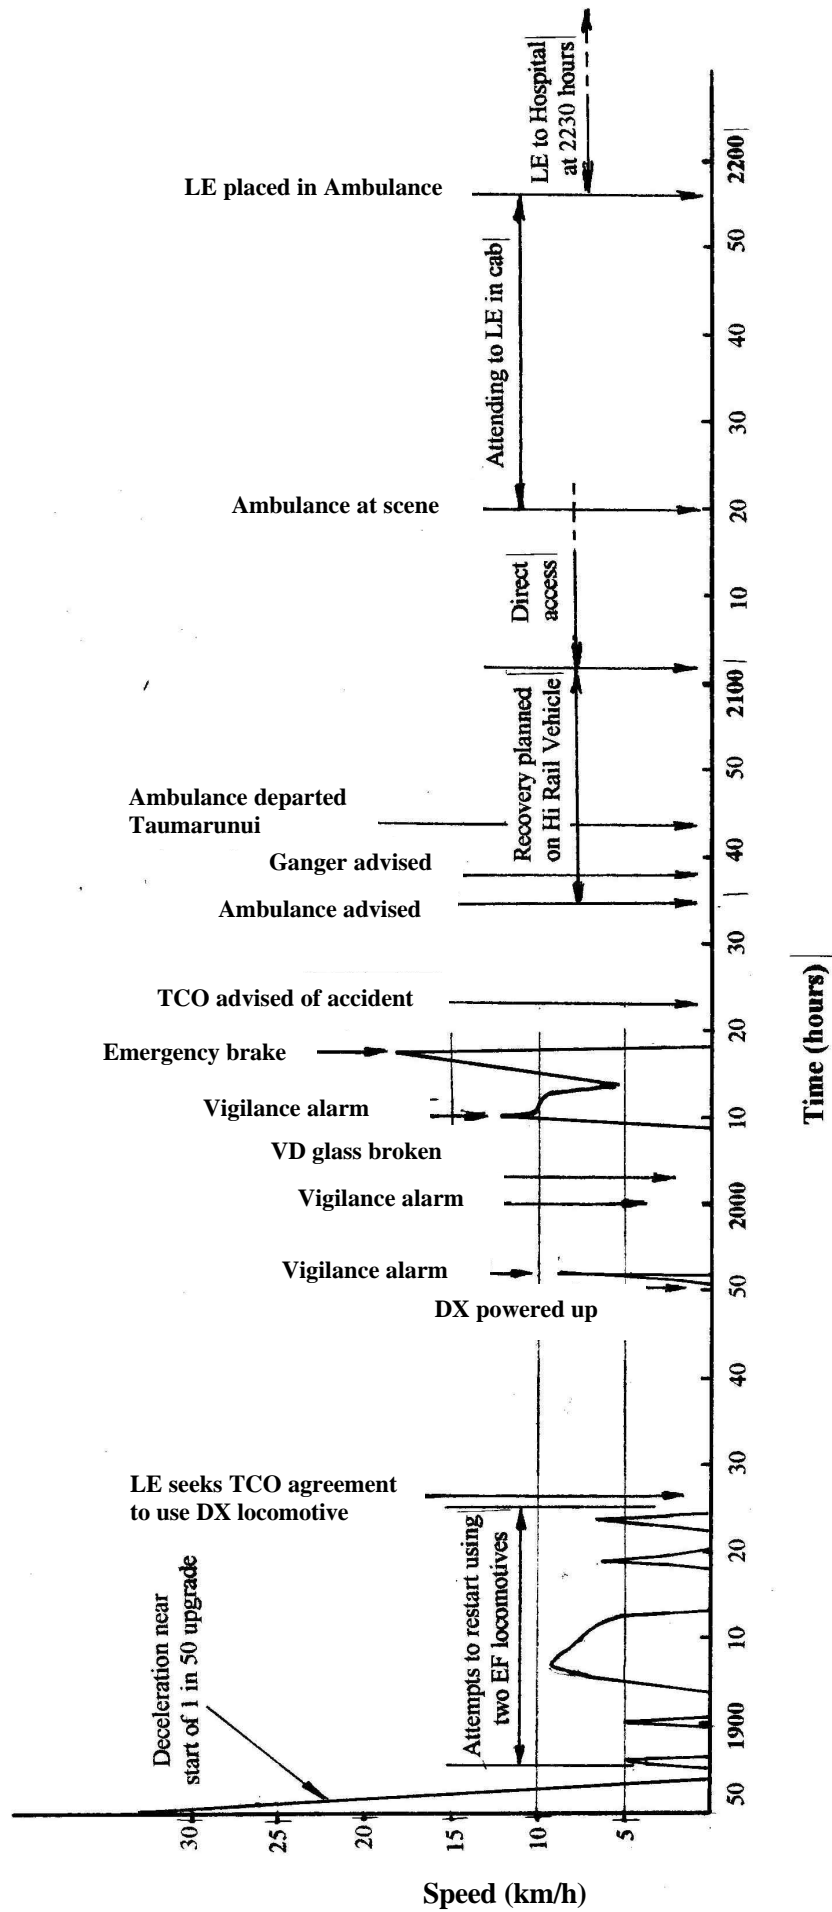
1.4.1 The locomotive log was extracted from EF 30094 (the leading locomotive) and analysed with respect to train speeds in the Kakahi to Owhango section. The graphical presentation is shown in Figure 3 and shows the following:

- from a speed of 57 km/h just north of Kakahi (382 km NIMT), Train 281 progressively reduced speed and stopped over a 6 minute period.
- two attempts were made to move off, one at 1854 hours and one at 1859 hours, each attaining a maximum speed of approximately 5 km/h, but for only a minute’s duration.

- at 1904 hours another attempt was made to move Train 281 which lasted for 8 minutes and reached a maximum speed of 9 km/h before again stalling.
- at 1919 and 1922 hours 2 further attempts were made but they lasted for only one and a half minutes each, reaching a maximum speed of 7 km/h.

- at 1951 hours the train attained a speed of 9 km/h but was stopped suddenly after one minute.
- at 2008 hours Train 281 picked up speed over one minute to 12 km/h, decelerated over 6 minutes to 6 km/h and then picked up again to 17 km/h at 2018 hours before suddenly dropping to zero after a further minute.

Figure 3  
Diagrammatic representation of events vs time
