Report 99-121

No 84 shunting service

fall from wagon

1 October 1999

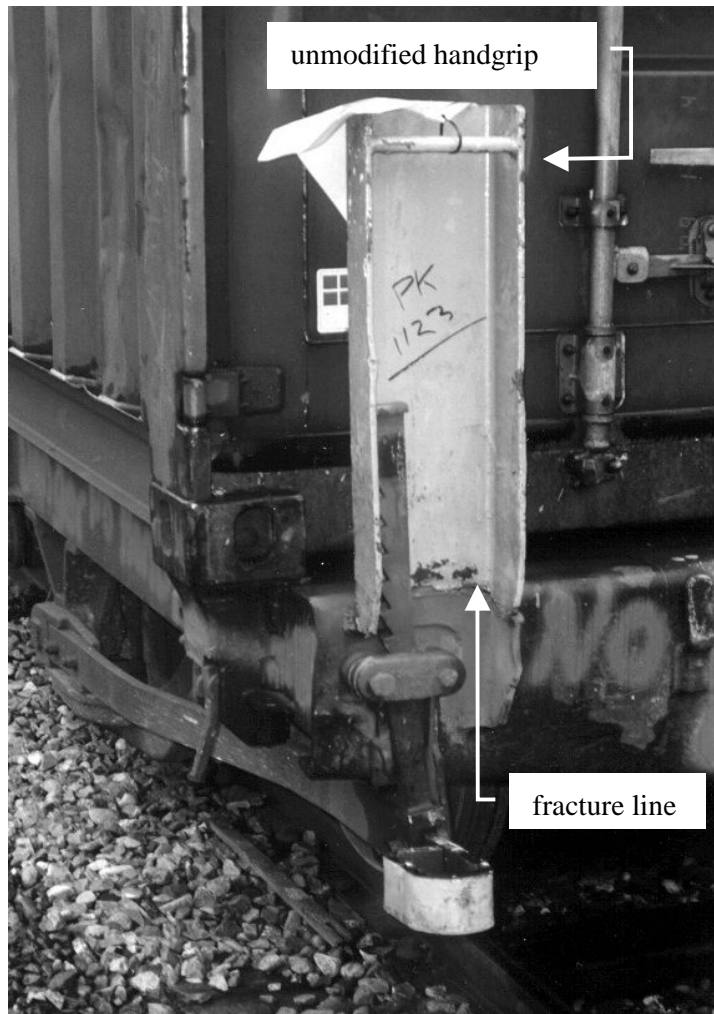
1.2.3 The handgrip frame had a large notch in the side channel about 350 mm above the fracture (refer Figure 2) which had been painted over. A second, unpainted notch was also present about 320 mm above the fracture. Figure 2 shows the failed handgrip in position.

1.2.5 The failure was along previous welds from both sides of the handgrip with only a small section of the original metal remaining (see Figure 4). The majority of the fracture was covered in red brown rust indicating it had been broken for some time. The only bright area on the fracture was an area about 50 mm long and 2 mm wide.

Figure 2
The failed handgrip held in its original position on PK1123 (the fracture line is shown)

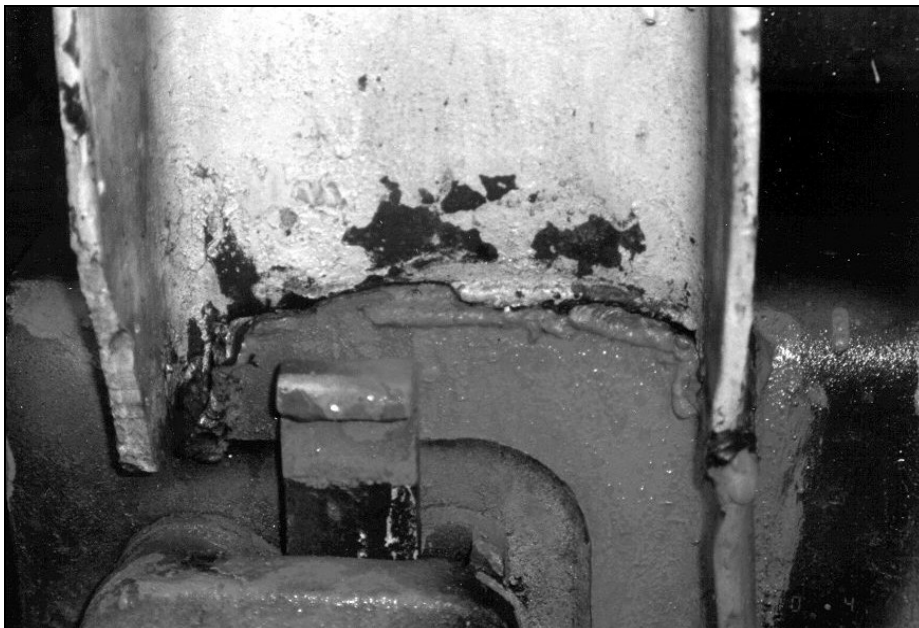
1.2.4 The handgrip frame had failed at wagon deck height and showed evidence of having been repaired by welding previously. Surface welds had been used with minimum penetration. The weld beads were discontinuous, uneven and sagging. Unfused lumps of excess weld were visible (refer Figure 3).

Figure 3
Closer view of the failed handgrip in position with previous weld repairs visible

- 2.1.3 The repairs carried out in March 1999 by straightening and welding were undertaken in accordance with Tranz Rail practice at the time. The handgrip was repaired following cold re-straightening which would have introduced cold deformation into the remaining material making it more prone to brittle failure in that area.
- 2.1.4 The wagon had been booked for handgrip repairs 6 times in the last 9 years. Although details of the repairs were not kept, the handgrip frame showed evidence of repeated weld repair which is an indication of the demanding operating environment in which handgrips must be maintained.

- 5.1.2 take immediate steps to control the weld repair of safety critical components to recognised standards to ensure the integrity of the original installation is retained (079/99); and

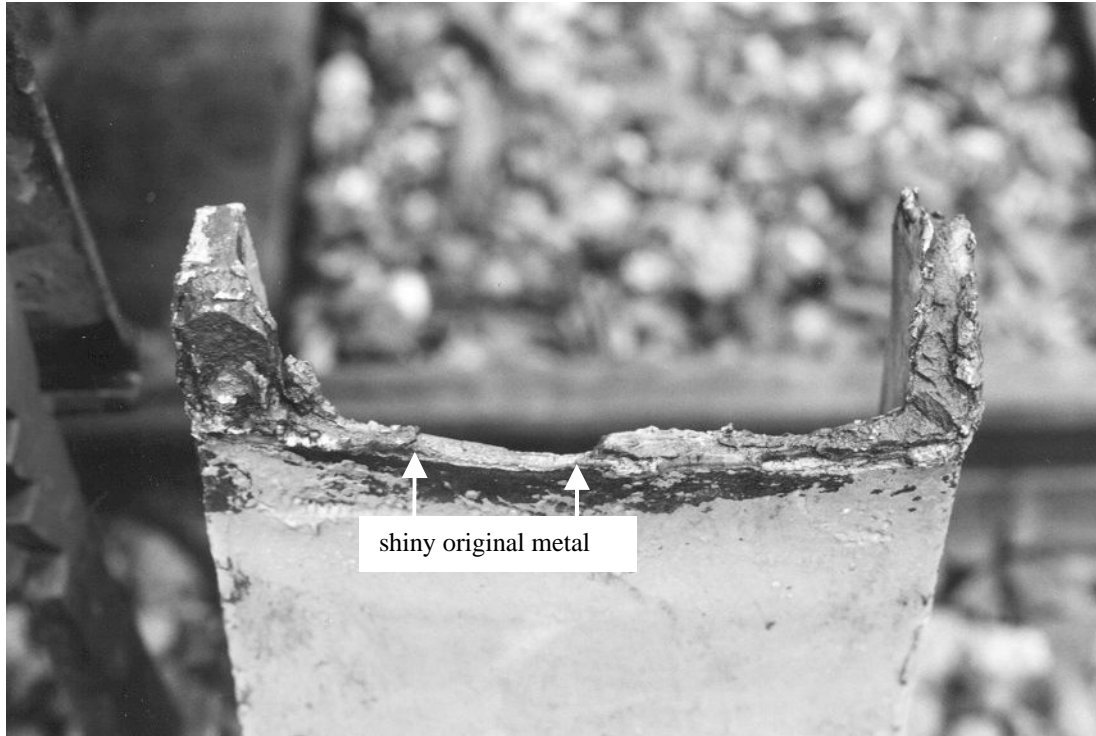
Figure 4
Failure surface

2.1.1 The repaired handgrip had cracked under shock impact loading during normal operations some time before the incident. The small amount of remaining parent metal was insufficient to take the weight of the shunter and it failed as he pulled himself up.

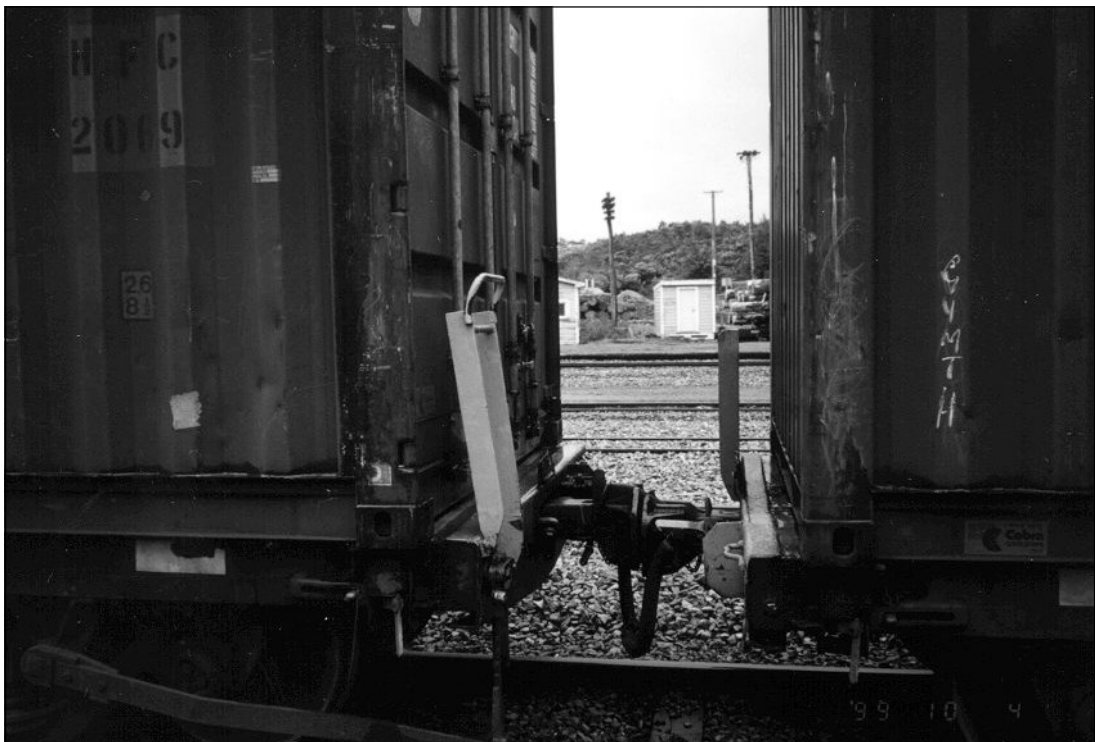
Figure 5
Example of a handgrip bent inwards

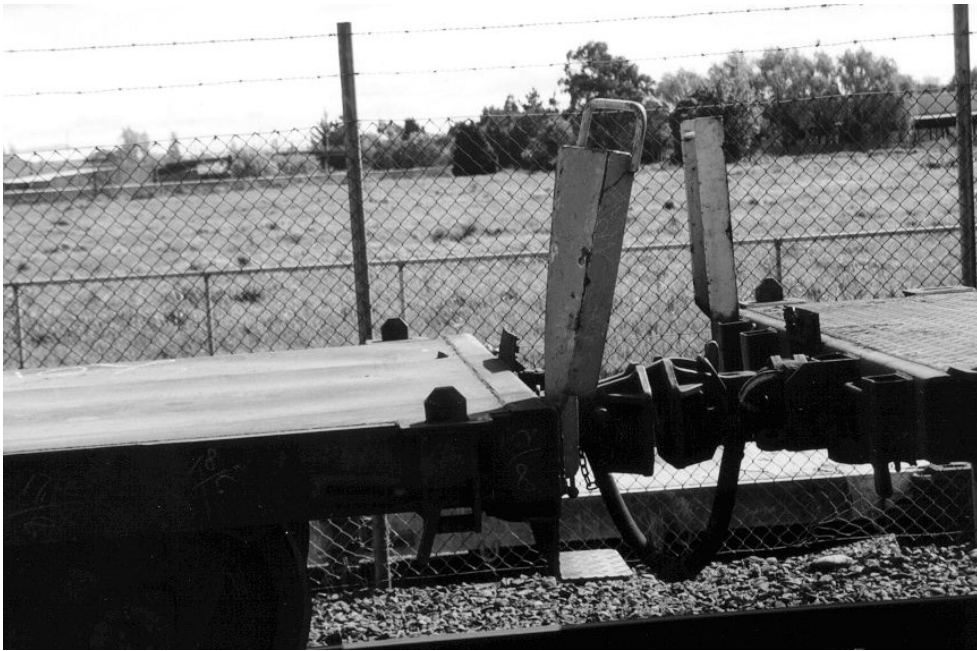
Figure 6
Example of a handgrip bent outwards

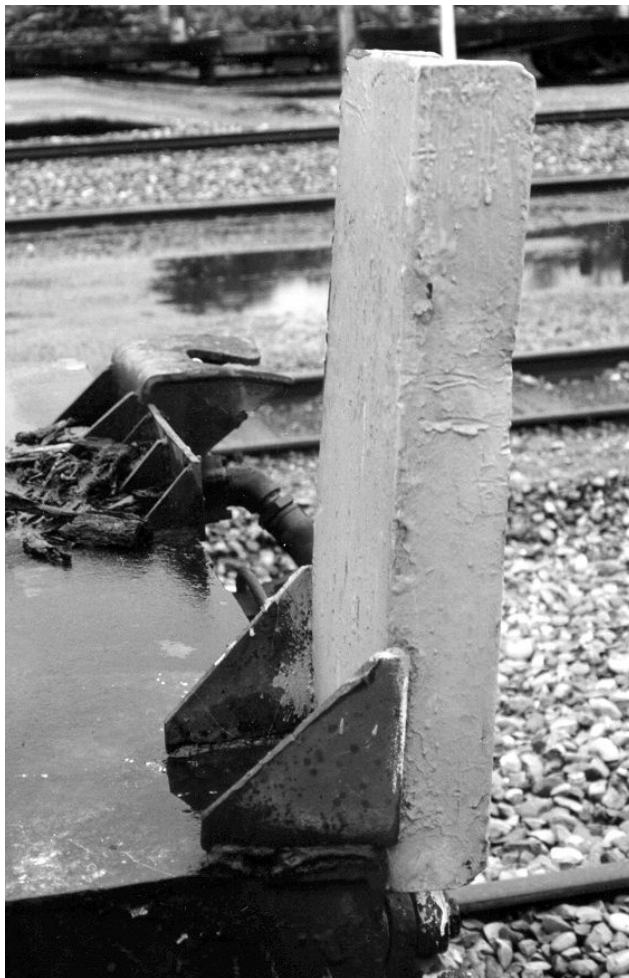
Figure 7
Example of a handgrip with stiffener attached.

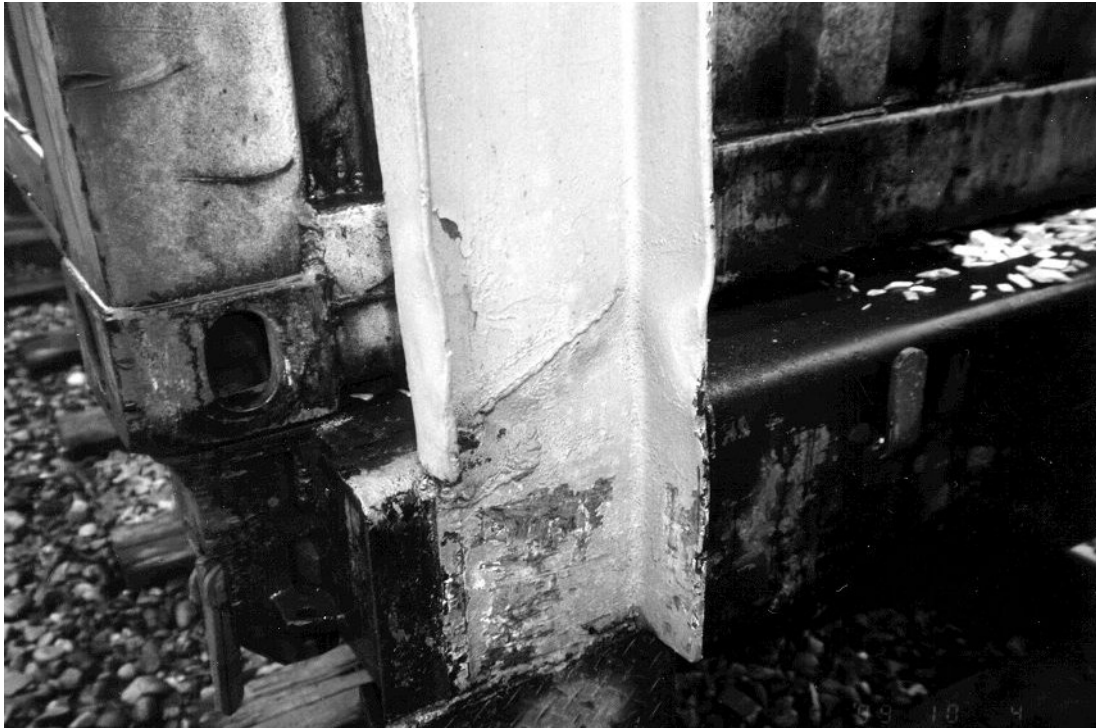
- 1.5.2 Some flat-deck log wagons in the sample had stiffeners to support the channel handgrip frames. These frames generally showed evidence of impacts, but with little significant deformation (see Figure 7). However not all log wagon handgrips were strengthened in this way.
- 1.5.3 Handgrip frames on container flat top (CFT) wagons did not have such stiffeners due to lack of room. A number of handgrips on CFT wagons showed evidence of deformation, with some of these having been weld repaired (see Figure 8).

Figure 8
Example of a handgrip which had been repair welded

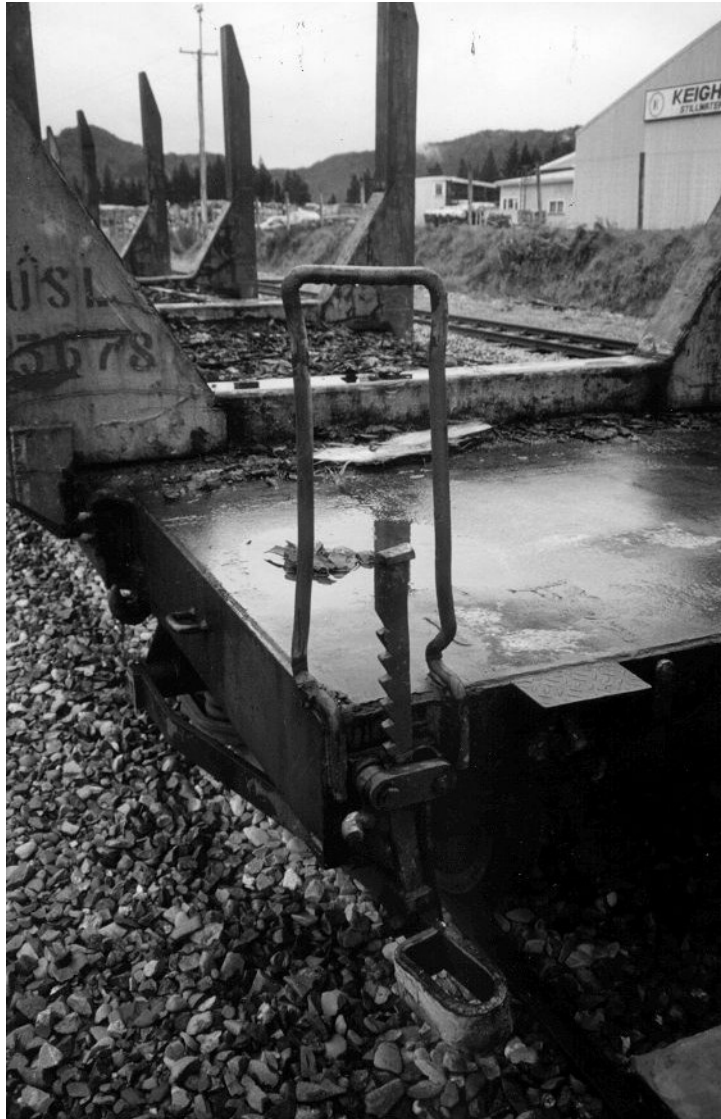
Figure 9
The new hoop style handgrip in service

- 1.6.5 In 1998 Tranz Rail started progressively introducing a hoop design handgrip to replace the pedestal type. An example of this type of handgrip is shown in Figure 9. The handgrip involves a 24 mm diameter steel rod bent in a U-shape and fitted in combination with a lower, newer design footstep (the “ergonomic” design).

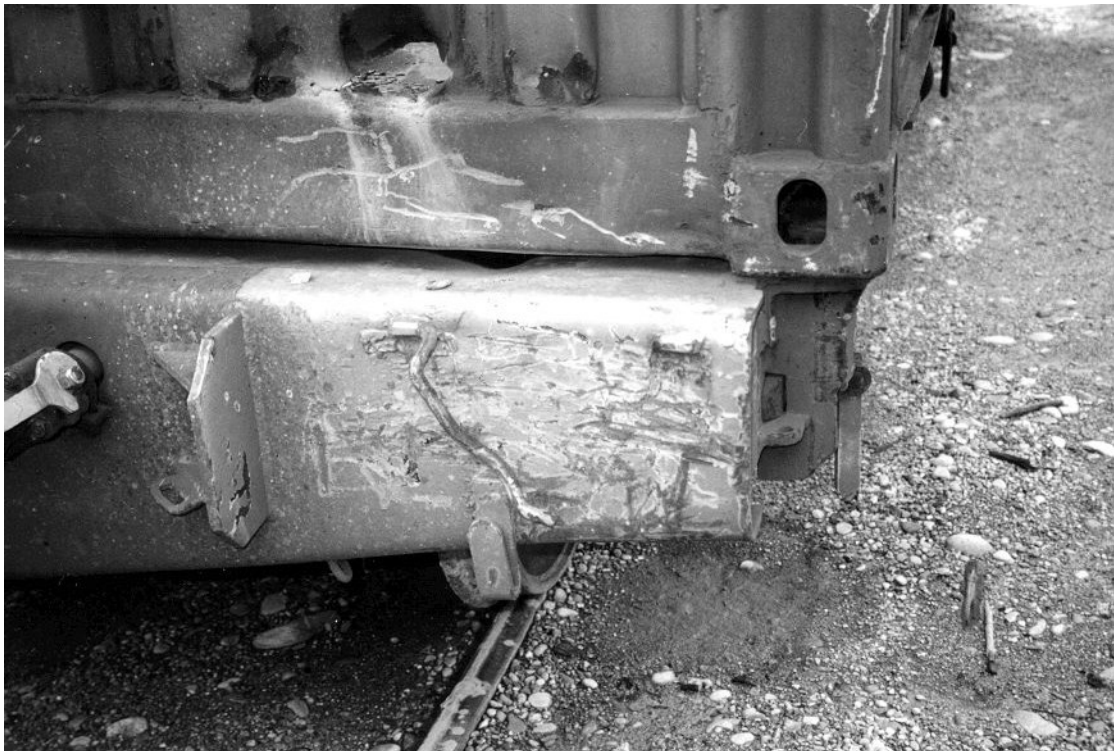
- 1.7.1 Site inspection of the “Ashley pool” private siding facilities showed shunting methods were being employed which were likely to have resulted in loads being applied to handgrip frames. These included the use of both a rubber-tyred tractor and a forklift for positioning wagons to loading points. During the inspection one of the private sidings was being operated using a rubber-tyred vehicle to cut out empty wagons and place them to another road for loading. Bent and damaged handgrips were found during the inspection.
- 1.7.2 The random sample also revealed evidence of damage to wagon headstocks and the attached coupling handgrip used by shunting staff when moving between wagons for coupling or uncoupling purposes. In many cases these handgrips were badly damaged as a result of impact from equipment being used to shunt wagons from the headstock. Figure 10 shows a typical wagon.

Figure 10
Typical damage to a coupling handgrip, headstock and container
