**Report 99-122**

**express freight Train 938 and**

**intercity express freight Train 919**

**collision**

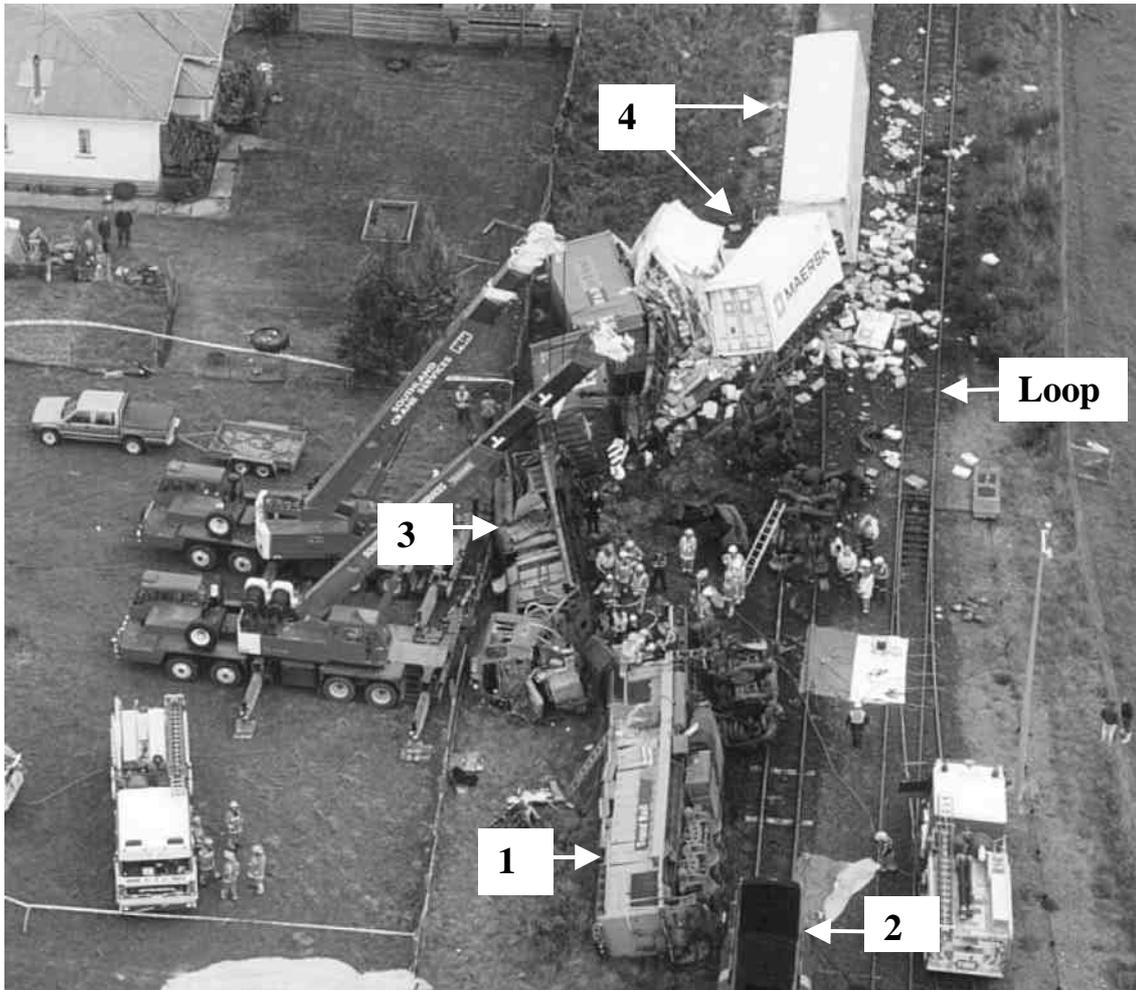
**Figure 2**  
**The accident scene looking south**

- 1.2.14 The collision derailed the leading 3 wagons of Train 938 and damaged buffer gear throughout the train. The leading 2 wagons on Train 919 also derailed. These were sprung from the track by the impact and jack-knifed as the locomotive was pushed back, as shown in Figure 3.

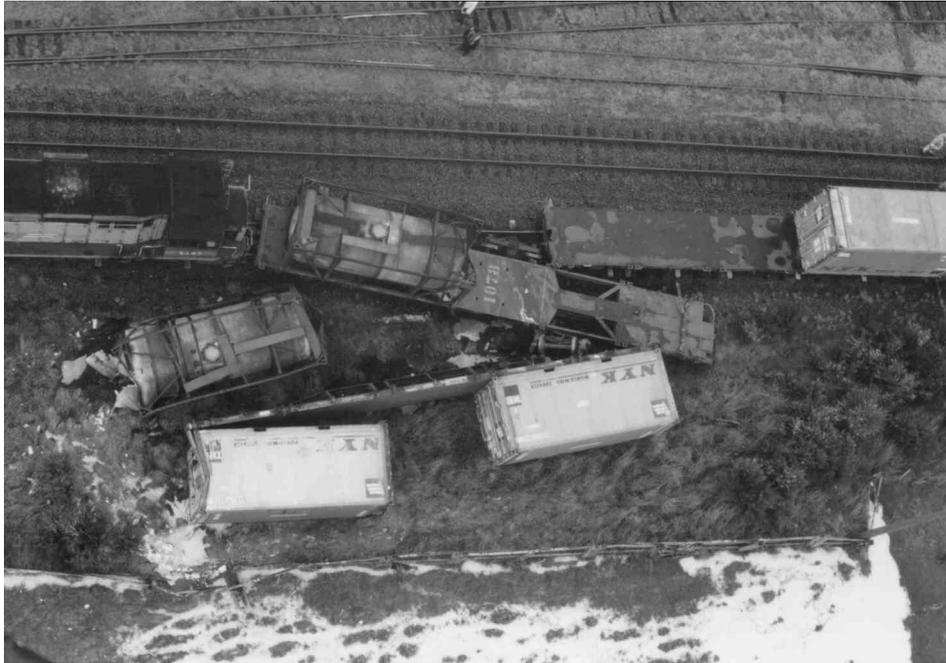
**Figure 3**  
**The derailed leading 2 wagons on Train 919**

Note: DC 4202 had been moved east (to the left of the photograph) about 1.5 m at this stage to allow access to the cab area of DFT 7254.
