Report 99-127
siding shunt derailment
Fletcher Paper private siding
Mt Maunganui
17 December 1999

At approximately 1630 hours on Friday 17 December 1999, a rake of wagons being propelled from Fletcher Paper private siding in Mt Maunganui derailed as a result of being pushed over a derailing block. The wagons slewed from the track and crossed a public road level crossing before colliding with a building and coming to rest on the opposite side of the road. The safety deficiencies identified included:

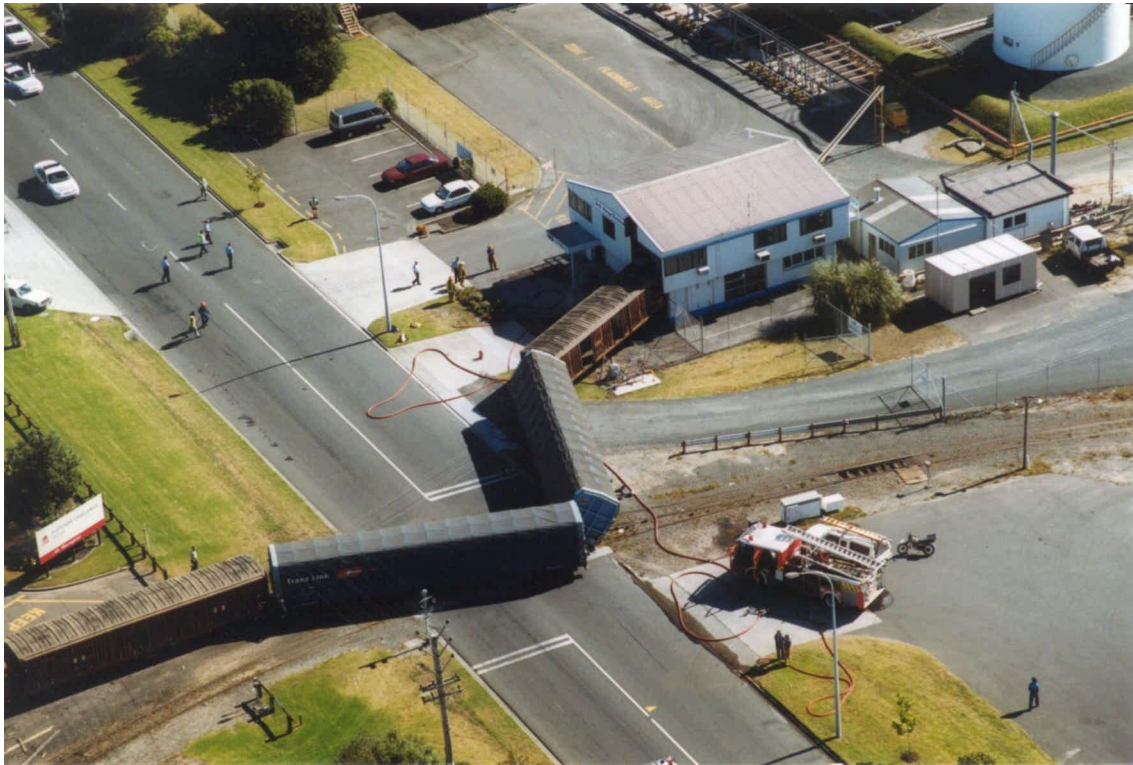
Figure 1
Aerial view of the derailed rake

- 1.1.16 When the rake stopped, the leading wagon had gone over the derailing block, crossed the road and crashed into a building. The second and third wagons had followed the leading wagon over the derailing block and had come to rest at an acute angle across Totara Street. The fourth wagon, which had also derailed, had not reached the street. All wagons in the rake remained coupled although the brake pipe between the first and second wagons had fractured (refer Figure 1).

- 2.1.5 The distance the rake travelled after riding over the derailing block indicated that it was probably travelling between 20 and 25 km/h, which equated to about 7 m per second. At that speed it would have taken about 8 seconds for the leading wagon to have covered the distance from the derailing block to the building. By the time the shunter reacted and called the RCO to stop, and the RCO had responded, it was too late for an emergency stop application to prevent the wagons striking the building.

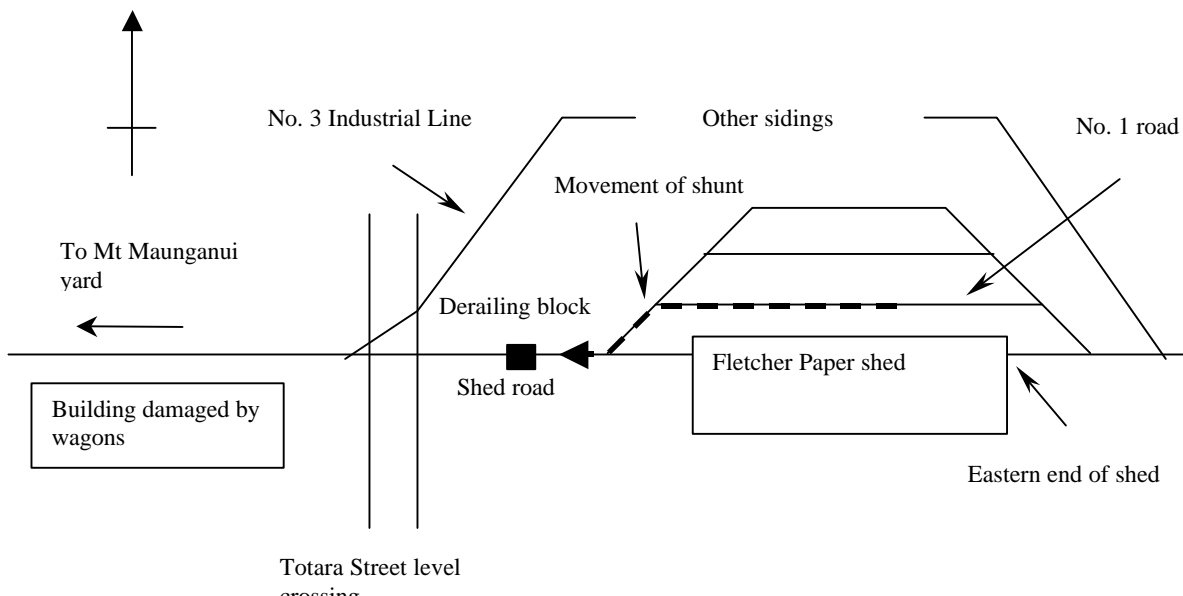
Figure 2
Site plan of the derailment area
(not to scale)

- 1.2.1 A connecting spur ran from Mt Maunganui yard to a set of points approximately 10 m west of Totara Street level crossing. From here the spur continued straight ahead, becoming the shed road providing access to the western end of the shelter, as well as to roads 1, 2 and 3. No. 3 Industrial Line veered away to provide access to other private sidings (refer Figure 2).

- 1.2.2 No. 1 road was one of 3 other roads accessed off the shed road. It was classed as a siding and was not used for discharging/loading of wagons.
- 1.2.3 No 1 road rejoined the shed road through a set of points approximately 70 m before the derailing block and between the western entrance to the shed and Totara Street level crossing. The derailing block was sited 27 m before the level crossing to prevent runaway wagons from the western end of the shed fouling Totara Street level crossing or No.3 Industrial Line and had been installed approximately 2 months earlier.
- 1.2.4 The derailing block was a New Zealand Railways 1946 design, the current standard, and complied with Railnet Code P54(f), which stated in part:

- 1.2.5 The distance from the derailing block to the building on the western side of Totara Street was 57 m.
