Report 99-209

coastal passenger and freight ferry *Arahura*

premature release of rescue boat

21 May 1999

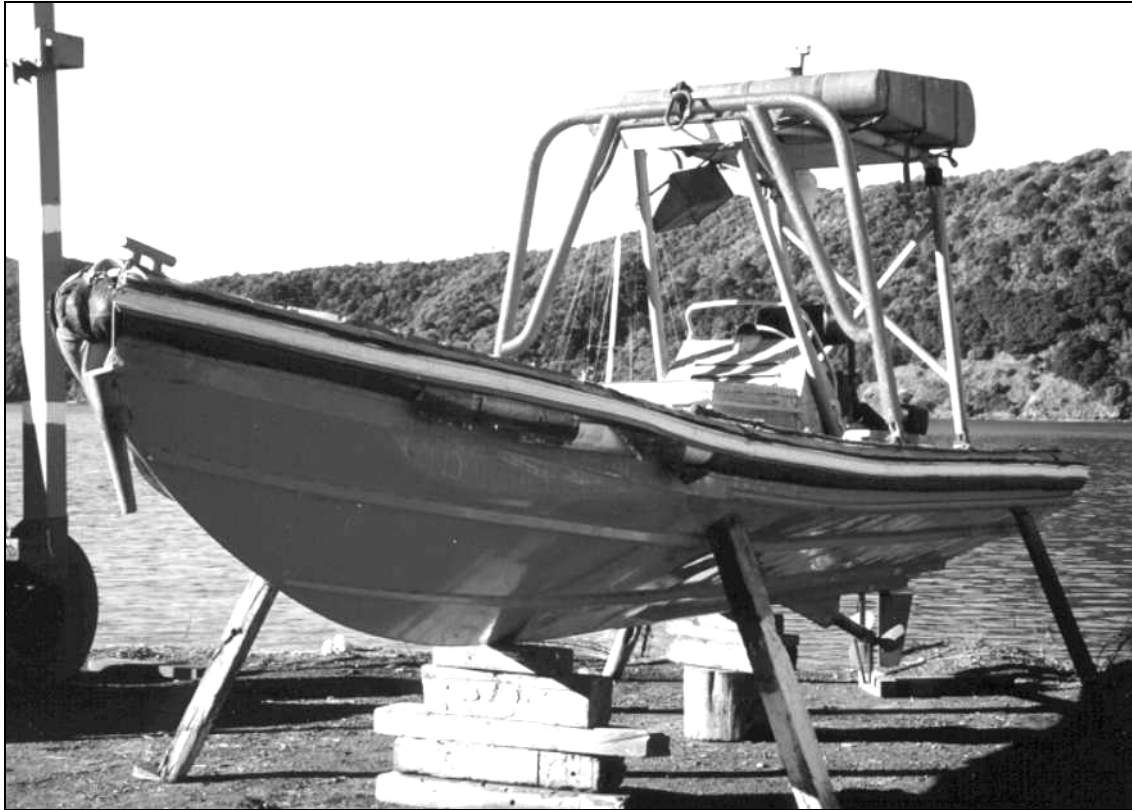
Figure 2
Starboard rescue boat on the stand following the accident

- 1.2.5 Damage to the rescue boat was minimal. There was a dent in the aluminium plating below the soft belting near the port bow. The stainless steel box containing a fixed very high frequency (VHF) radio mounted under the lifting frame above the driver had partially torn loose from its mounting when the boat had hit the sea.

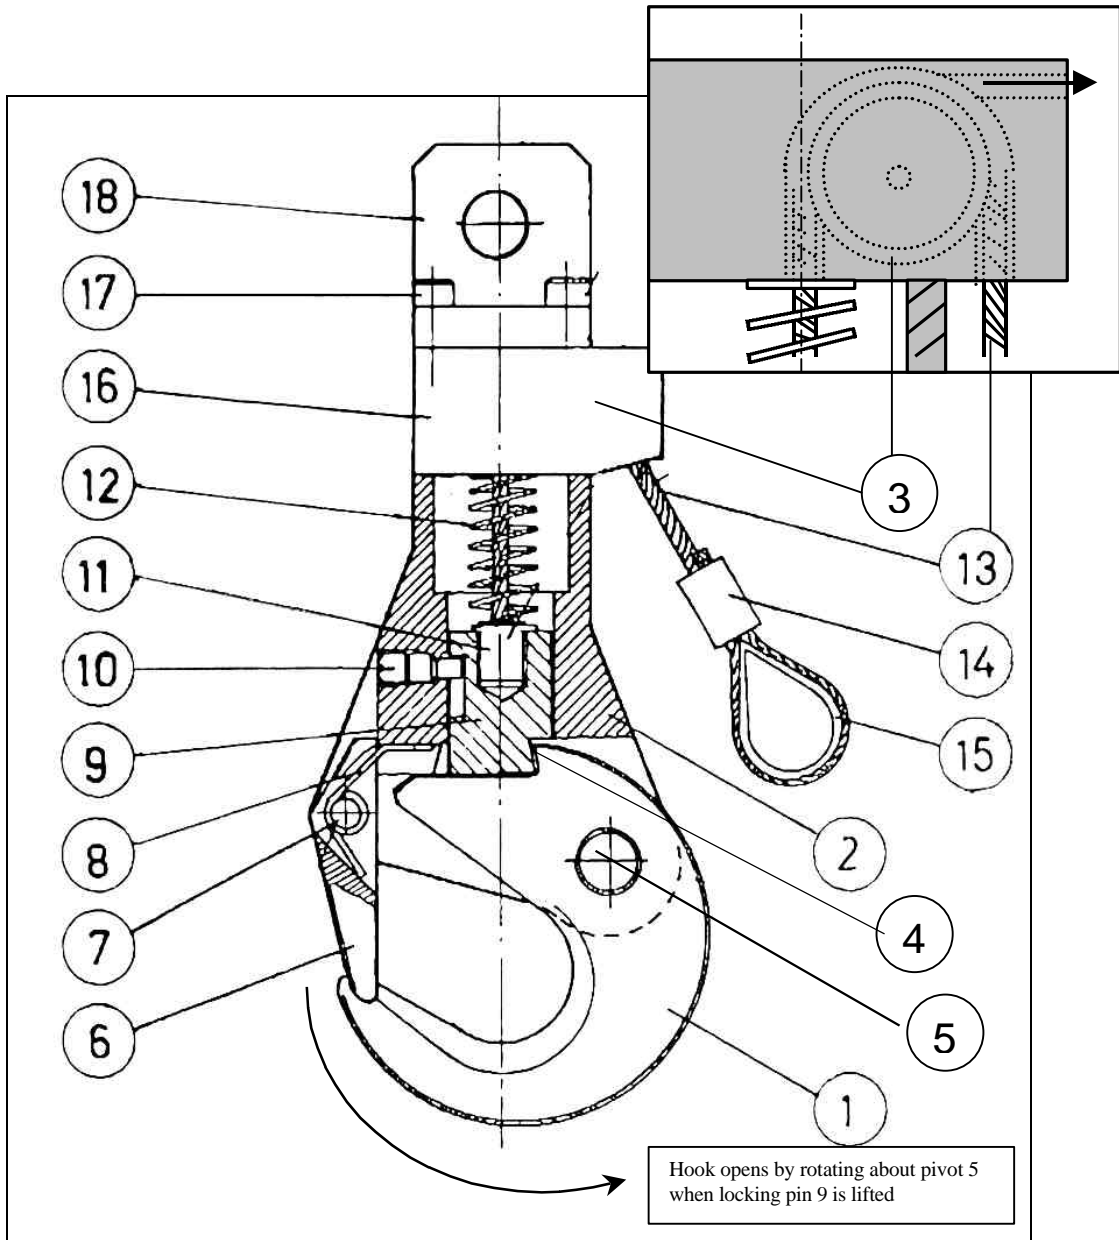
Figure 4
Cranston hook assembly drawing
 (The text and notes 3, 4 and 5 have been added by the commission. The insert diagram shows the arrangement for the accident hook, which differs from the hook shown)

- 1.7.10 The lock pin had been manufactured without the 10° reverse bevel shown in Figure 4, and as a result of the stepped deformation, the locking face had achieved a forward bevel which would encourage the locking face to release under load rather than discourage it.

- 1.7.11 The hook locking face did not have a reverse bevel as shown in Figure 4. It could not be established if it ever did have, or whether the reverse bevel had been worn away over the years by the action of snap connecting and releasing the hook. The manufacturer thought that the reverse bevel may have been a design improvement made in 1984, one year after the manufacture date for the accident hook.

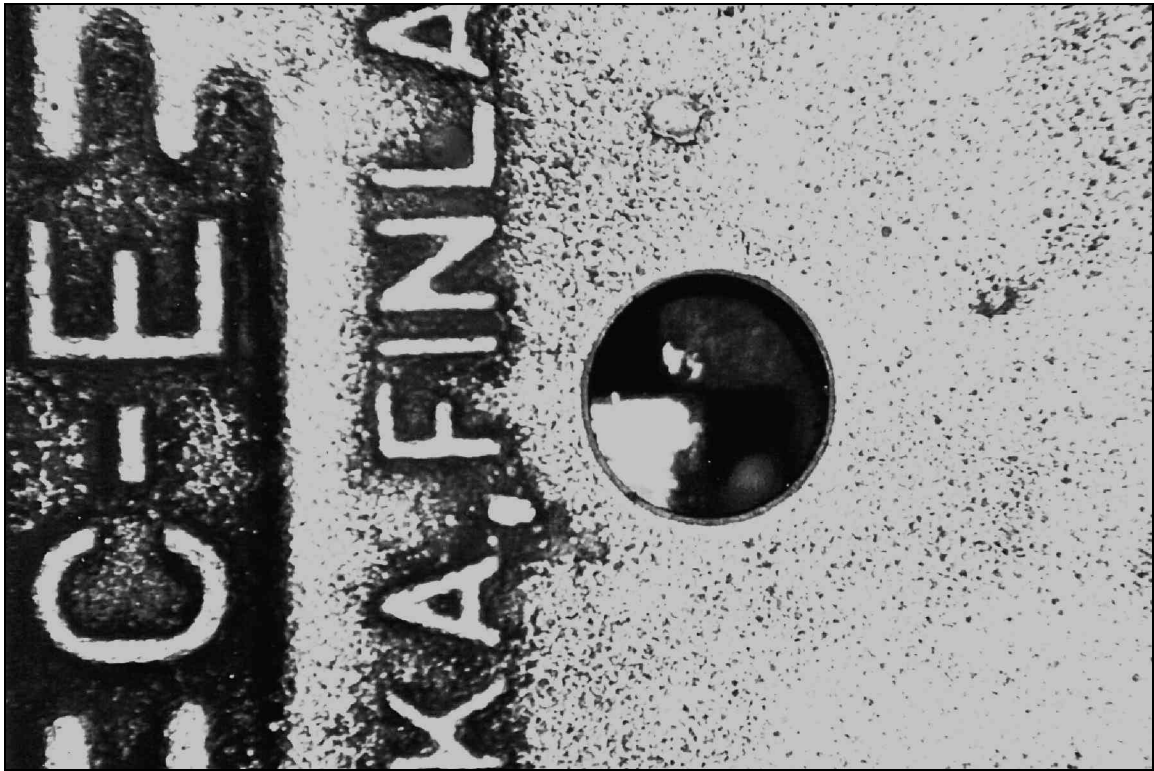
Figure 5
View through the aperture showing hook locking face
only just engaged with the edge of the locking pin

2.2.7 The Cranston hook failed to carry the load of the rescue boat and crew because the lock pin was probably not in the fully locked position. If the lock pin had been engaged by 3 to 4 mm as shown in Figure 6, the hook would have been unlikely to have released without some strong steady pull on the release cable, as proved in the post-accident tests conducted on the boat. As there was no evidence of anyone on board pulling on the release cable at the time the rescue boat dropped, the lock pin was probably in a position similar to that shown in Figure 5; only just engaged with the edge of the hook locking face.

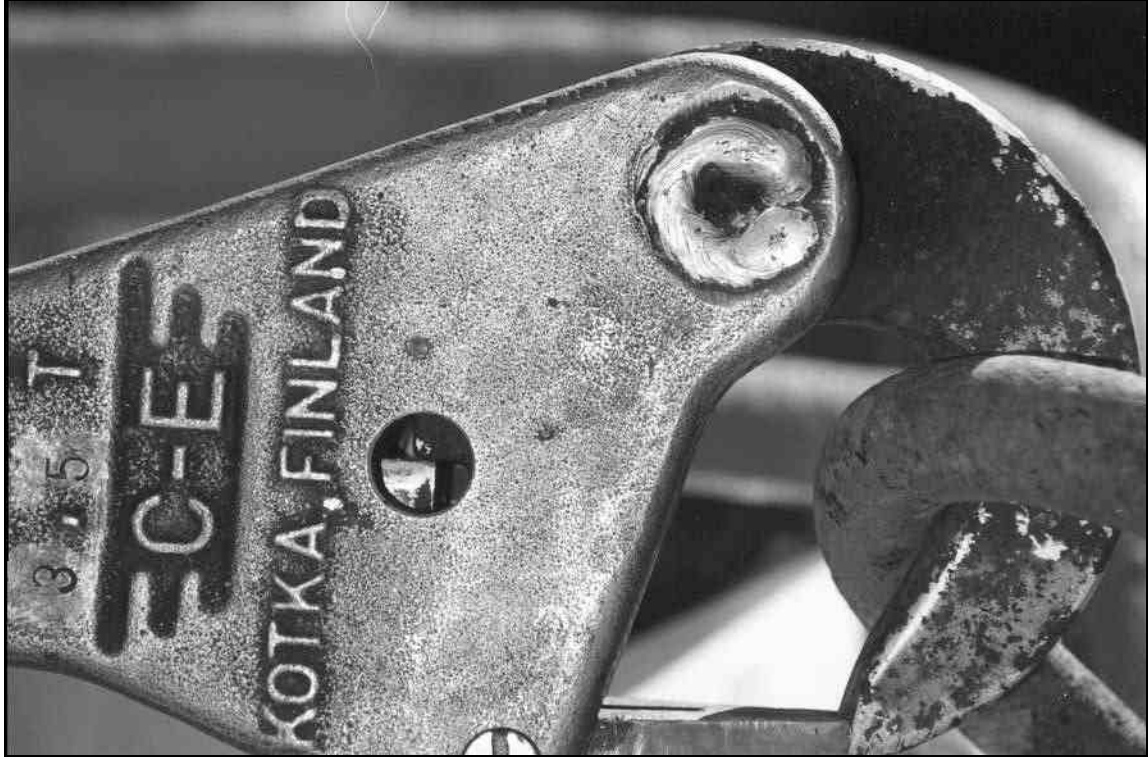
Figure 6
View through the aperture of the locking pin partially
engaged with the hook locking face (by about 3 to 4 mm)

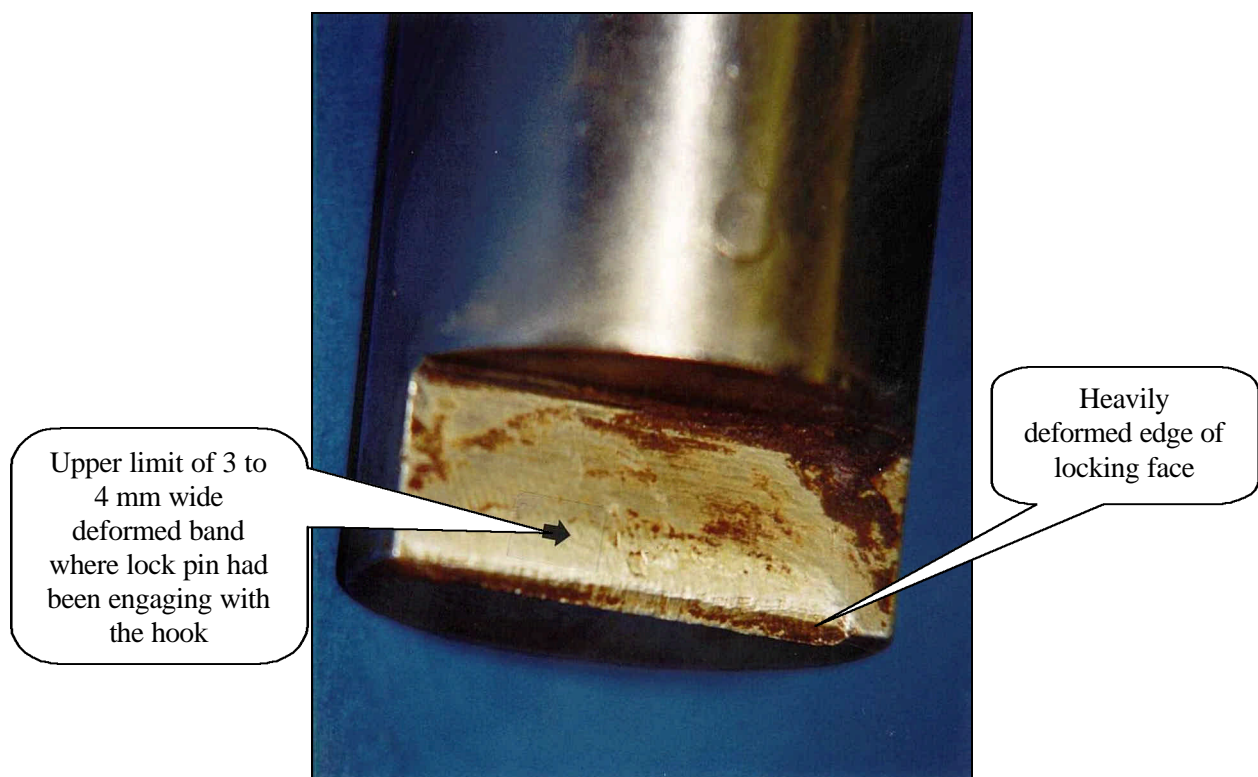
Figure 7
Photograph of lower part of lock pin

- 1.7.9 A closer examination of the damage at the bottom of the lock pin revealed that a distinct step had formed on the locking face, as seen in Figure 7. When the lock pin was fully engaged with the hook the contact length of the locking face should have been 9 mm. The bottom load-bearing face of the lock pin was deformed in a 3 to 4 mm band. The location of the upper limit of this band was consistent with the limit of travel of the lock pin under force from the spring, leaving some 5 mm not engaged with the hook. A sharp step was present at the bottom of this band where the edge was heavily deformed.

2.2.8 Taking into account the leverage in the hook, the force on the locking face was about half the load on the hook, about 1.35 t. This force was probably sufficient to deform the end of the lock pin and release the hook. This would have been assisted by the sideways movement of the lock pin in the block, allowing it to tip slightly and the load to not be applied in a direction that was normal to the locking face owing to the rotation of the hook. The effect would have been exacerbated by the locking faces of both the hook and lock pin having worn to a positive bevel, discouraging the faces to lock rather than interlocking as designed to do with a 10° reverse bevel.

2.2.10 It could not be positively established if the deformation at the bottom of the lock pin occurred as a result of this one incident, but numerous small polished indents were present in the area of wear on the lock pin, suggesting that it had regularly been loaded in a similar manner.

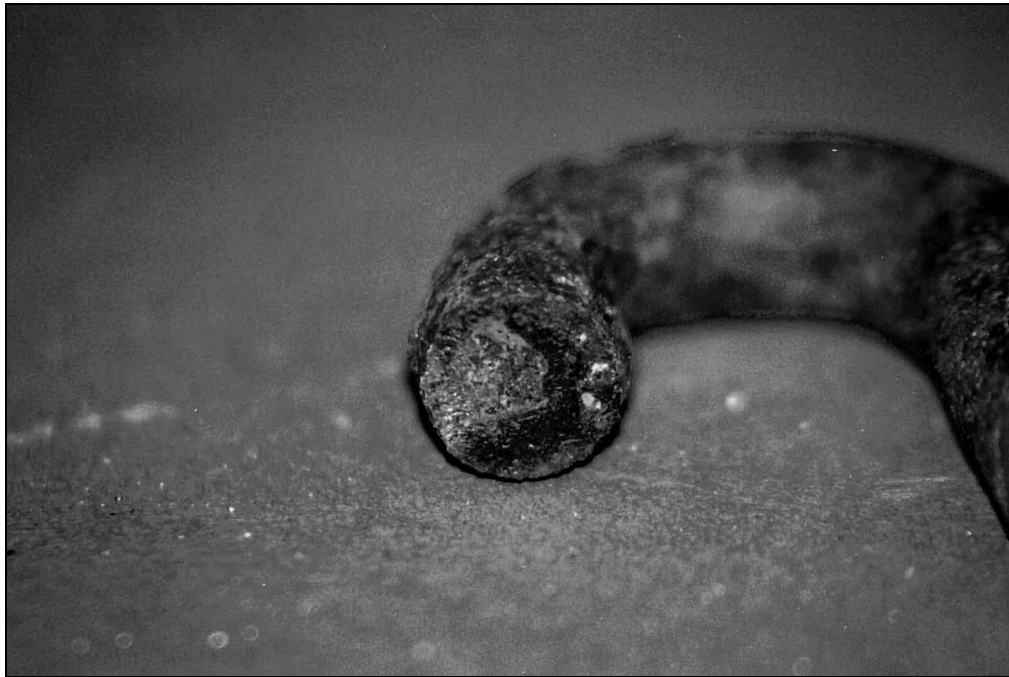
Figure 8
Brittle fracture of failed link from preventer chain

- 1.7.12 The failed chain link had fractured at 2 locations. One of these was located half way along one side of the link. This fracture had a brittle failure appearance. The other fracture surface was typical of a ductile overload failure, evidenced by the adjacent material being necked down and bent as a result of the link opening out.
- 1.7.13 The ductile overload fracture appeared to have occurred after the brittle fracture and after the chain had partially opened.

- 1.7.14 The brittle fracture appears to have occurred in the middle of a weld, evidenced by the adjacent material being slightly larger in diameter. There were 2 distinct areas on the brittle fracture face: an area covered with red/brown oxide and an area covered by dark brown/black oxide (see Figure 8). The black oxide was thicker and covered an area of about 120 mm² out of a total 160 mm² cross section. The brittle fracture was sectioned to allow one half of it to be examined in detail. After the removed section was chemically cleaned it revealed a number of obvious corrosion pits on the fracture surface.
