## **Report on investigations 99-212 and 99-213**

### **jet boats *Shotover 14* and *Shotover 15***

### **separate collisions with canyon wall**

### **Shotover River, near Queenstown**

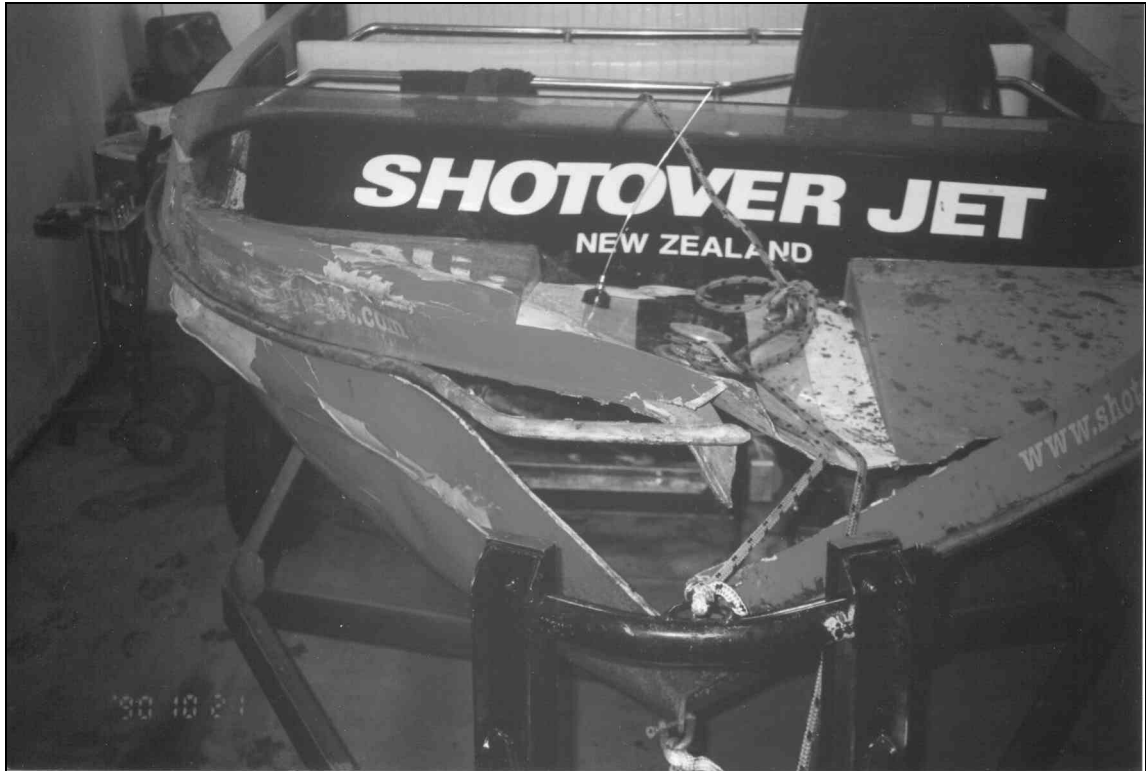
*Shotover 14* after the 21 October accident

1.1.6 The forward right side of *Shotover 14* struck the outcrop heavily, causing extensive damage to the hull and topsides. The initial impact on the back left corner left a significant dent near the chine about half a metre long. The force of the impact dislodged the motor from its mounting, causing the exhaust couplings to part and water began entering the boat through the exhaust outlets.

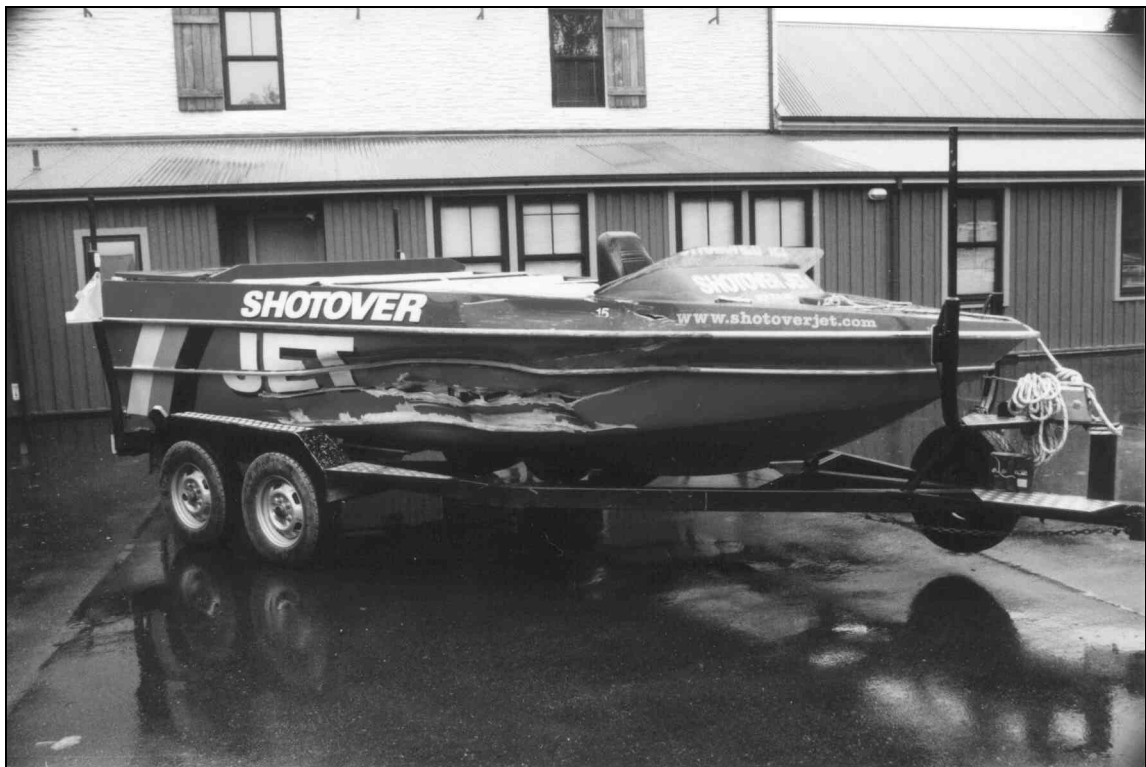
*Shotover 15* after the 12 November accident

- 1.7.1 The first impact point was in line with the front passenger seat on the starboard side just below the windscreen. The hull was severely pushed in from there back to the second row of seating. The hull was ruptured for about one metre just above the water line. The hull next to where the deceased was sitting was virtually undamaged.

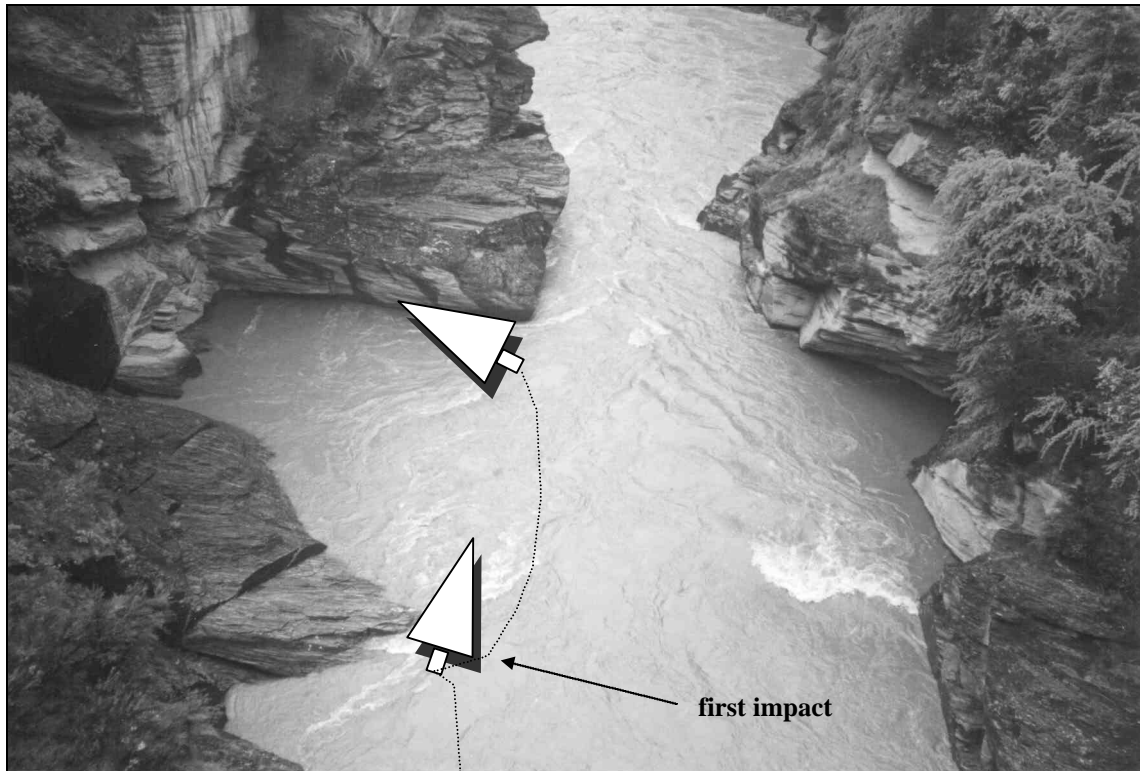
**Figure 1**  
**Accident site in the first canyon**  
**and the approximate path of *Shotover 14***

1.1.5 The driver intended to pass about one metre off the rock wall but when he tried to steer to the right the steering wheel would not turn in that direction. The driver made 2 attempts to steer right and then applied considerable force to the steering wheel, which caused it to come free. The boat turned sharply to the right, causing the back left corner to glance off a rock outcrop and sending the boat into a sharp left-hand sliding turn toward the next rock outcrop (see Figure 1). The engine stopped during the accident sequence.

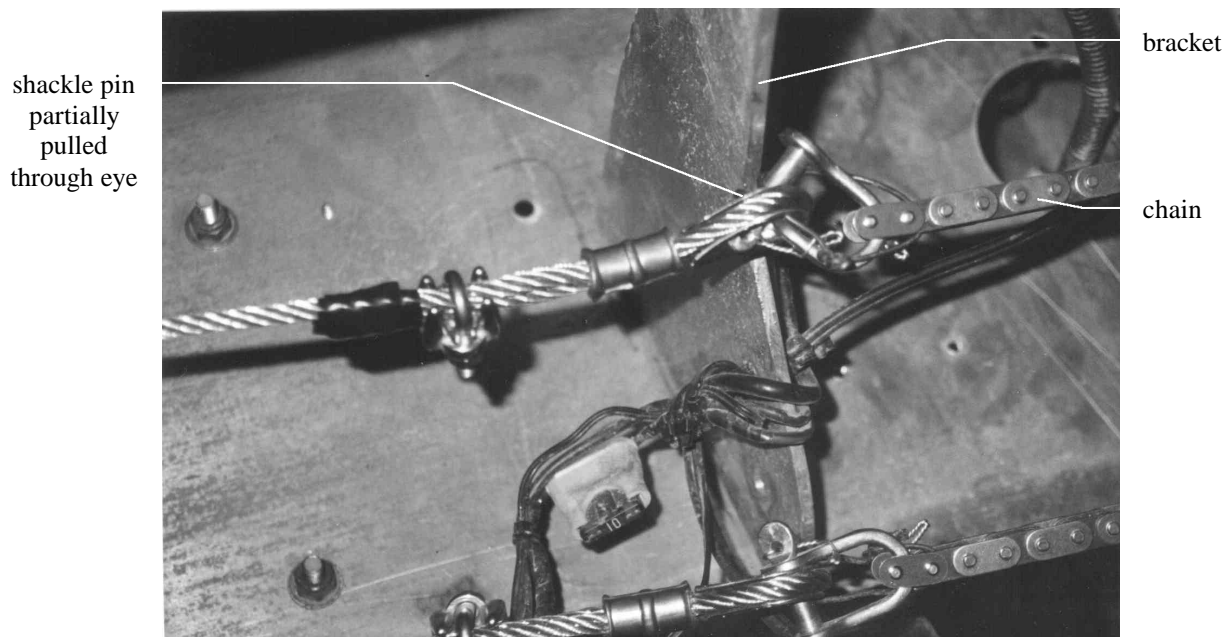
**Figure 2**  
**The steering arrangement behind the dashboard, as found**

- 1.1.8 One passenger received fractures to her wrist and 2 ribs. The driver and other 8 passengers received minor cuts and bruising.
- 1.1.9 Steering of *Shotover 14* was achieved using the steering wheel to turn a sprocket and chain located behind the dashboard. The chain was joined by shackles to cables that ran through a pulley system and were attached to the steering tiller mounted on the jet unit steering shaft at the transom. An inspection of the steering system revealed that a shackle connecting the chain to the steering cable had caught on an aluminium bracket supporting the dashboard. There were many marks on the bracket, indicating the shackle had been catching on the bracket for some time.

- 1.1.10 Heavy fresh marks were evident on the edge of the bracket where the shackle would have been passing across the bracket with each movement of the steering wheel. The shackle was found with its pin end partially forced through the thimble at the cable end, consistent with some considerable force having been applied to the shackle through the steering system when the other side of the shackle was being restrained (see Figure 2).

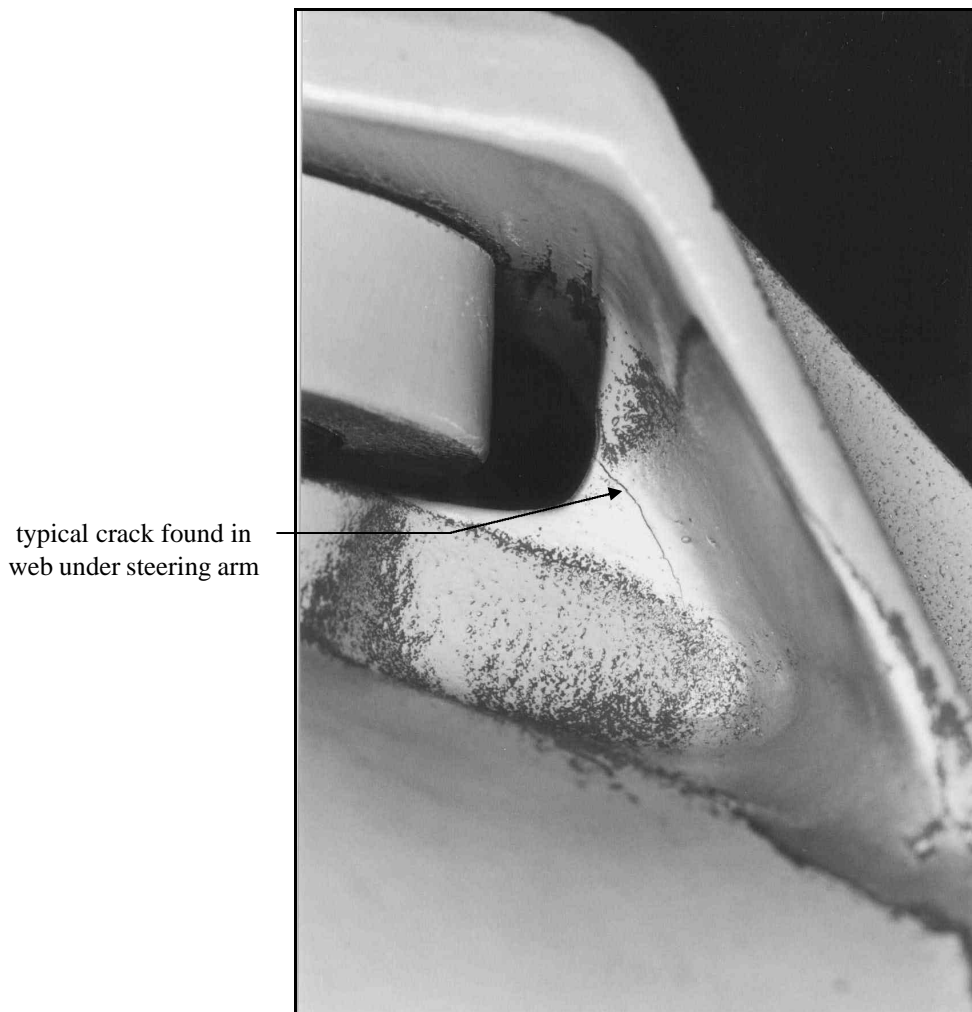
- 1.7.5 The reverse bucket was removed from the jet unit to inspect the operation of the steering nozzle arrangement as fitted. The spare steering nozzle used to recover the boat was still fitted. The web under the steering arm on the replacement unit was cracked as shown in Figure 5.

**Figure 5**  
**Crack in web of replacement nozzle for *Shotover 15***  
**Crack shown was typical of other cracks found in other steering nozzles**

- 1.7.7 The steering nozzles on all HJ-212 units in the Shotover fleet were removed and crack tested. Seven of 8 nozzles tested were found cracked in the same web. Two of those tested had cracks near the change in section of the steering arm, indicating that fatigue failure of the steering arm had begun.

- 1.8.4 A 10.5 mm long crack was present in the web supporting the steering arm similar to that shown in Figure 5. One side of this crack was removed from the casting by sectioning. Examination of the fracture surface revealed that it was typical of fatigue that had started at both top corners of the web. The crack then ran 45 degrees to the surface on both sides. In cross section a vee shaped fracture was then produced which was consistent with the web being cyclically twisted.

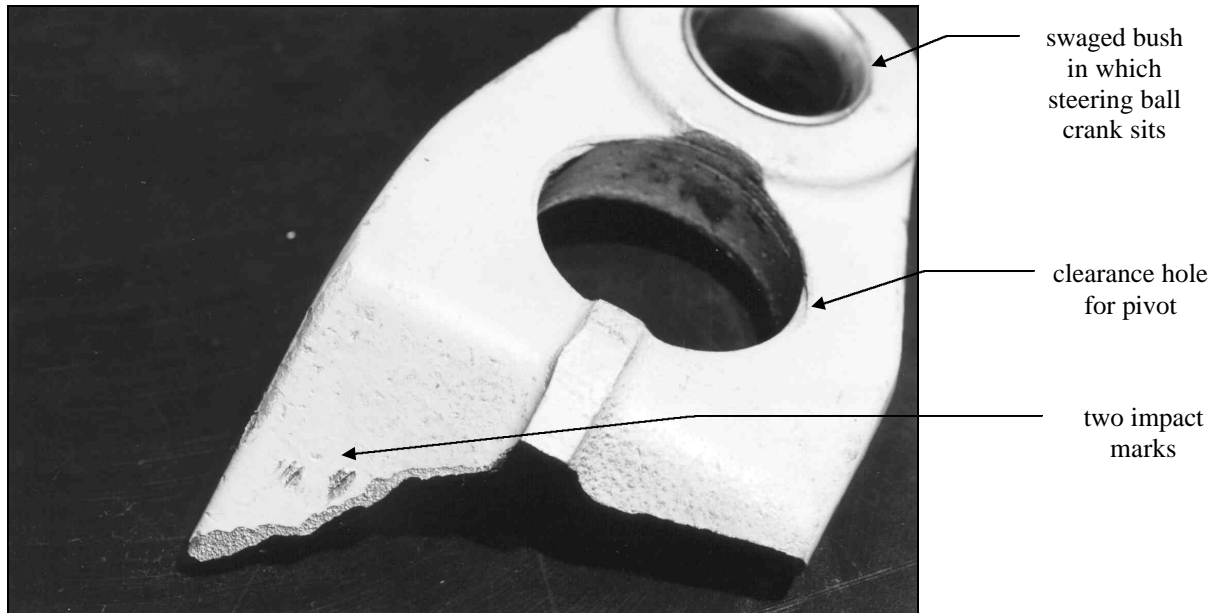
**Figure 6**

- 1.8.1 The fracture surface on the steering arm started near the change in section of the steering arm and ran at 2 distinctly different angles: from the right side looking forward, at an angle of about 5 degrees to the line of the change in section and then at an angle of about 45 degrees to that same line (see Figure 6).

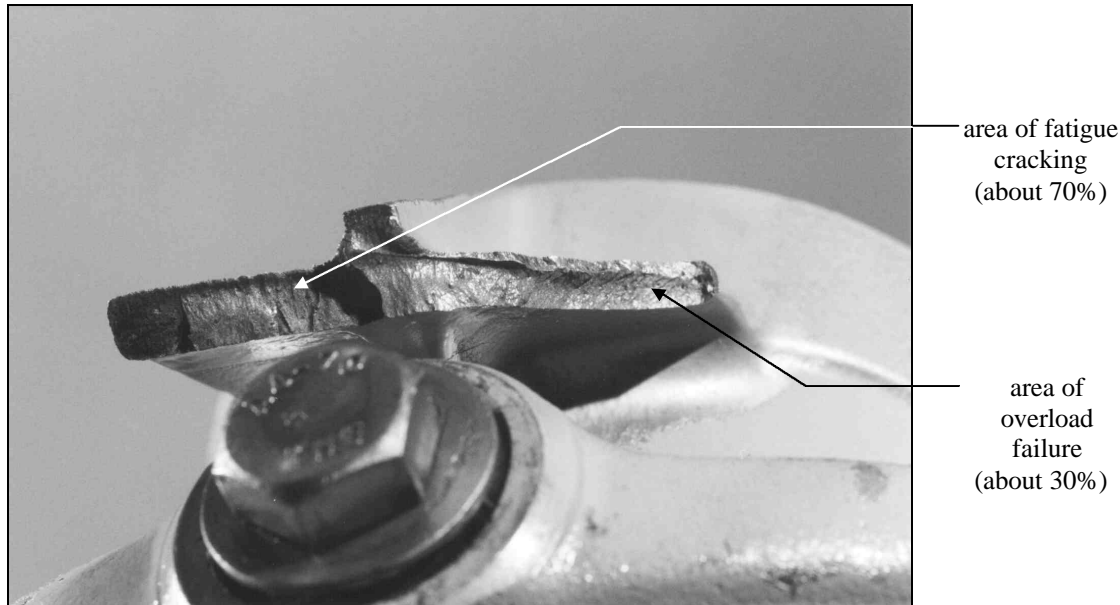
- 1.8.2 The fracture on the right side of the steering arm was typical of a multi-originated fatigue crack that had started under the steering arm. Fatigue cracks had also started on the left side of the casting. A series of fine cracks was present in the paint under the steering arm on both sides (see Figure 7).

**Figure 7**  
**The fracture surface**

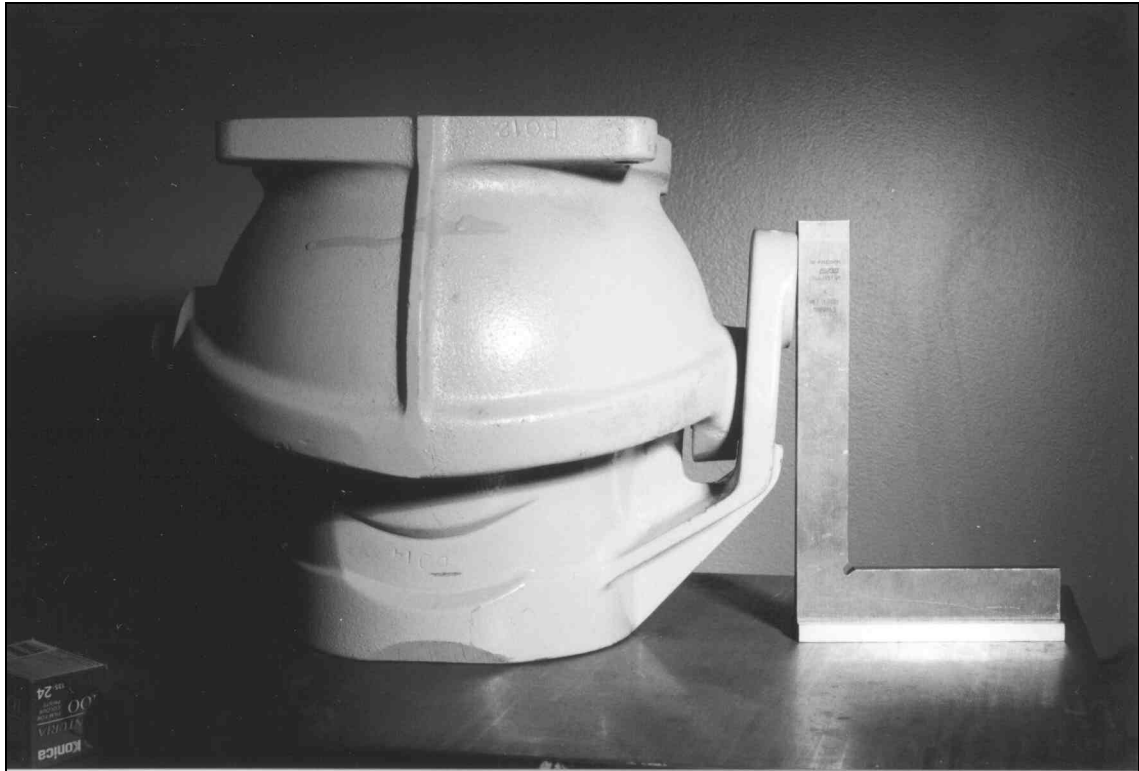
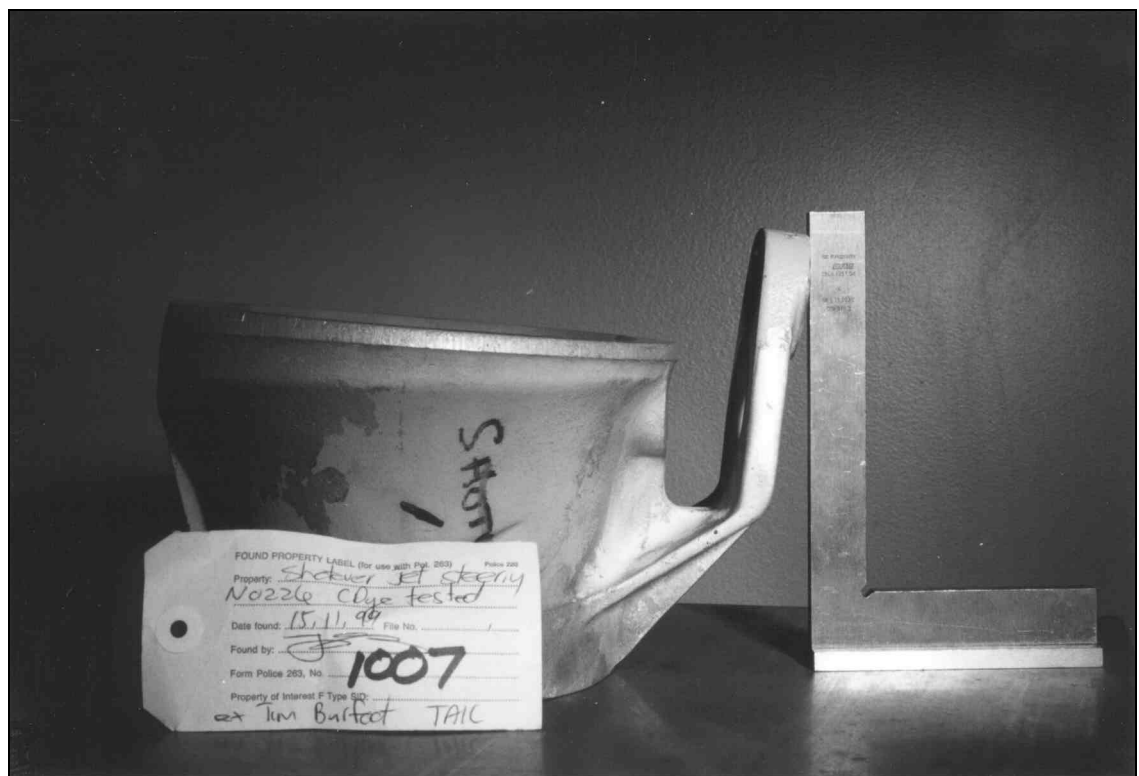
- 1.8.3 When the fracture surfaces were placed together this revealed that the arm had been bent upwards. Similar deformation was noted on the other 2 used steering nozzles. Figure 8 shows the comparison between a new and used steering nozzle.

**Figure 8**  
**Comparison between a new (top) and used steering nozzle**  
**Note how steering arm on the used nozzle is bent away from the nozzle**

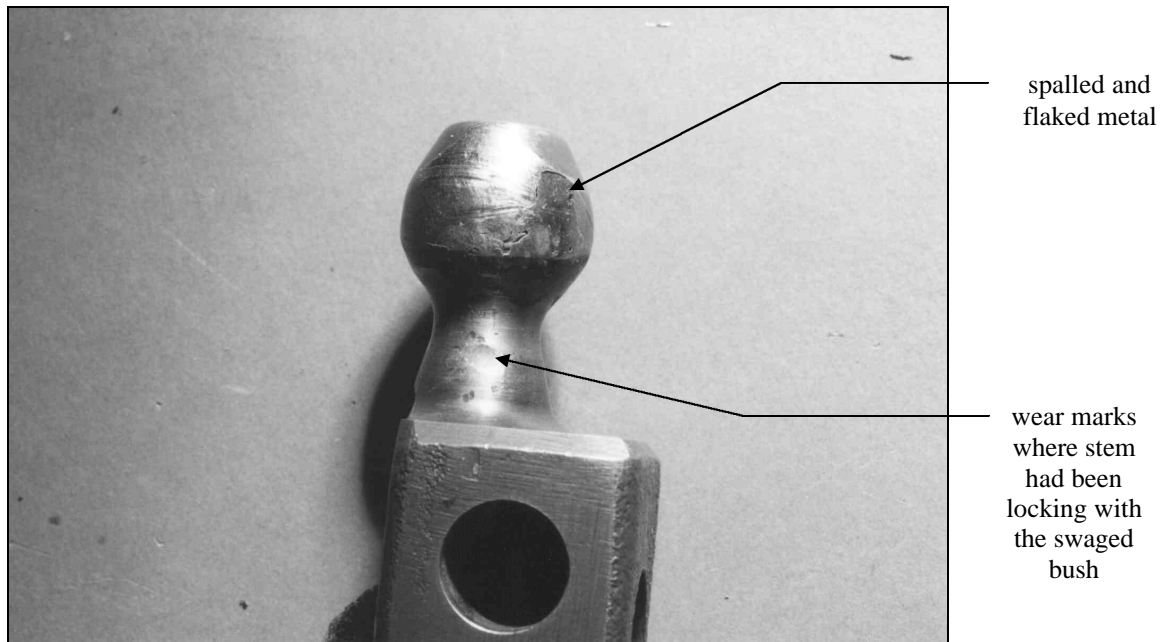
- 1.8.8 The steering ball crank was heavily worn. It had been reconditioned at some time and the metal used had worn through to the original metal and spalled. Wear marks were present on both sides of the steering ball crank stem. These marks were consistent with the wear marks on the inside edges of the swaged bush. These marks together with the heavy wear at the base of the swaged bush indicated that the steering ball crank and bush had become locked near the end of its travel on a regular basis (see Figure 9).

**Figure 9**  
**Steering ball crank from *Shotover 15***

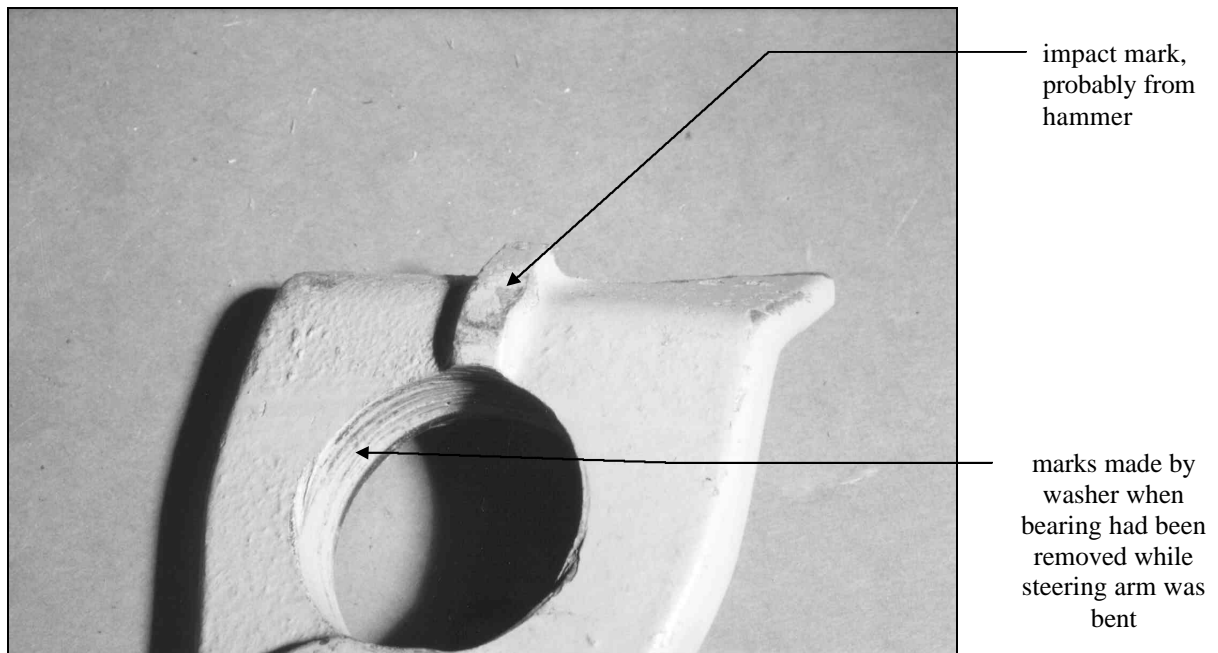
- 1.8.9 The clearance hole in the steering arm where the top pivot bearing sat contained a significant impact damage mark where the bolt washer had been forced into the side of the hole. The washer found in the hole was deformed. A series of marks was present in the paint inside the clearance hole where the washer had rubbed on the inside when the bolt had previously been removed (see Figure 10). This indicated that the steering arm had been bent before the bolt was last removed. Maintenance records showed that the nozzle bearings had been last changed on 23 November 1999, 3 weeks before the accident. Since that date the unit had been disassembled on 3 other occasions: once to replace a broken stud securing the jet unit, once to sharpen the impeller and once to fit a rebuilt impeller.

**Figure 10**  
**Failed steering arm showing markings inside the bearing clearance hole**
