Final Report AO-2015-003: Robinson R44, Main rotor blade failure,
Waikaia, Southland, 23 January 2015

Aviation inquiry A0-2015-003
Robinson R44
Main rotor blade failure
Waikaia, Southland
23 January 2015

Approved for publication: May 2019

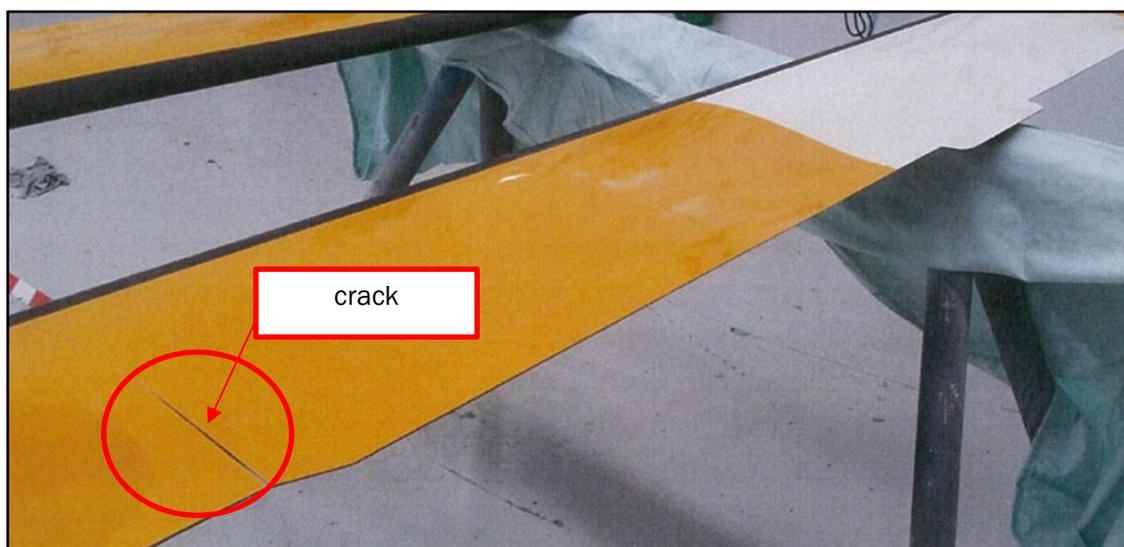
Figure 1
Cracked blade

- 3.1.3. The vibration began when the helicopter was about 200 metres from the landing site, so the pilot elected to land there. After landing, ground staff noticed an abnormal movement of one of the main rotor blades, so the pilot shut down the helicopter immediately. The helicopter was inspected and a large crack noticed on the lower surface of one of the main rotor blades, extending from the trailing edge to just behind the 'D spar'³ leading edge (see Figures 1 and 2).

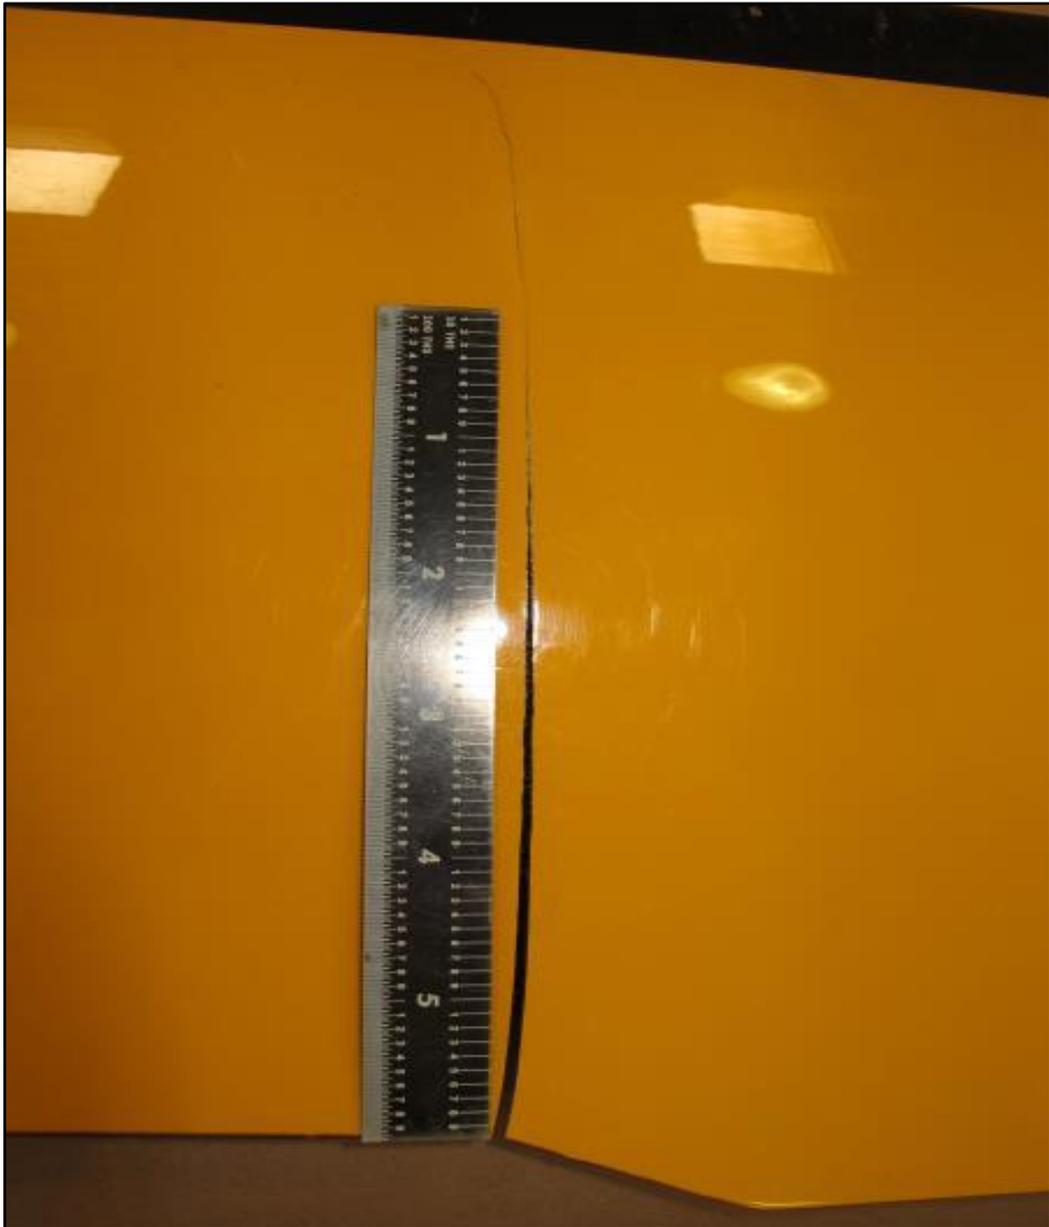
Figure 2
Blade crack at chord transition

- 3.1.4. The helicopter was taken out of service and both main rotor blades were removed. The blades were shipped to the Robinson factory in the United States for detailed inspection. Here it was noted that the crack appeared to have started in a radius in the trailing edge where the chord length⁴ of the blade increased, known as the 'chord transition'⁵ (see Figures 2 and 3).

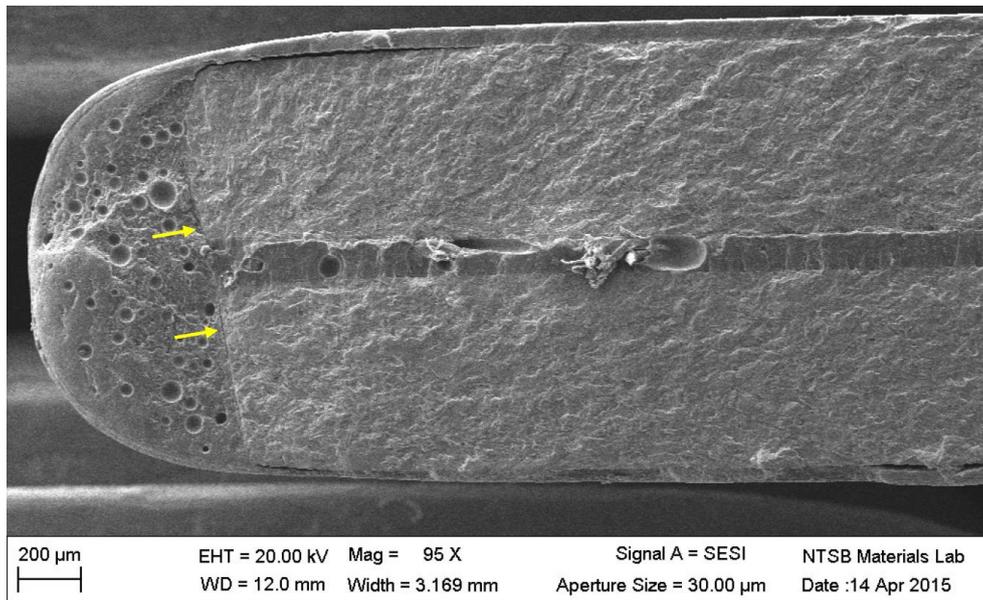
Figure 7
Crack origin

- 4.2.3. The NTSB examination report concluded that there were no manufacturing defects in the materials or in the construction of the blade, with all components of the blade meeting the design specifications. The materials experts from the NTSB also stated that the crack may have started in the epoxy sealant that coated the trailing edge, and that it could have spread into the aluminium skin from there. The epoxy sealant was not intended to be a structural or load-bearing component of the blade and was designed to flex with it. However, if the blade flexed significantly in service under cyclic loads, it is possible that the epoxy cracked first, creating a further stress concentration at that location.

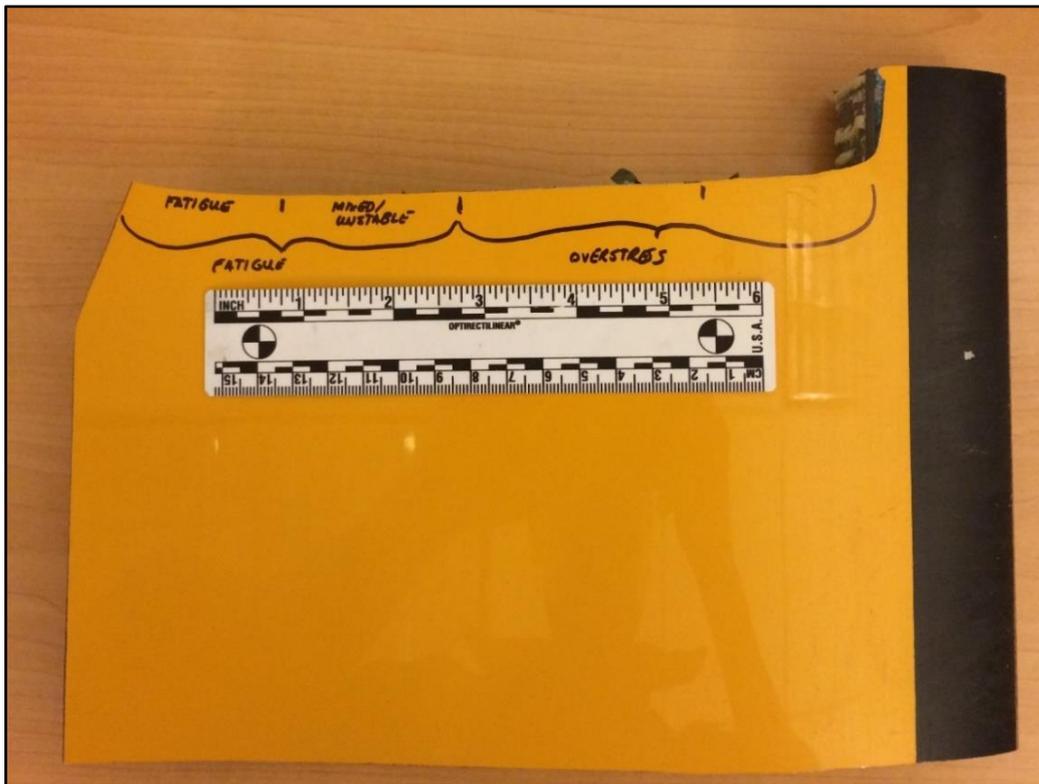
Figure 8
Upper surface of blade with annotations of crack failure mode regions

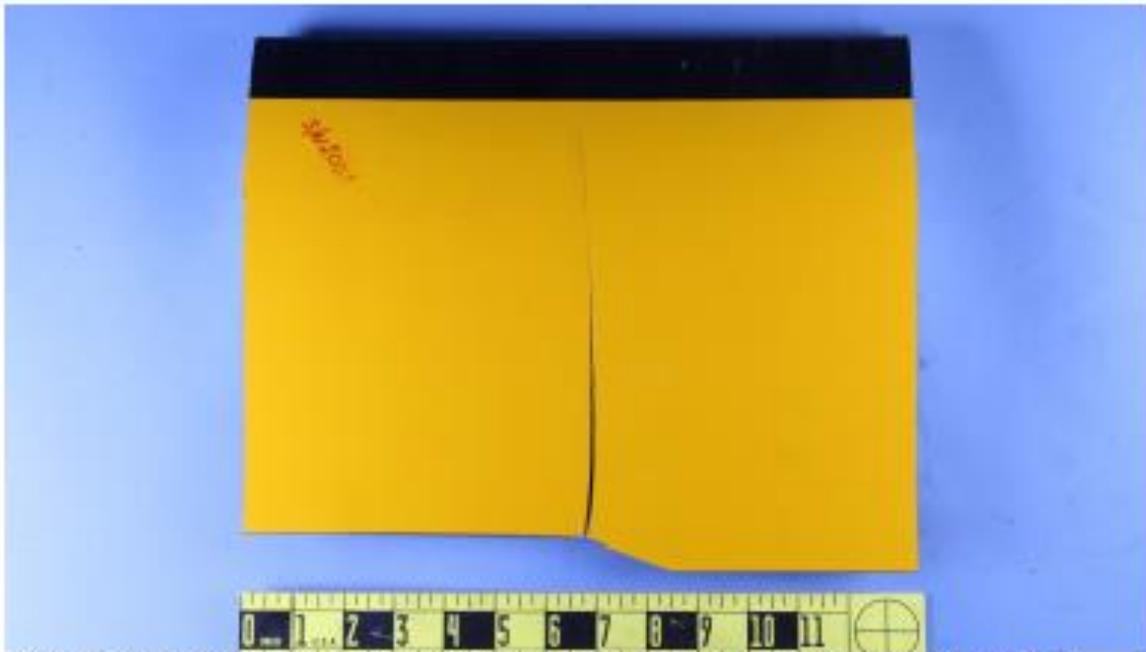
Figure 1 – The excised section of the main rotor blade, showing the crack originating at the trailing edge, as received.

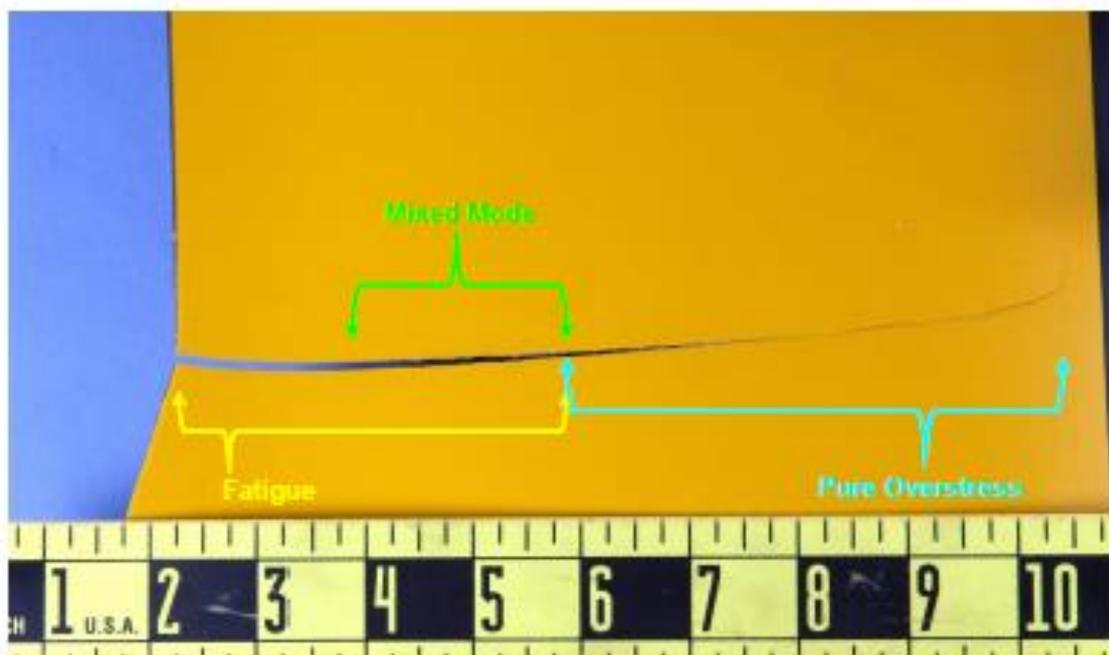
Figure 3 – Closer view of the crack in the main rotor blade rotated 90° clockwise from Figure 1, as received. The area later determined to be fatigue, mixed mode, and overstress are labeled on the figure.

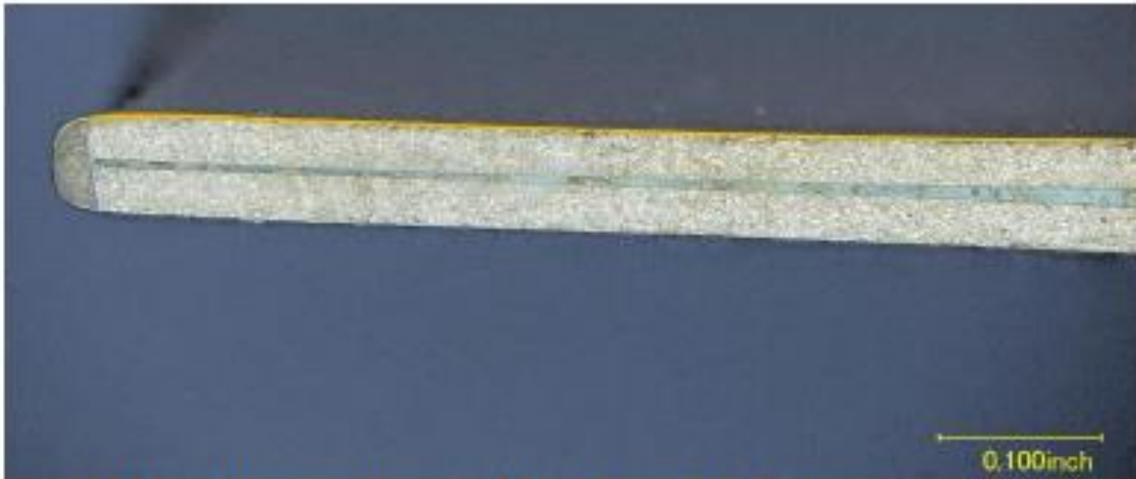
Figure 6 – The initiation point of the fatigue crack at the trailing edge of the main rotor blade.

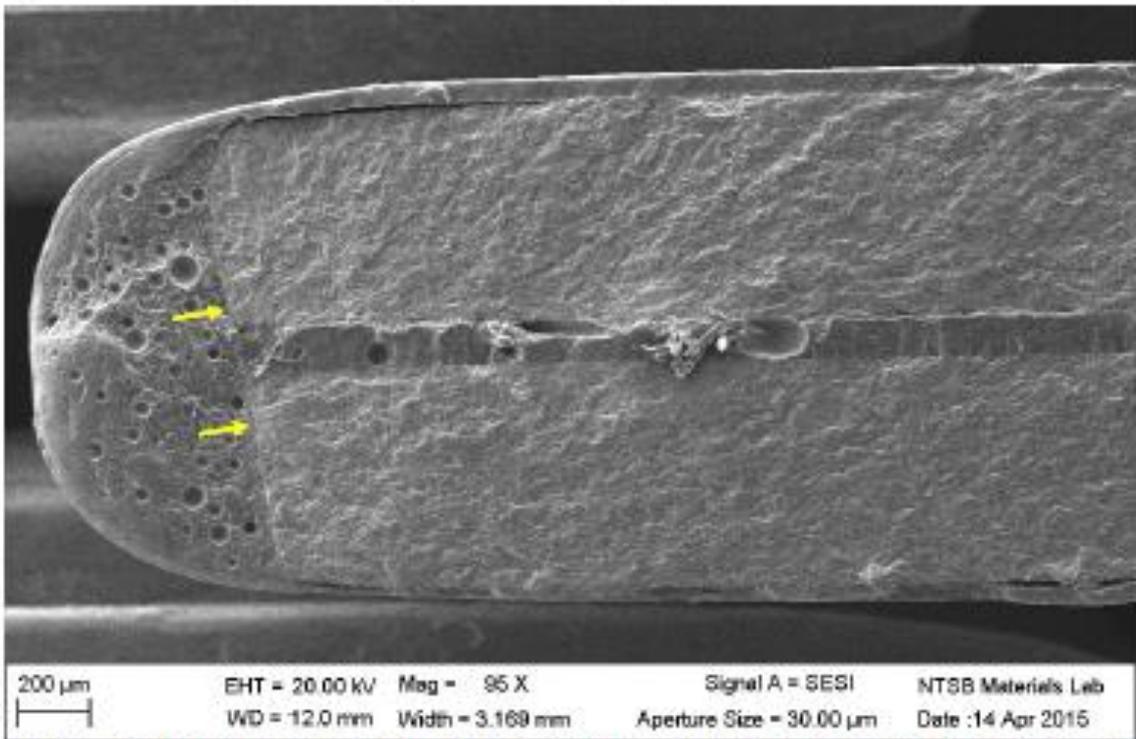
Figure 7 – Secondary electron (SE) micrograph of the fatigue crack initiation site in the composite rotor blade. The arrows denote the fatigue crack initiation sites in the aluminum sheets.

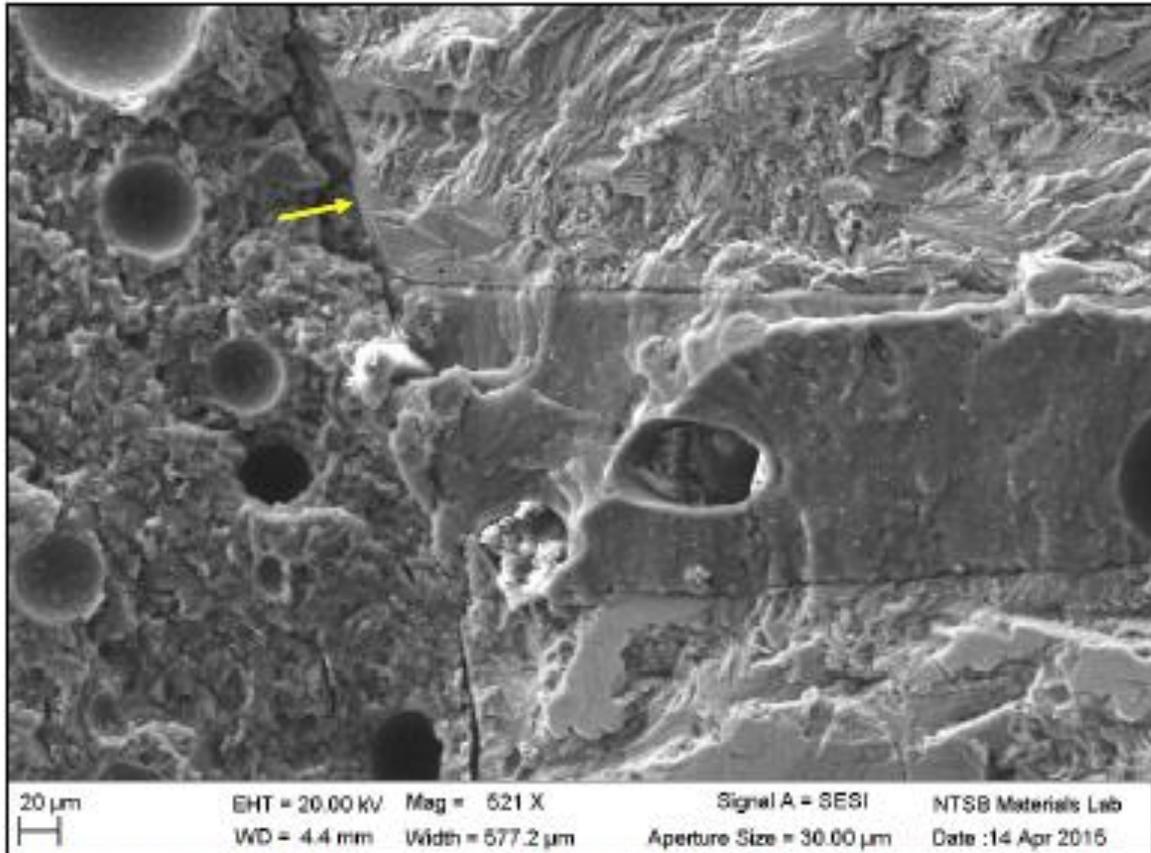
Figure 8 – SE micrograph showing the fatigue crack initiation sites (arrow) in the aluminum sheets at the trailing edge.

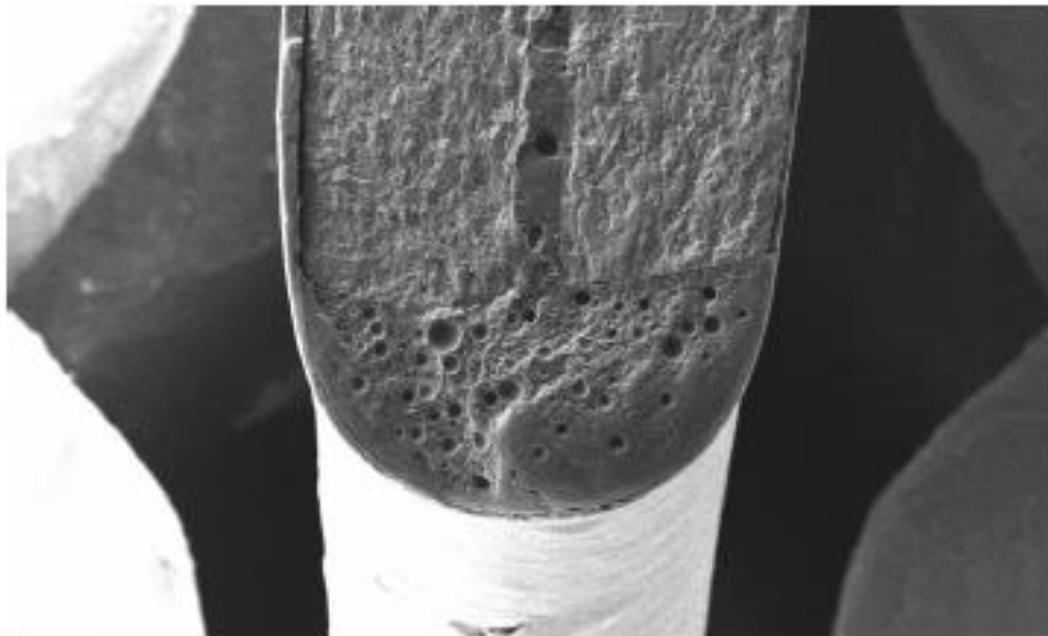
Figure 9 – SE micrograph of the crack initiation site at the rotor blade trailing edge.

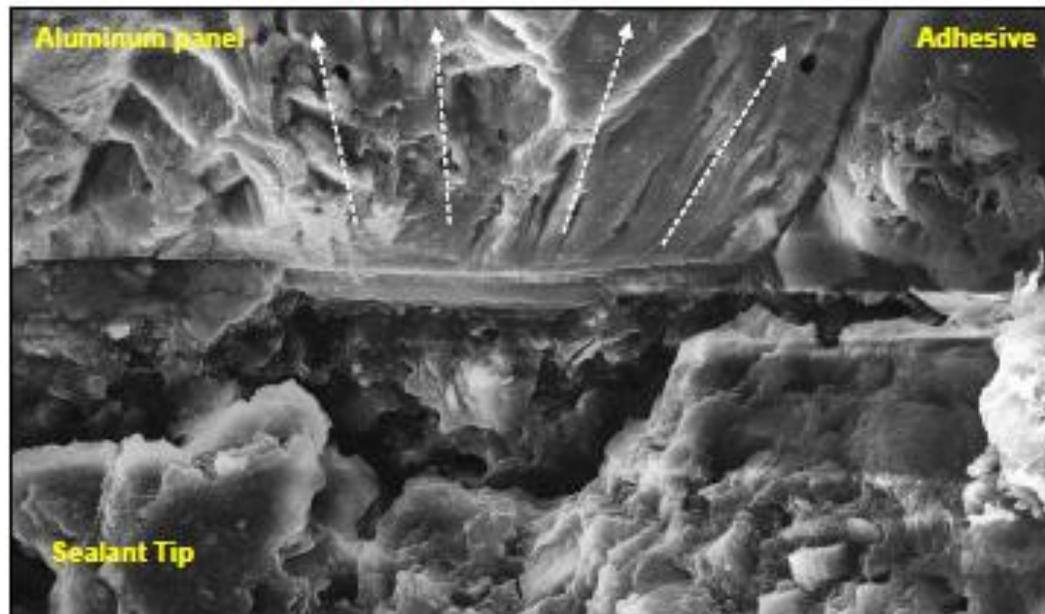
Figure 10 – SE micrograph of the upper aluminum sheet crack initiation site in Figure 7.

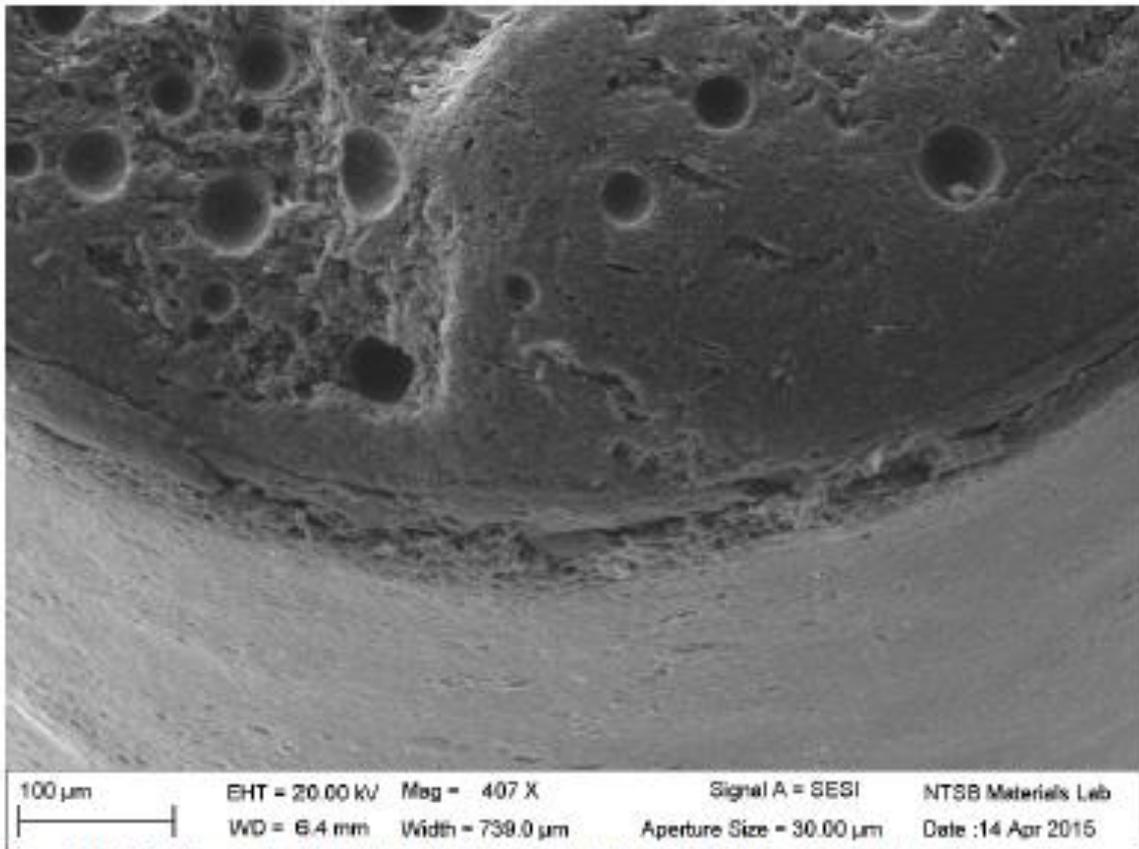
Figure 11 – SE micrograph of the fatigue crack initiation site in the trailing edge epoxy material.

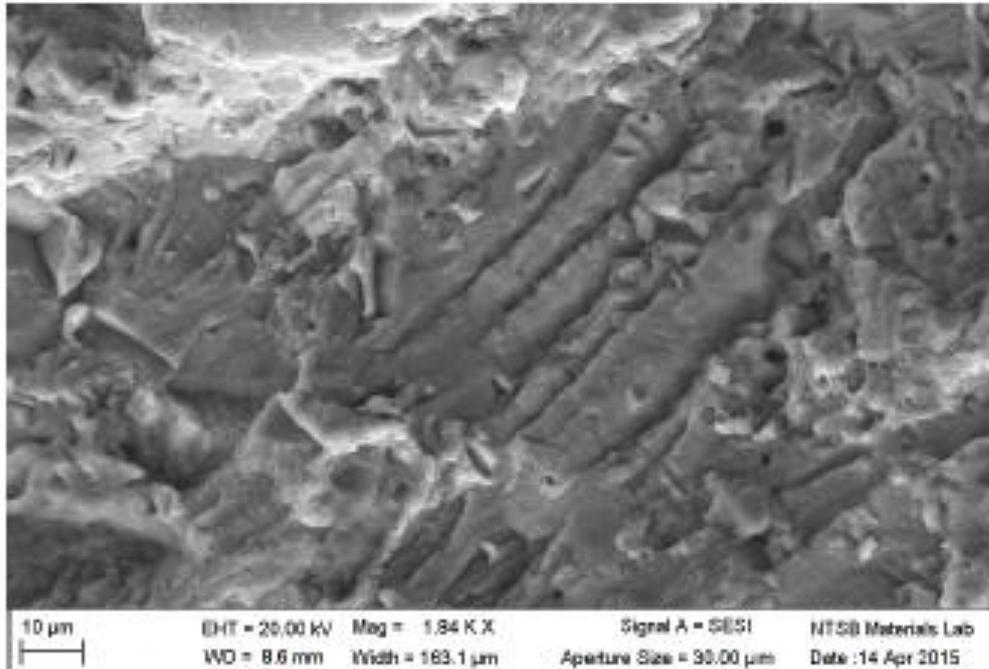
Figure 12 – SE micrograph of fatigue striations and river patterns near the trailing edge of the rotor blade in the upper aluminum sheet.

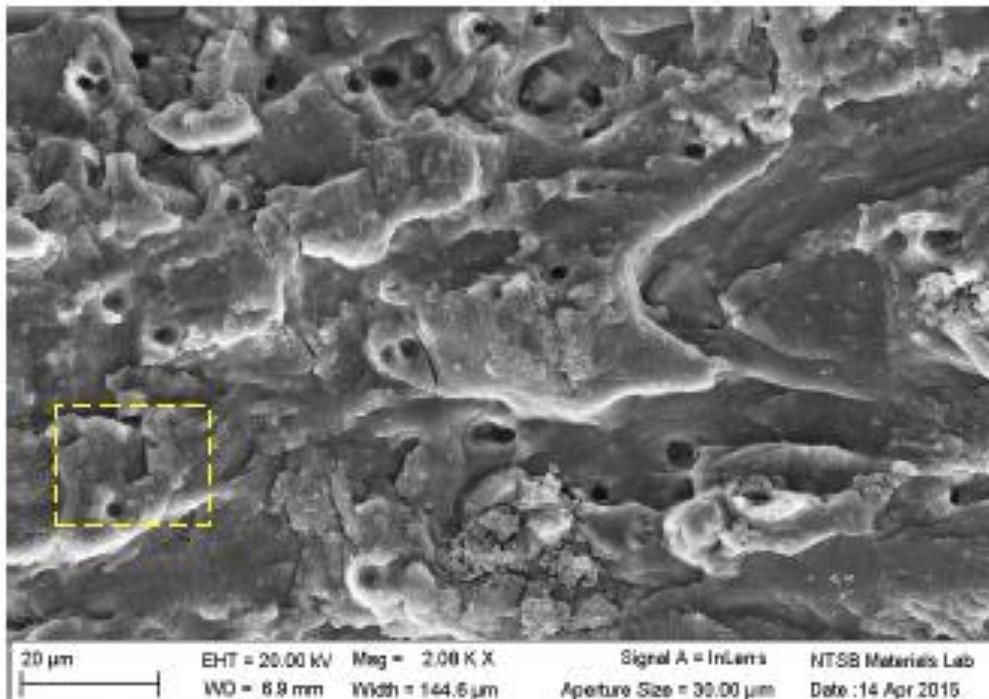
Figure 13 – SE micrograph showing fatigue striations and sporadic dimple rupture in the beginning of the mixed mode portion of the aluminum sheet fracture surface.

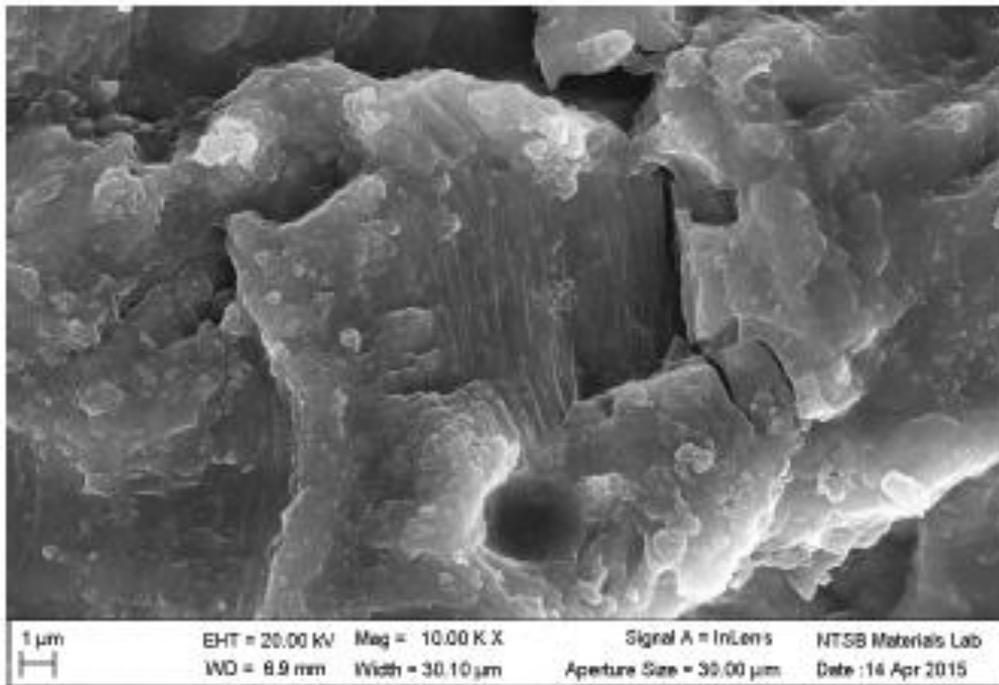
Figure 14 – SE micrograph of the yellow boxed area in Figure 13, showing fatigue striations.

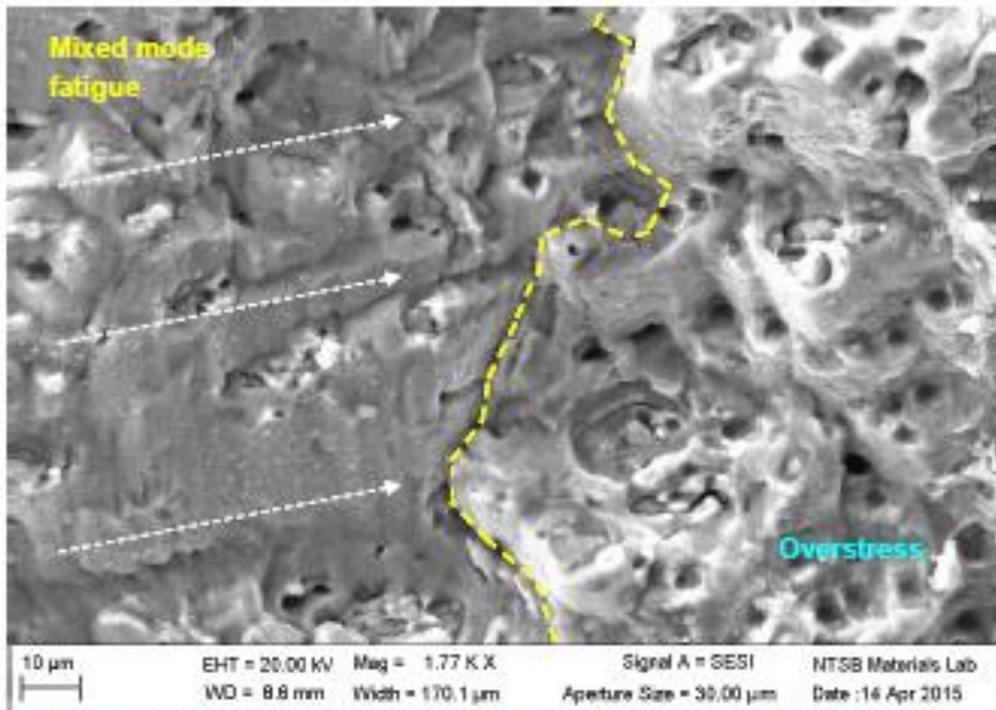
Figure 16 – SE micrograph of the end of the mixed mode fatigue cracking transitioning to pure overstress (dashed line).

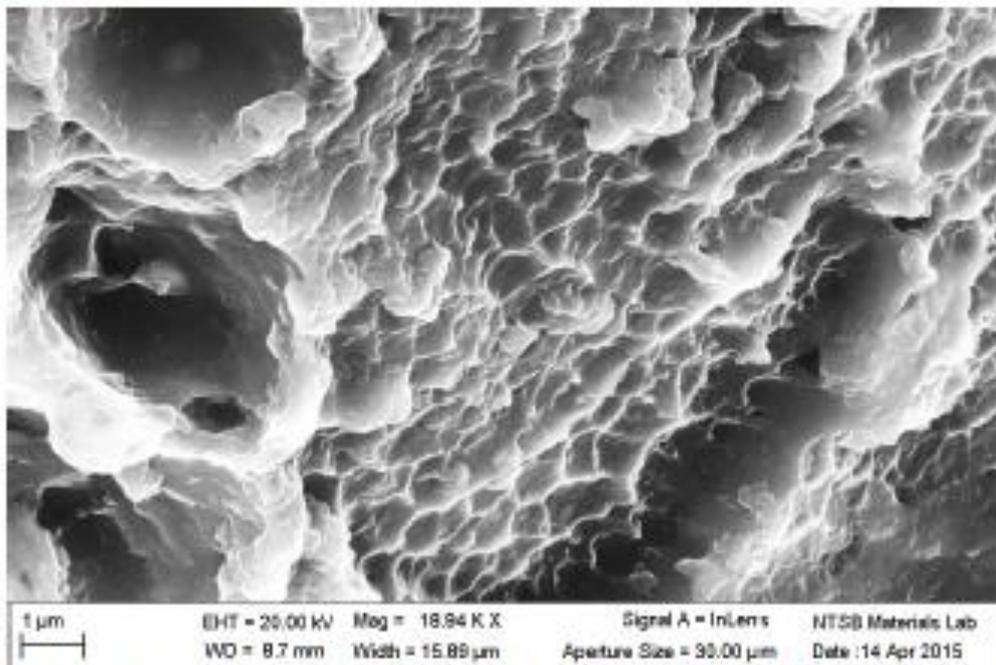
Figure 17 – SE micrograph of dimple rupture in the overstress region of the aluminum fracture surface.

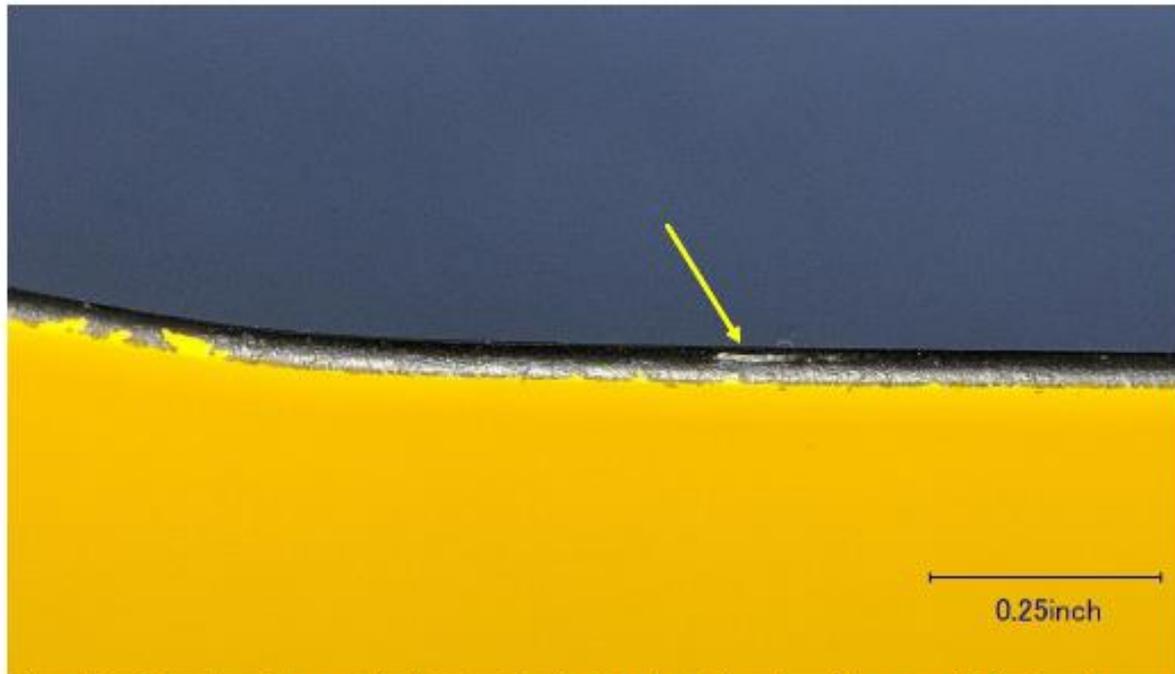
Figure 20 – Closer view of the small paint protrusion found on the trailing edge of the exemplar blade section (arrow), as received.

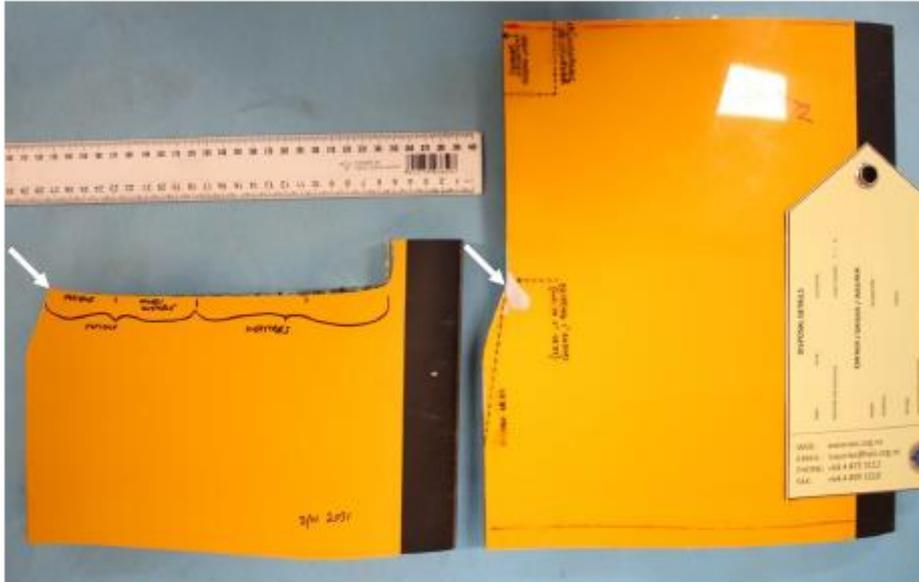
Figure 1: Fractured blade sample shown at left, matching location on opposite blade shown at left. Trailing edge transition radius arrowed on both samples. Upper surface shown

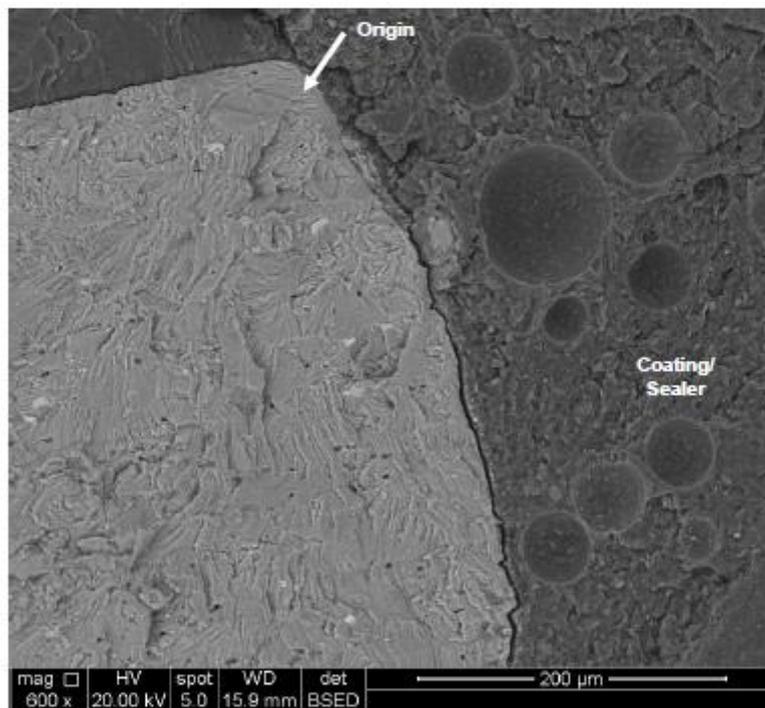
Figure 4: Possible origin (arrowed) on upper aluminium layer as indicated by tear ridges, river marks and faceted appearance. Back scattered image. Note porosity and lack of adherence between aluminium and coating/sealer at trailing edge.

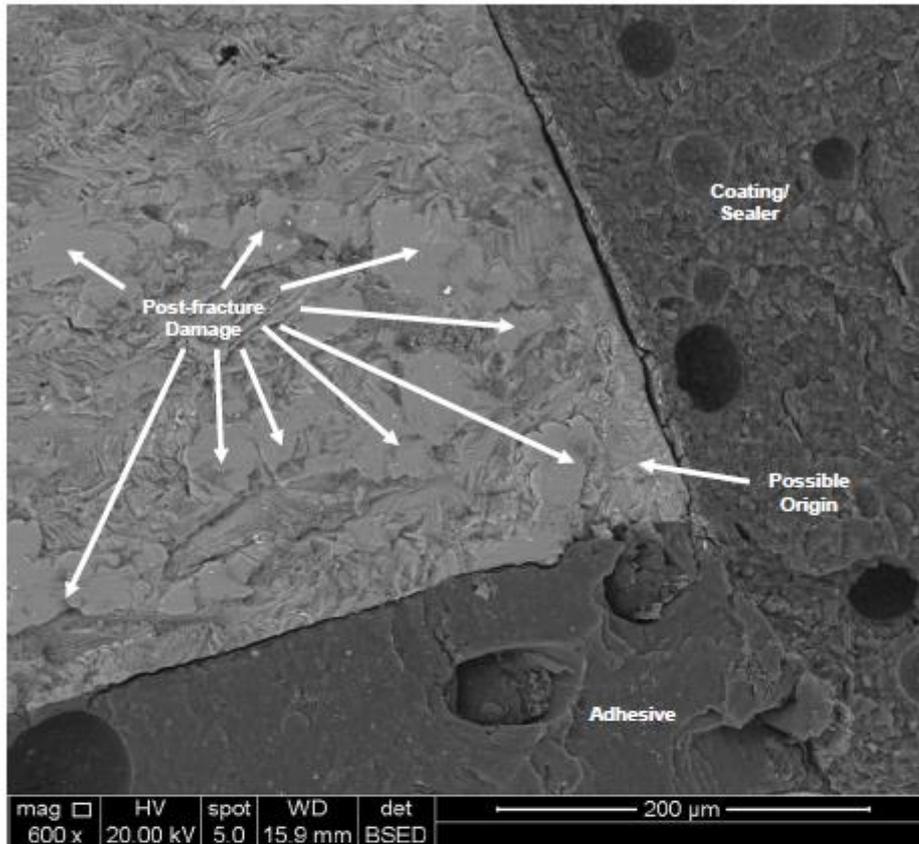
Figure 5: Possible origin (arrowed) on lower aluminium layer. Associated fracture surface showing considerable post-fracture mechanical damage. Back scattered image. Note porosity and lack of adherence between aluminium and coating/sealer at trailing edge.

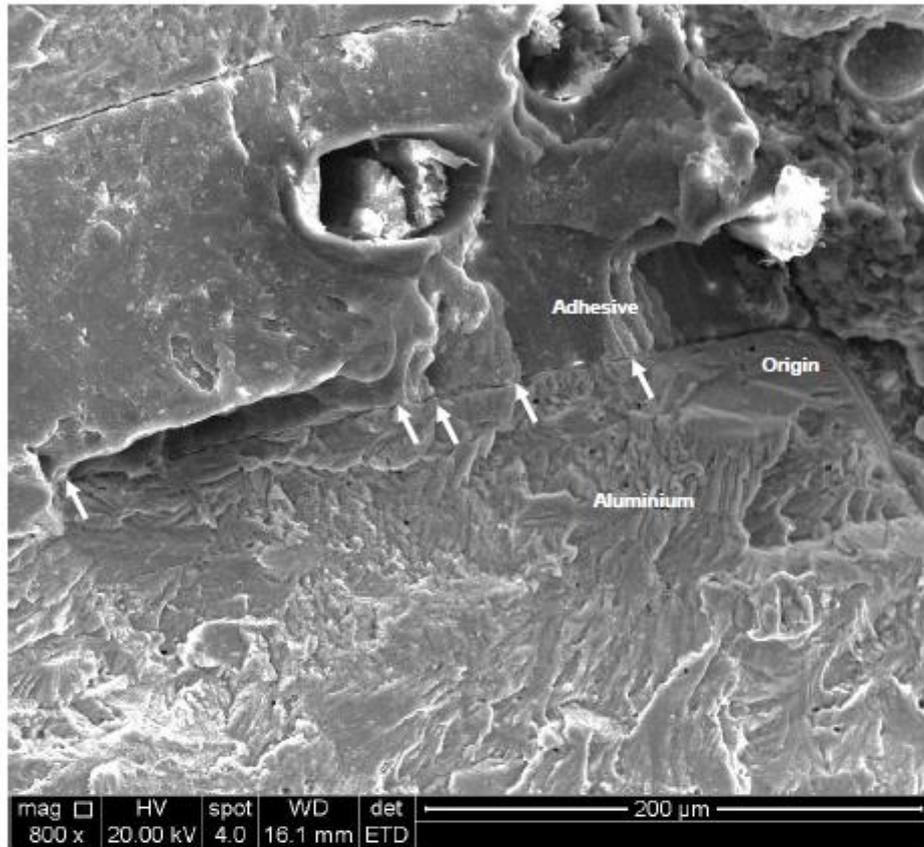
Figure 6: Detail near upper aluminium origin, showing apparent simultaneous propagation through adhesive and aluminium (matching fracture steps arrowed).

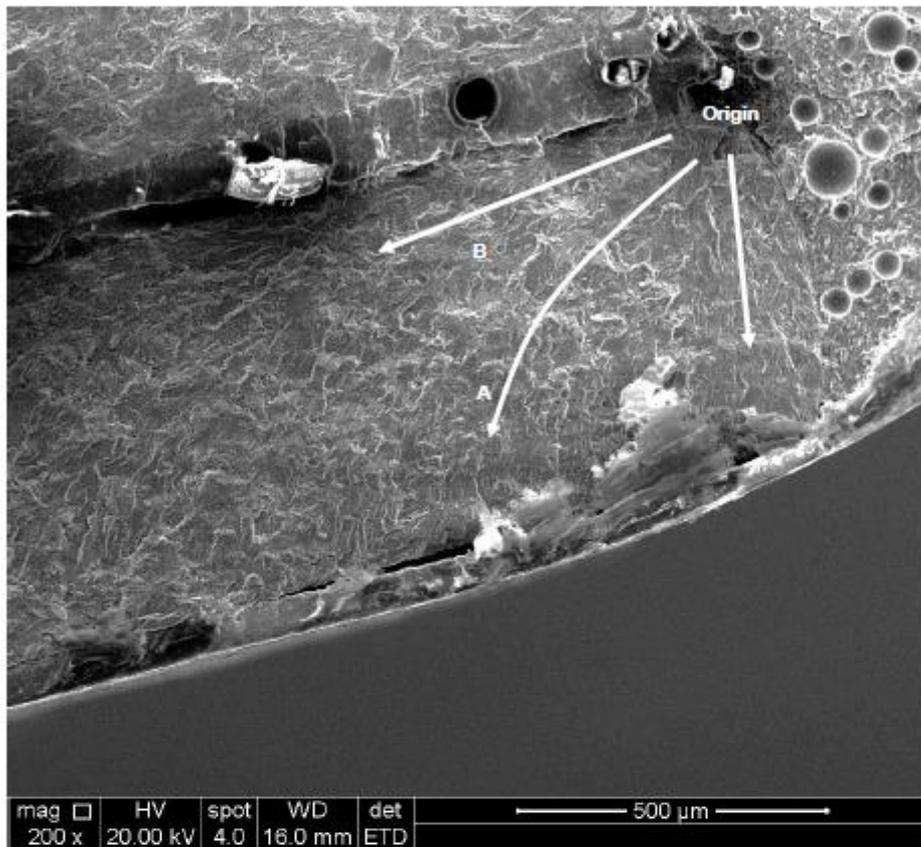
Figure 7: Secondary electron image of upper aluminium layer showing tear ridges radiating from origin (propagation direction arrowed). Detail regions labelled "A" and "B".

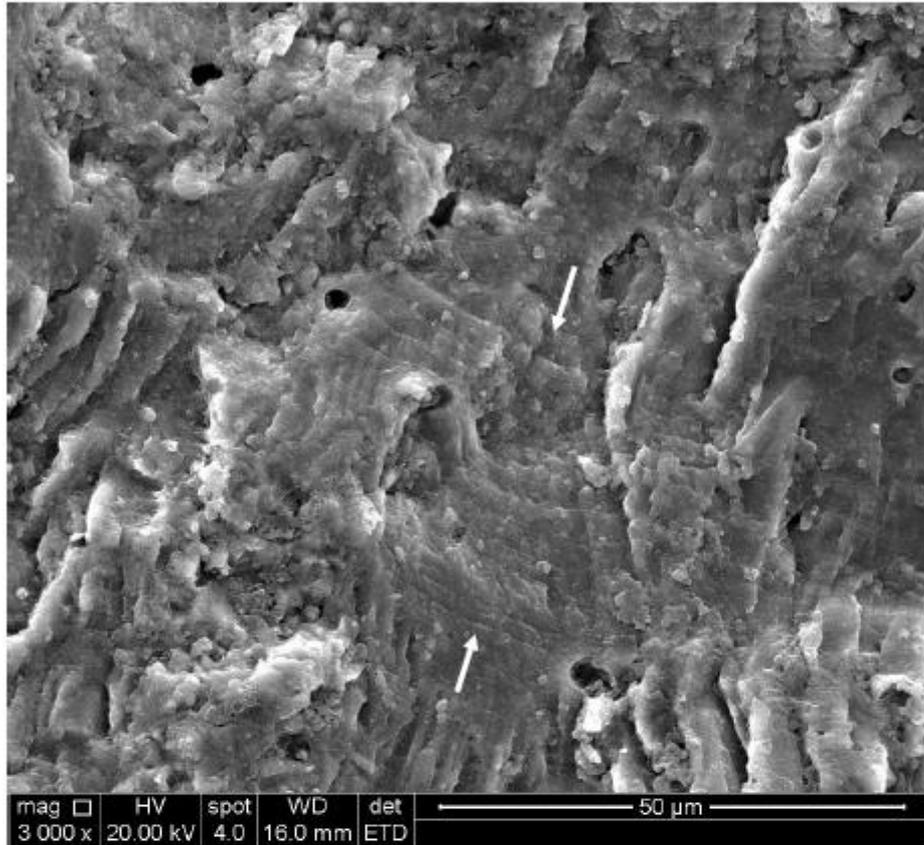
Figure 8: Region "A" in Figure 7. Faint striations visible, perpendicular to tear ridges, at 2 µm to 3 µm separation, between arrows.

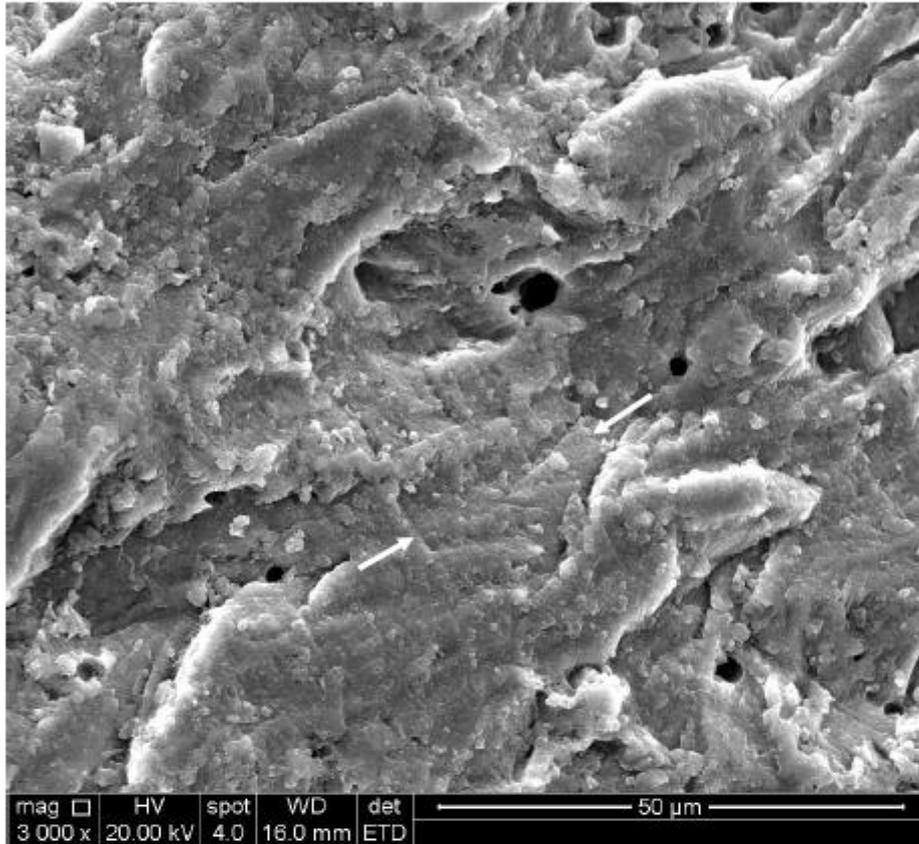
Figure 9: Region "B" in Figure 7. Faint striations visible, perpendicular to tear ridges, at 2 μm to 3 μm separation, between arrows.

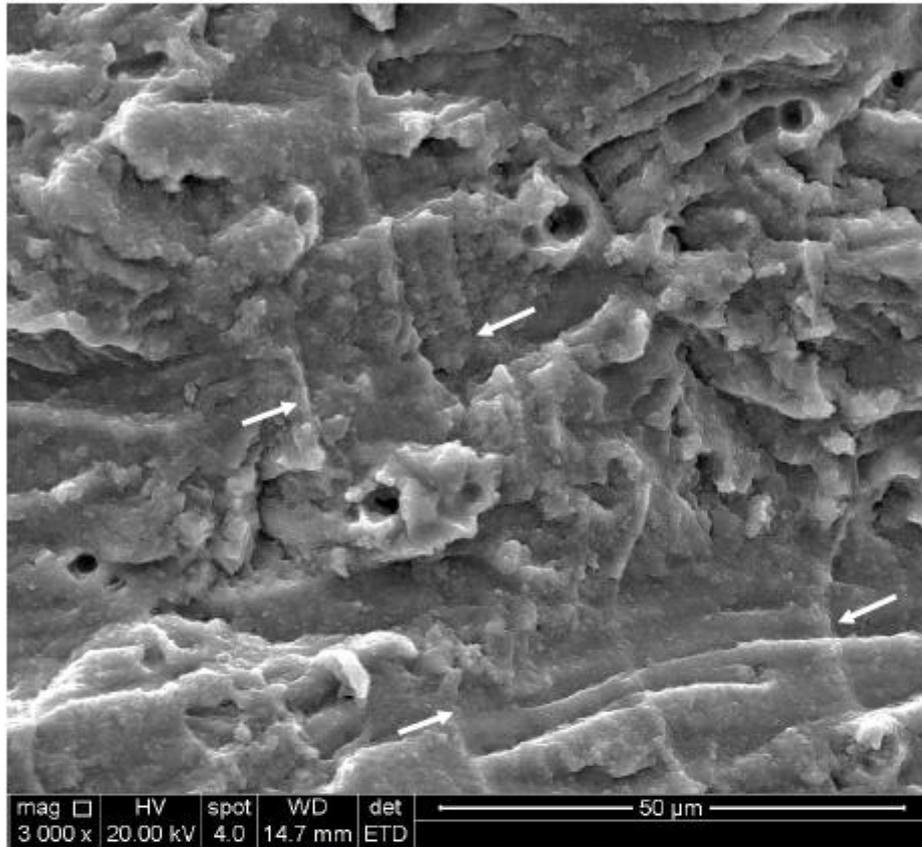
Figure 10: Widely spaced (approximately 10 to 20 µm) striations approximately 15 mm from trailing edge in lower aluminium layer.
