Final Report AO-2016-007: Collision with terrain, Robinson R44, ZK-HTH,
Glenbervie Forest, Northland, 31 October 2016

Aviation inquiry AO-2016-007
Collision with terrain
Robinson R44, ZK-HTH
Glenbervie Forest, Northland
31 October 2016

Approved for publication: February 2019

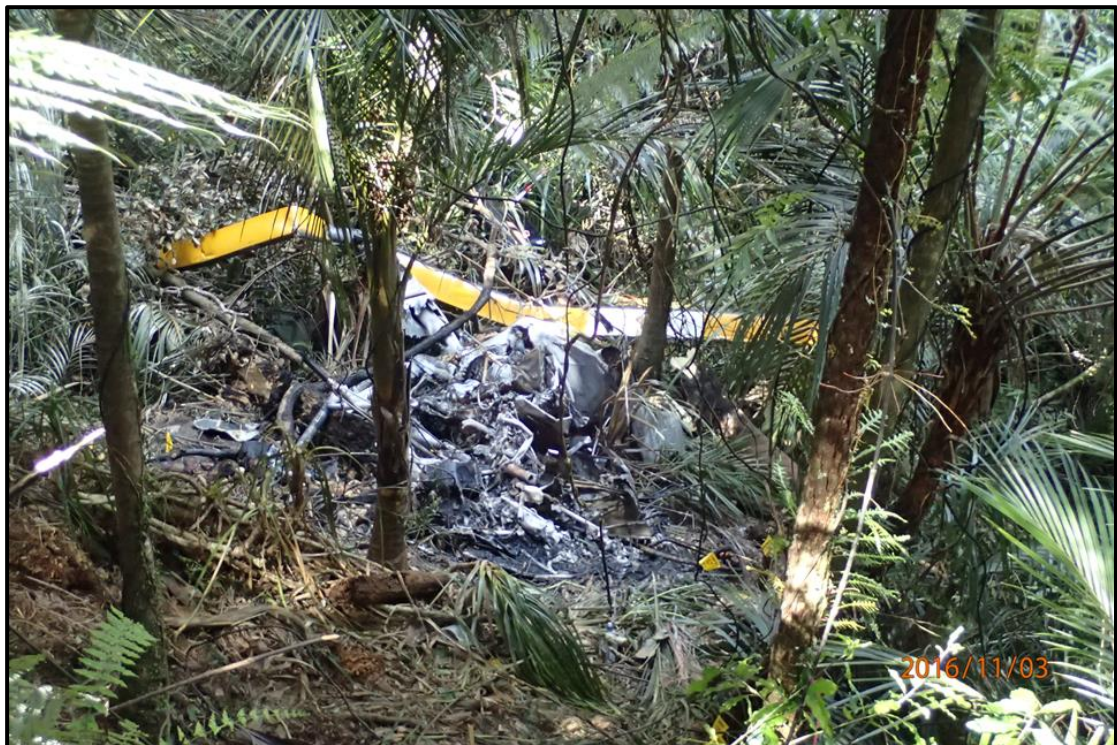
Figure 1
Accident site

- 3.1.5. The helicopter had crashed and caught fire. Smoke from the fire led searchers to the site (see Figure 1). Both occupants were later found deceased in the wreckage.

- 3.2.1. The accident site was in hilly terrain, 1.5 km north of the loading area, in an area of native bush within the forest blocks. The site was on a north-facing slope about 150 m north of and below a forestry road that ran along a ridgeline. The tree canopy was about 20 m high with thick undergrowth (see Figure 2). Damage to the trees indicated that, after striking the tree-top canopy, the helicopter had descended through the trees at a descent angle of about 50 degrees (°).

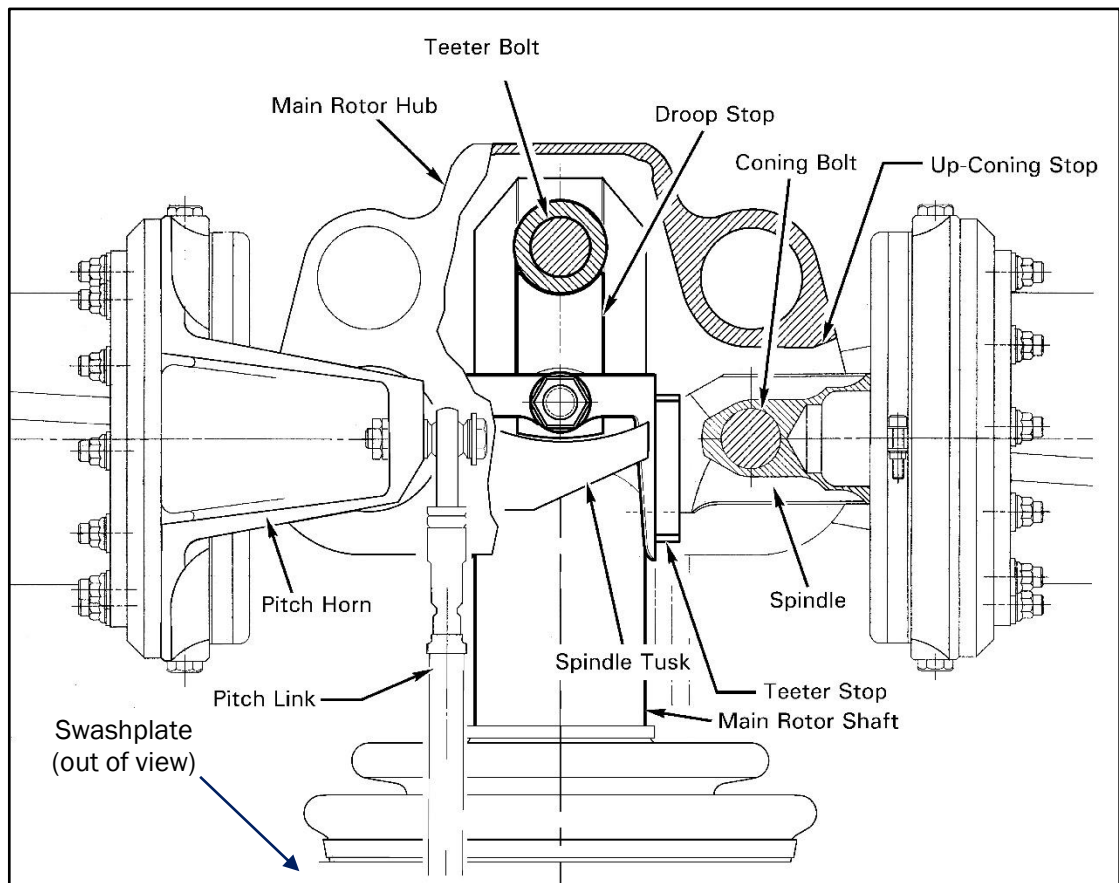
Figure 3
Robinson main rotor head

- 3.4.5. Figure 3 shows the items comprising the rotor head. Both teeter stops were crushed to varying degrees of damage. Both pitch links⁶ remained attached to the upper swashplate.⁷ However, both had disconnected from their respective main rotor blades. The pitch link for blade serial number (S/N) 3325 had broken at the upper rod-end thread. The pitch link for blade S/N 3347 was complete, but the attachment bolt that connected it to the pitch horn was missing and was never found. The bolt hole for the pitch link attachment to the swashplate was elongated in an upward direction.

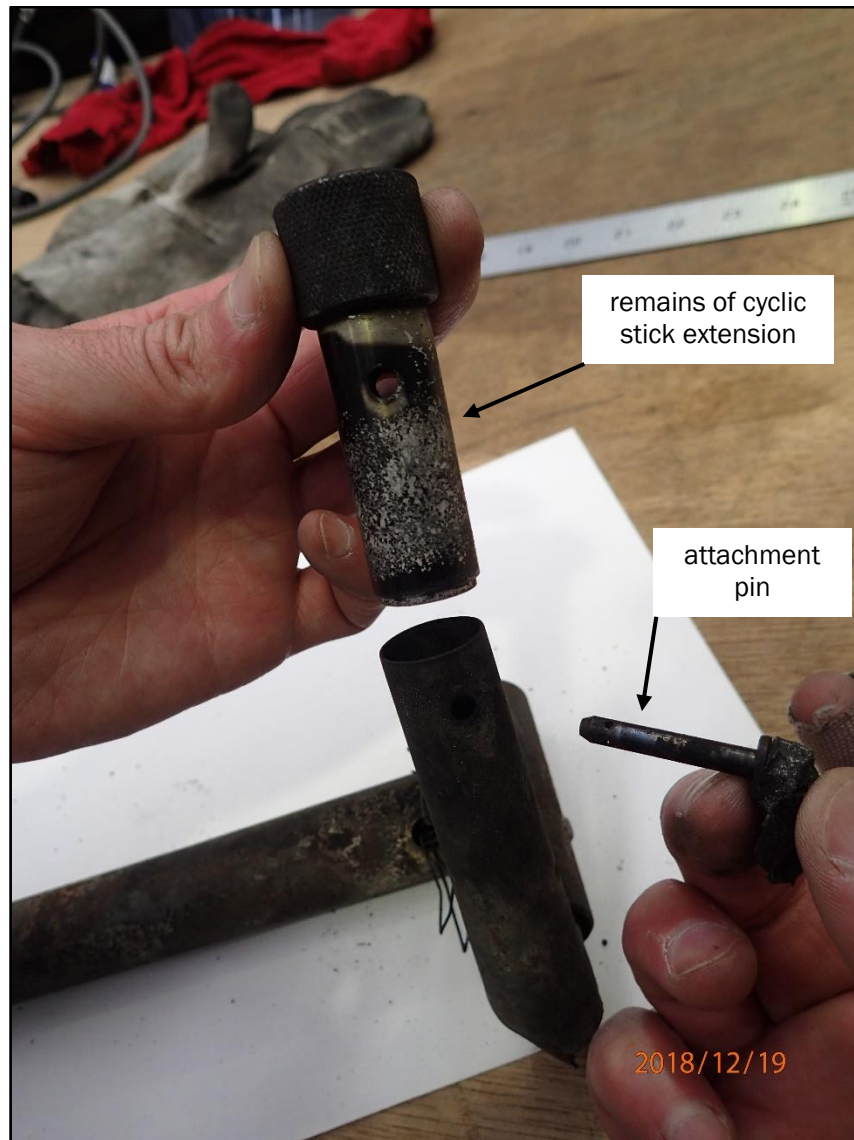
Figure 4
Cyclic stick extension

- 4.7.1. The cyclic stick extension for the left seat was found installed. The ground loader recalled that it had not been installed at the beginning of the day, which indicates that it was installed at some time later in the day. It could not be determined why the cyclic extension was installed. Equally, it could not be determined if it had been used by the contractor to manoeuvre the helicopter at any time during the flight.

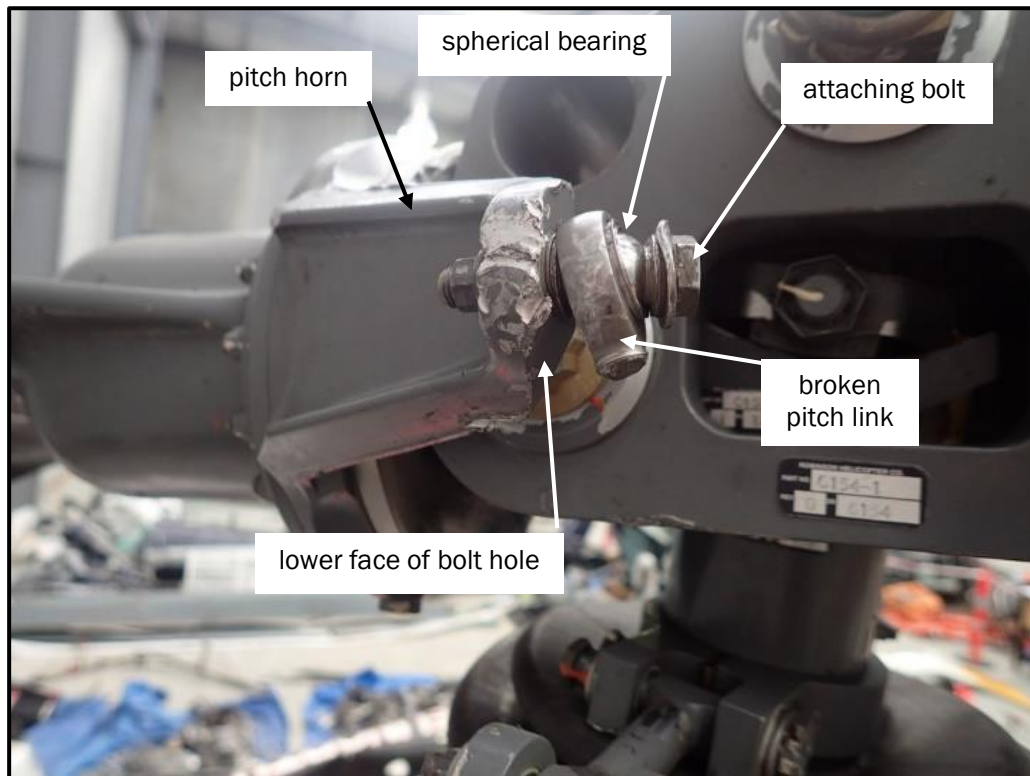
Figure 5
Broken pitch link for blade S/N 3325

- 3.5.7. An expert metallurgist examined the two pitch links from the main rotor assembly. The pitch link for blade S/N 3325 had broken at the threaded portion immediately below the spherical bearing (see Figure 5), through which a bolt attached the link to the pitch horn. The mode of failure was determined by the metallurgist to be overload. Robinson advised that the mode of failure and location were typical of those seen in other accidents where a severe bending motion had been applied to the pitch links.

Robinson accidents investigated by the Commission where the main rotor has flapped beyond its design limits. Pitch link failure can also be caused by column buckling²³ or by the lower attachment point moving out of its normal position, thereby applying a bending load to the top of the pitch link, causing it to break just below the spherical bearing.

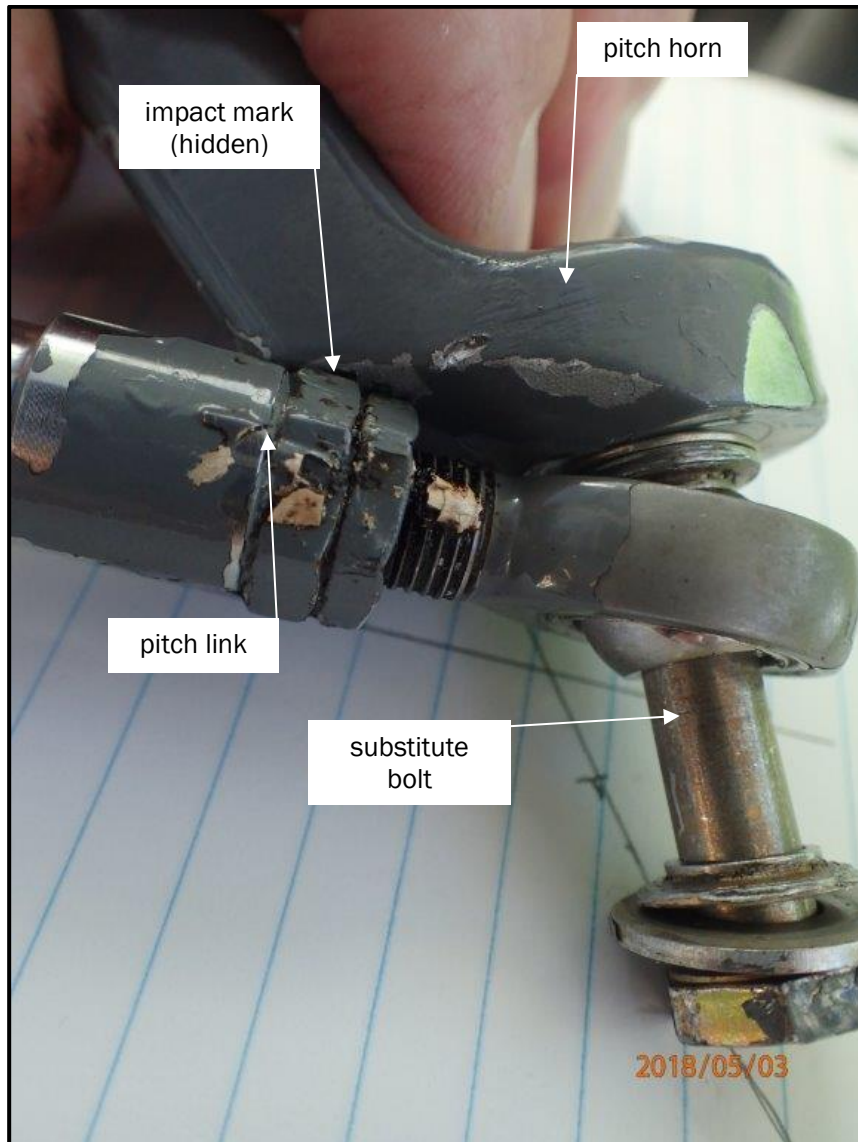
Figure 6
Pitch horn and link for blade S/N 3347

- 3.5.8. The bolt that attached the pitch link to the pitch horn of the other blade, S/N 3347, was missing. The pitch link itself displayed no obvious damage. The metallurgist examined this pitch link and the bolt hole in the associated pitch horn. The report stated, in part:

- the lower edge of the bolt hole was noticeably deformed in one corner, presumably from the bolt at some point. Burnishing (rubbing) was noted on the bore of the bolt hole below this area of deformation

- the nut face of the bolt hole was bright, surrounded by dark sealing compound. The machined seat underneath the washer displayed machining marks that would be expected from original manufacture. This is a strong indicator that there was no movement of, or wear from, the washer under the nut

- 3.5.9. The metallurgist's report concluded that the amount of damage on the pitch horn and the lack of damage to the pitch link "strongly suggests that there was no impact force[s] transmitted to or through the pitch link at the time of the final impact of the aircraft – it is feasible that the

- 3.5.10. Impact marks on the lower face of the pitch horn matched the dimensions of the pitch link upper locking nut (see Figure 6). The impact marks could only have been made when the main rotor blade was at an extremely high pitch angle, measured to be about 31°. The normal maximum blade pitch angle achievable with the collective lever fully raised is 19.9°.

- 4.4.4. It was virtually certain that the pitch link attachment bolt for blade S/N 3347 broke and was lost as a consequence of the impact sequence, rather than being the cause of the accident. If the bolt had become loose before impact with the bush, there would very likely have been more evidence of fretting or wear around the upper attachment bolt hole. If the bolt had come completely out before the accident, the blade pitch would have been uncontrollable. The blade would almost certainly have moved to a very high (positive or negative) pitch angle. Because the main rotor's rotational speed was more than six revolutions per second, a blade with uncontrollable pitch could have struck the fuselage within a fraction of a second and that would very likely have been followed by an in-flight break-up. There was no in-flight break-up in this accident.

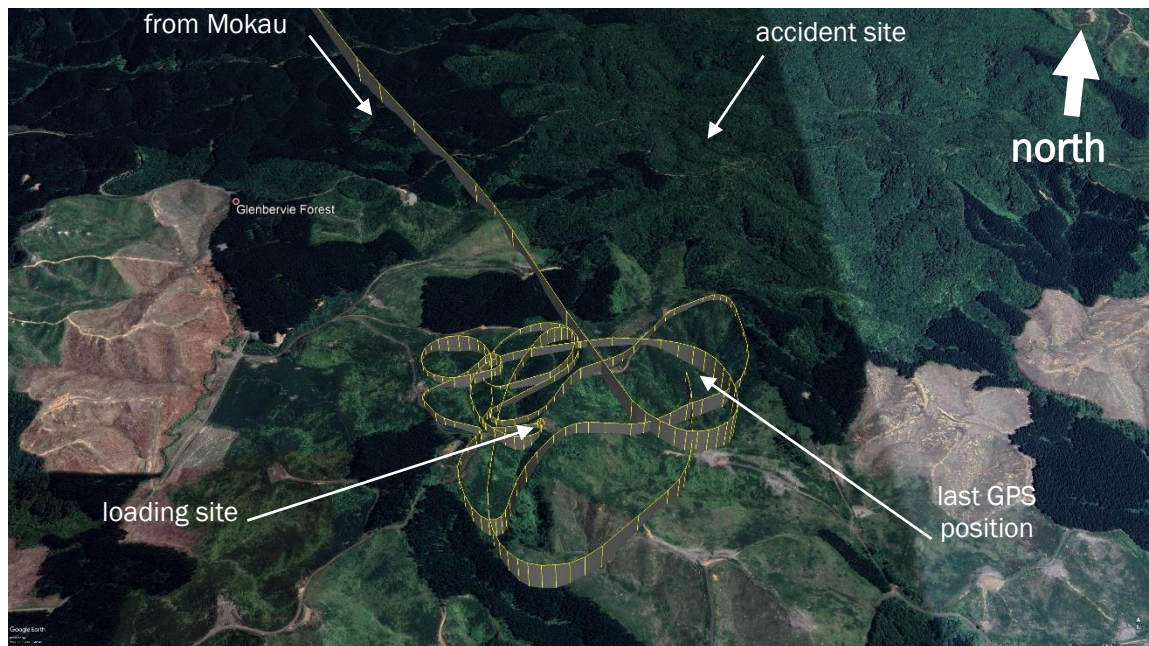
Figure 7
GPS track

permanent memory so was not able to be recovered.¹⁷ The ELT started transmitting about 40 seconds after the last recorded GPS position report.
