Transport Accident
Investigation
Commission

Aviation inquiry AO-2017-002

Robinson Helicopter Company R22, ZK-IHA

Impact with terrain

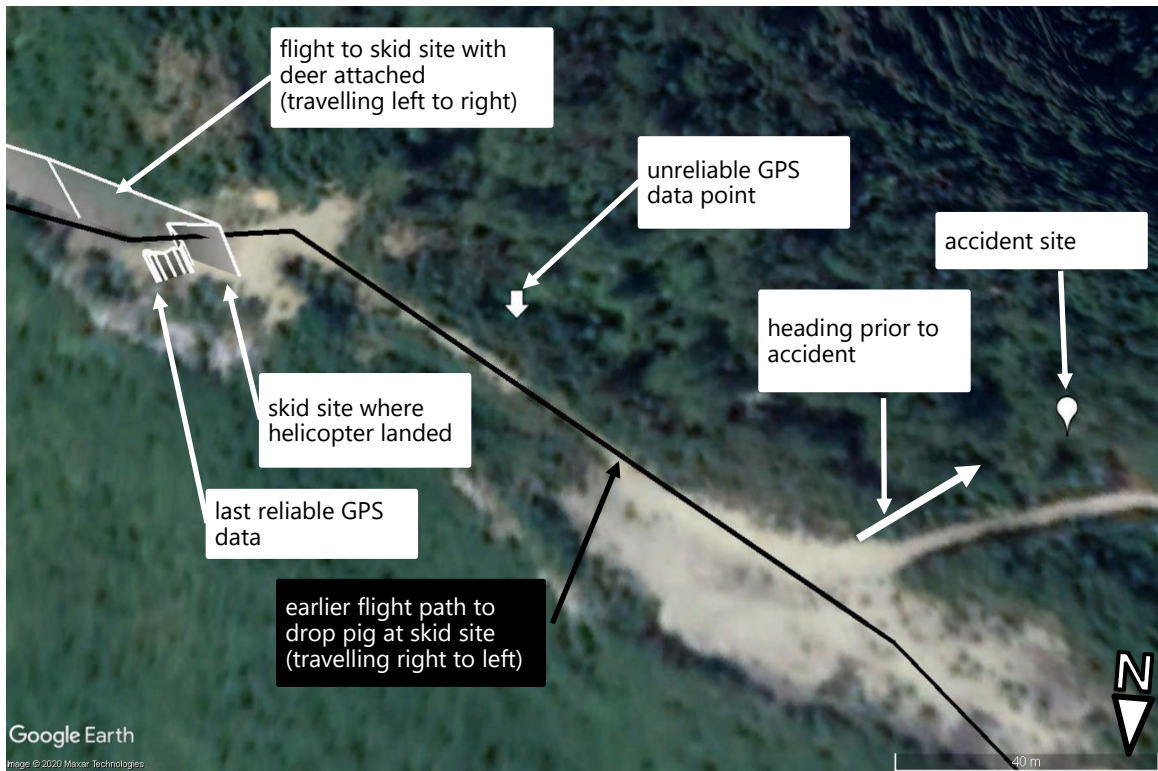
Figure 4: Accident area and recorded GPS data

- 2.24. The helicopter's descent path was marked by damage to the trees. The damage to the tree tops where the helicopter blades initially struck the tree canopy was relatively minor. However, the lower tree damage before that point and where the suspended load struck the trees was more substantial. The damage to the trees indicated that the helicopter had descended at an angle of approximately 37° on a heading of 225° true, before striking a large tree stump. The slung load and rope strop had been released before impact with the ground and were located about eight metres rearward of the main helicopter wreckage. The cargo hook was found in the released position.

- 3.4. The GPS data showed the helicopter was on the ground for approximately 30 seconds. During this period, the pilot would have needed to rearrange the rope strop to attach both animals. The GPS data then showed the helicopter lifting and departing. The last GPS data point, which was approximately between the departure location and the accident site was considered unreliable due to the accident sequence. The unreliability of Garmin GPS data just prior to an accident has been noted in previous investigation reports¹¹. However, the pilot unlikely conducted any manoeuvres to gain altitude, as this would have resulted in additional GPS data points being recorded. Instead, the path was likely similar to the earlier flight path (see Figure 4) with a final turn onto the accident heading.

- 3.5. The tree damage indicated that the helicopter was flying approximately south-west immediately before impact (see Figure 4). While it indicated that the helicopter and load entered in close proximity, the final locations of the helicopter and its load were separate. The cargo hook was in the released position, which indicated that the pilot likely jettisoned the load after the load made contact with the tree canopy. This suggests that the pilot was conscious at the time of the accident and was attempting to recover from the situation or minimise the consequences.

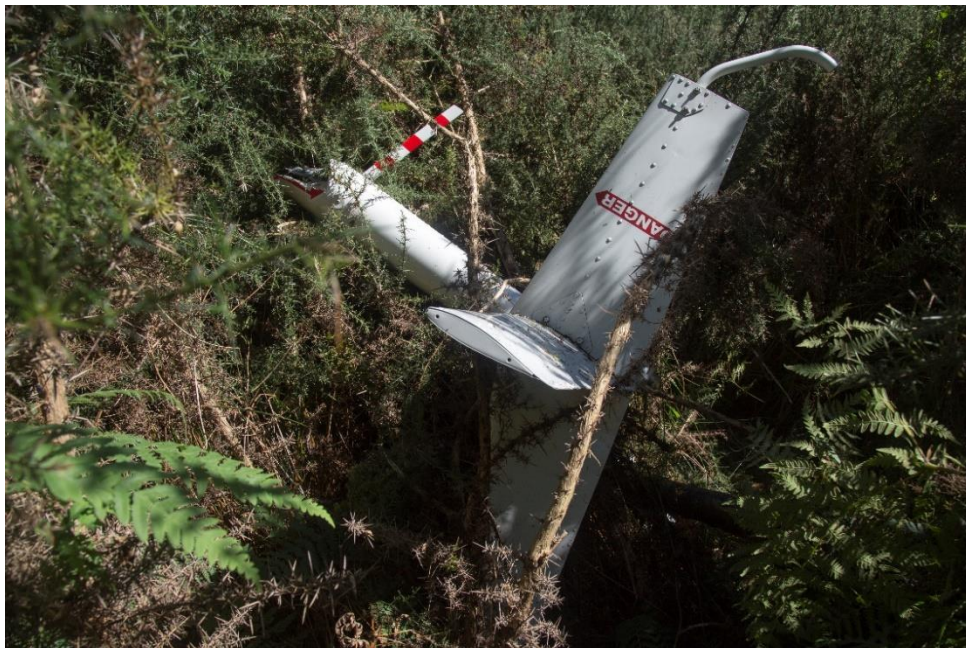
Figure 5: The helicopter's tail section

2.25. The tail section (Figure 5) of the helicopter was found lying inverted about six metres forward of the main helicopter wreckage. The damage to the tail section indicated that it had been partially damaged by a main rotor blade strike and subsequently separated from the main wreckage due to an impact with a tree. A severed piece of the tail boom upper skin was found about 30 metres to the right of the main wreckage⁶.

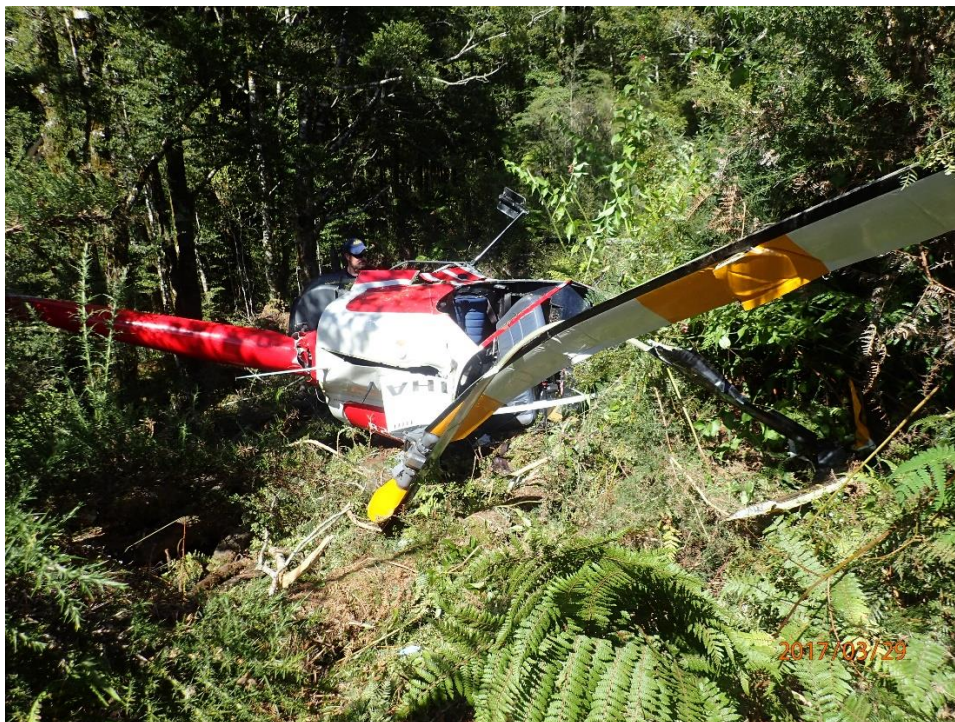
Figure 6: The main helicopter wreckage

2.26. The main rotor assembly (Figure 6) was still attached to the helicopter, with the blades lying together. One blade was severely damaged and there were chordwise⁷ crease marks along the blades. The aluminium fuel tank had ruptured, allowing any fuel to drain out. The fuel system was connected to the engine through a fuel strainer, which was found to still contain fuel when inspected at the accident site.

- 3.6. The damage observed on one of the main rotor blades was consistent with the main rotor having 'coned'¹². Similar damage was observed on the other blade, but it was masked by more significant impact damage from a tree. Coning is the result of power being delivered by an engine being insufficient to maintain the rotor blades' rotational speed under load. If the rotational speed decreases below a critical limit (the low rotor-RPM limit), the situation is unrecoverable. The illumination of the Low Rotor RPM caution light was also indicative of the main rotor being at low RPM.

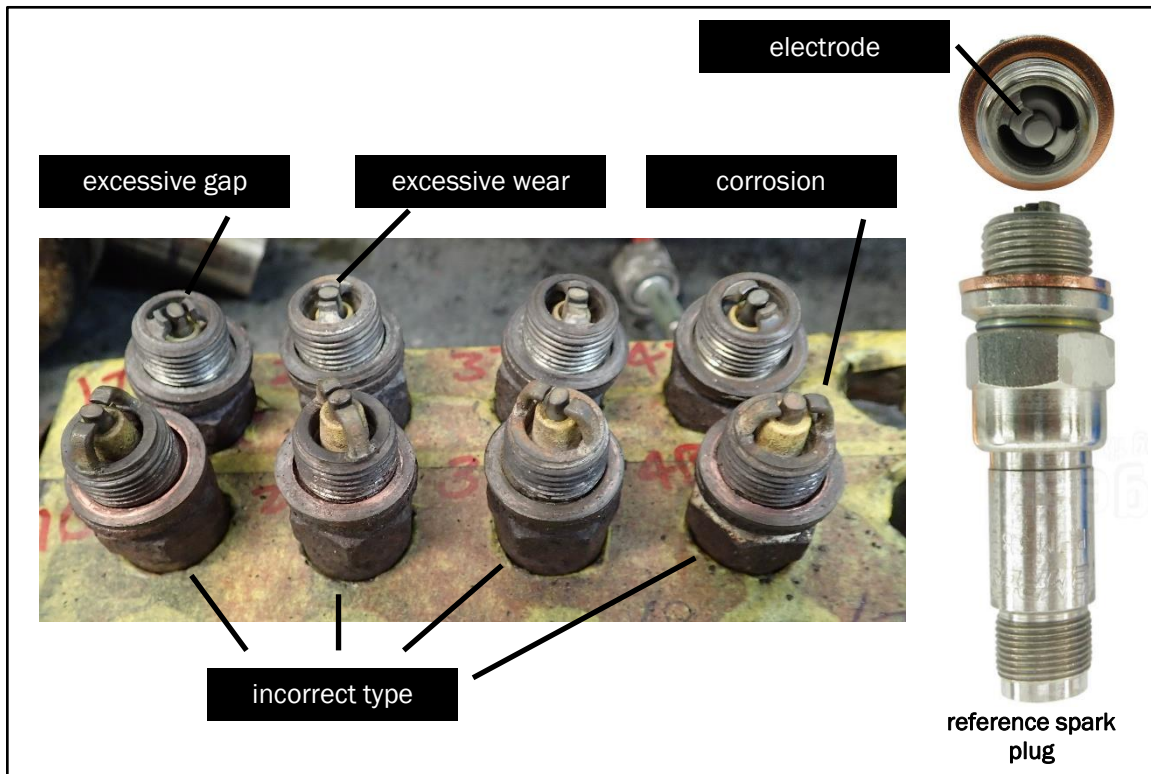
Figure 7: Spark plug condition

- the exhaust valve guide wear was greater than acceptable limits and greater than usual for an engine at the stated life
 - the crankcase bearing shells were worn more than expected for the engine life

- all spark plugs worked when tested but the electrodes had worn beyond the manufacturer's allowable limits (Champion Aerospace, 2014). The spark gaps were also excessive (see Figure 7)

- the overall engine wear suggested it was closer to the end of its reconditioned life than at the start as recorded in the logbook.

- 3.20. While the helicopter's engine was likely running just prior to impact, the reliability and maximum power available would have likely been affected by the engine's poor condition.
- 3.21. The helicopter had been operating at a similar altitude and weight prior to the accident flight; however, the issues identified may have resulted in the engine not providing the desired power when demanded. The extent to which this contributed to the accident could not be determined.

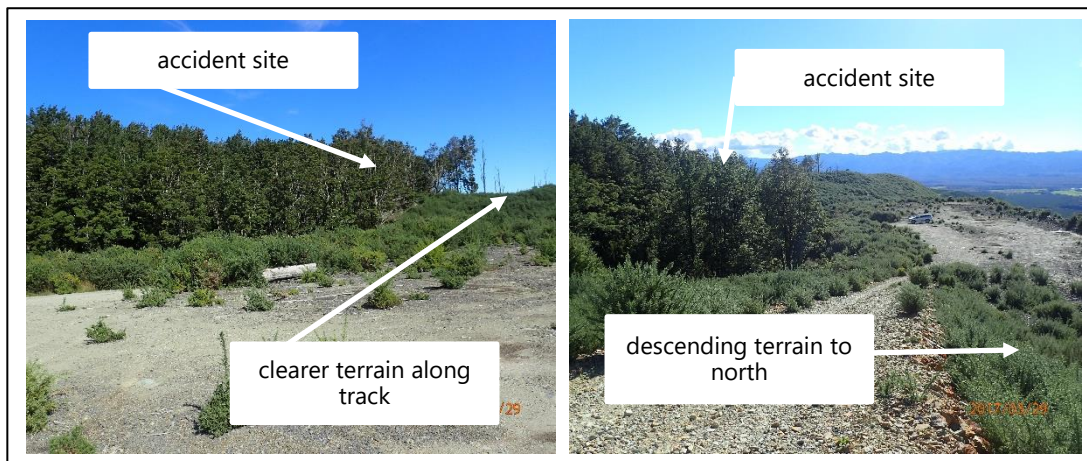
Figure 8: Clear and descending terrain adjacent to the accident site (looking west and north-west)

3.30. While the exact take-off technique and profile could not be established, the area adjacent to the densely forested accident site was clearer terrain. The clearer terrain also extended in the direction of the helicopter's track. Clear and descending terrain was also available on a north-easterly track from the skid site. The investigation was unable to determine if the pilot had sufficient time or control of the helicopter to direct it towards a more suitable area before striking the tree canopy.
