Transport Accident
Investigation
Commission

Final report

***Aviation inquiry AO-2017-004
MBB BK117 A-3 helicopter, ZK-IED
Loss of control
Porirua Harbour
2 May 2017***

June 2020

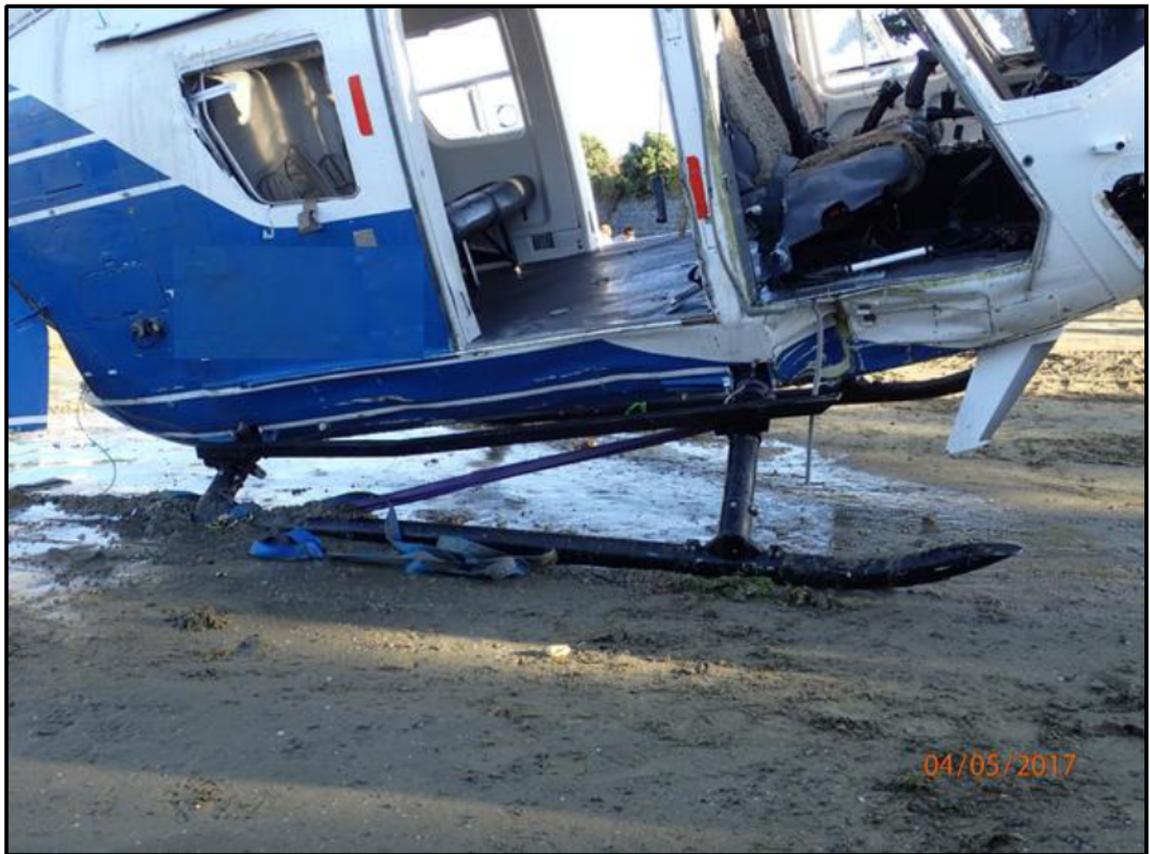
Figure 4: Hydrodynamic damage to fuselage

- 2.35. Moderate damage to the right-hand underside of the helicopter (see Figure 4) indicated that the helicopter had a right bank and level pitch attitude when it struck the water.

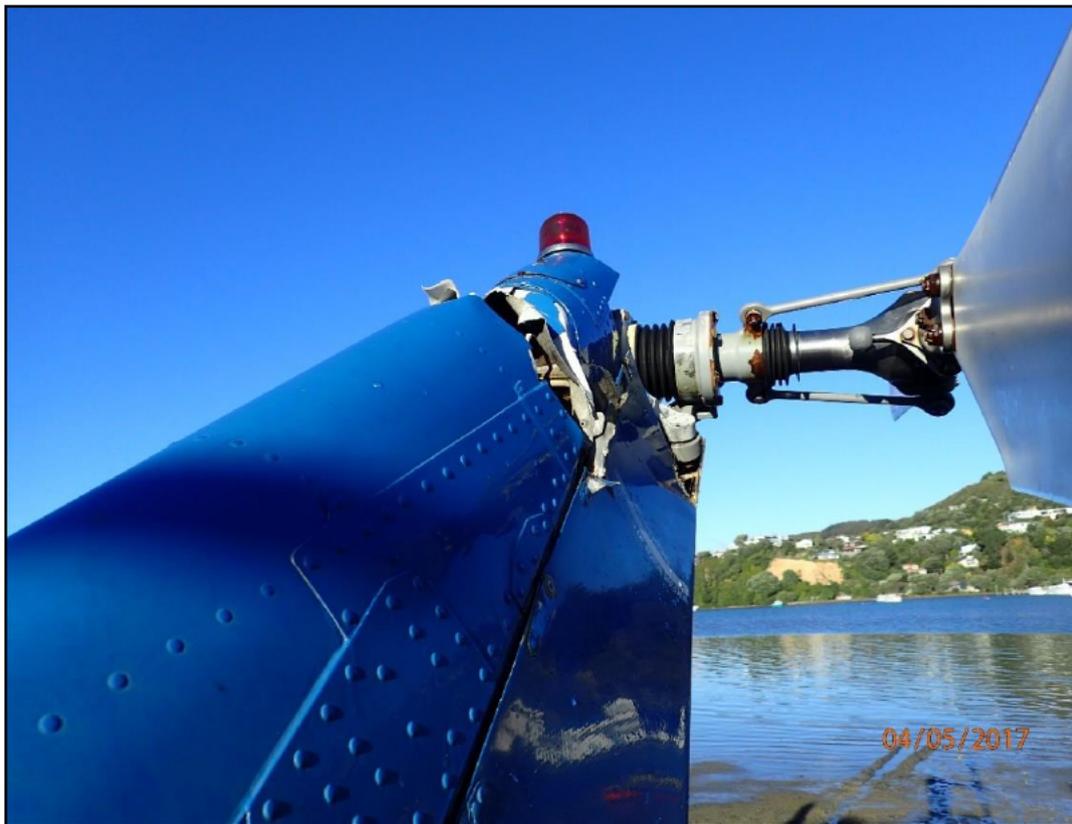
Figure 5: Failure of vertical fin

- 2.36. There was a slight twist in the tail boom structure. All four main rotor blades had been destroyed from striking the water while under power.
- 2.37. The forward left main rotor transmission mount had buckled under compression loading from the vertical component of the impact forces.
- 2.38. The power output assemblies of both engines were damaged by overload forces applied during the sudden stoppage of the main rotor.
- 2.39. The tail rotor blades and associated drive train appeared to be undamaged and remained connected to the main rotor transmission.
- 2.40. The flight control system was undamaged, with no defects evident.
- 2.41. The left side of the vertical fin had failed and separated and the right-hand side was buckled (see Figure 5).
- 2.42. The vertical fin spar was found to have a diagonal crack extending through it (see Figure 6).

- The impact site shows no evidence of scoring which would be associated with tail shaft rotation.
- 3.12. An in-flight failure of the tail fin was therefore considered unlikely due to the lack of rotational damage within the internal tail fin structure. The lack of rotational damage was consistent with the main rotor blades striking the water first and dissipating the energy in the rotor system, resulting in the driveline failure prior to the tail fin damage occurring. The right bank attitude during the impact would have also resulted in the tail fin damage observed in Figure 5 and the slight twist in the tail boom structure. It was therefore likely that the tail fin failed in overload when the helicopter struck the water.

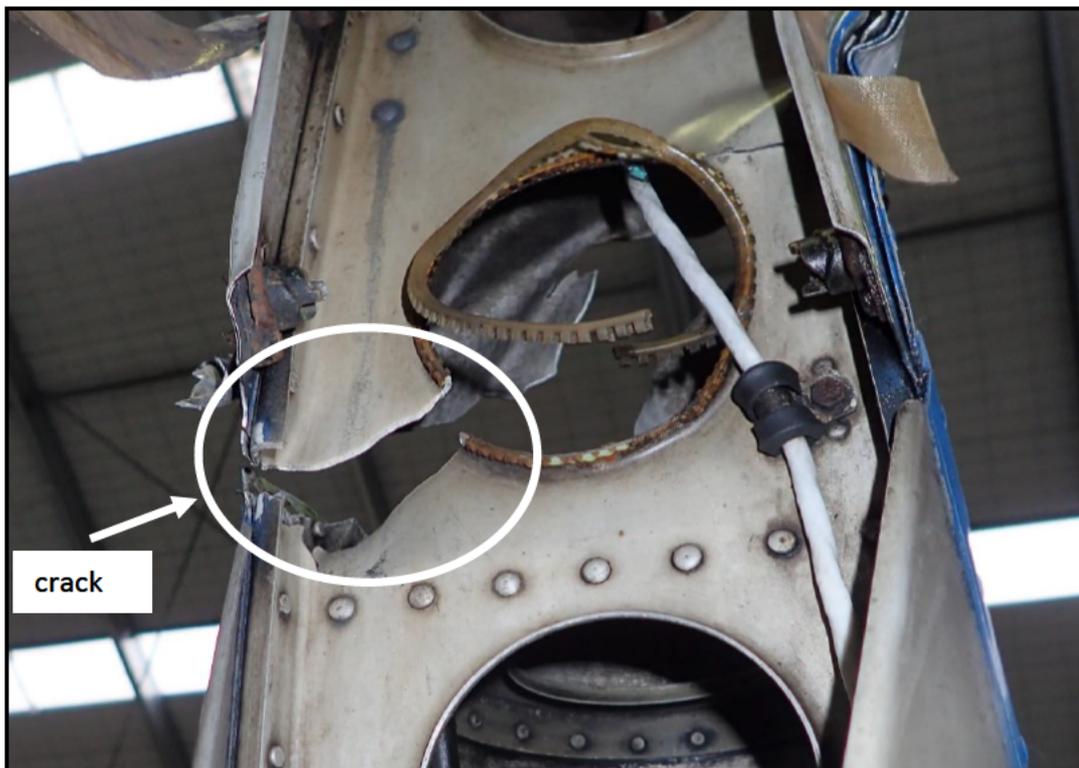
Figure 6: Cracked vertical fin spar

- 2.46. An expert metallurgist engaged by the Commission examined the vertical fin and determined that the crack in the spar was the result of structural overload during the forced landing. The Defence Technology Agency (DTA)¹⁶ also carried out testing. They visually inspected the vertical fin and then inspected six possible crack initiation sites using scanning electron microscopy (SEM)¹⁷. The results of the DTA inspection were consistent with the results of the previous expert metallurgist examination. The DTA concluded:

DTA inspection of the fracture faces of samples ... are consistent with overload fracture upon impact. There was no evidence of fatigue cracking, brittle fracture or pre-existing defects.

- 3.9. The damage to the vertical fin was examined by expert metallurgists using visual and SEM techniques. They determined that the crack in its spar was the result of structural overload and that there were no pre-existing cracks in the vertical fin. An excerpt from the SEM metallurgy report is at Appendix 1.
