Final Report AO-2017-007: Airbus A320 VH-VGY,  
Descent below clearance limit, Christchurch, 6 August 2017

Aviation inquiry AO-2017-007  
Airbus A320 VH-VGY  
Descent below clearance limit  
Christchurch  
6 August 2017

Approved for publication: March 2019

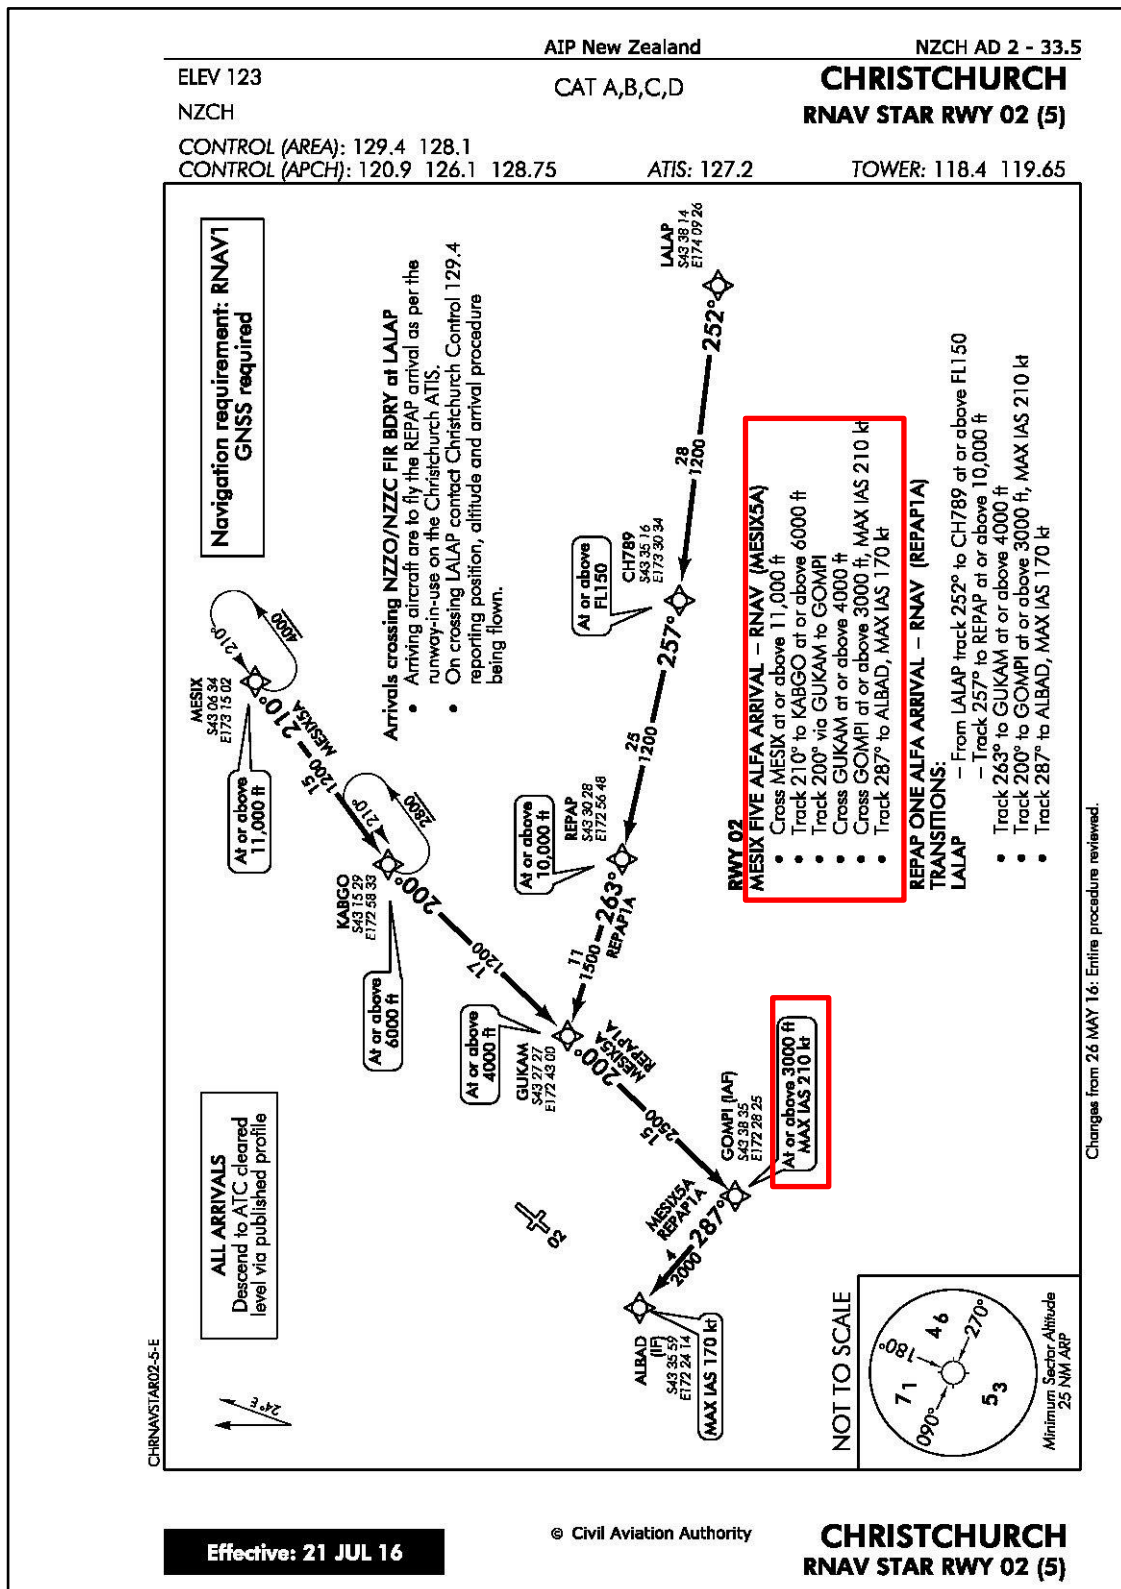
Figure 1  
MESIX Five Alfa Arrival (standard arrival route)  
(Courtesy of Aeropath)  
Not to be used for navigation

- 3.1.7. The standard arrival route included a number of altitude<sup>9</sup> restrictions below which an aircraft should not descend as it proceeded along the route. These minimum altitudes were set for a number of reasons, including to provide a safe clearance above terrain and other features, for noise abatement, and to ensure efficient traffic flows. Figure 2 shows the minimum altitudes for the approach route the aeroplane was following.

- 3.1.12. The aeroplane was required to remain above 3,000 feet (900 m) until it had passed the next waypoint<sup>11</sup>, GOMPI. At 1848:32 the aeroplane descended below 3,000 feet before reaching the GOMPI waypoint<sup>12</sup>. Additionally, the Christchurch standard arrival route included a minimum safe altitude of 2,500 feet (760 m) between GUKAM and GOMPI.

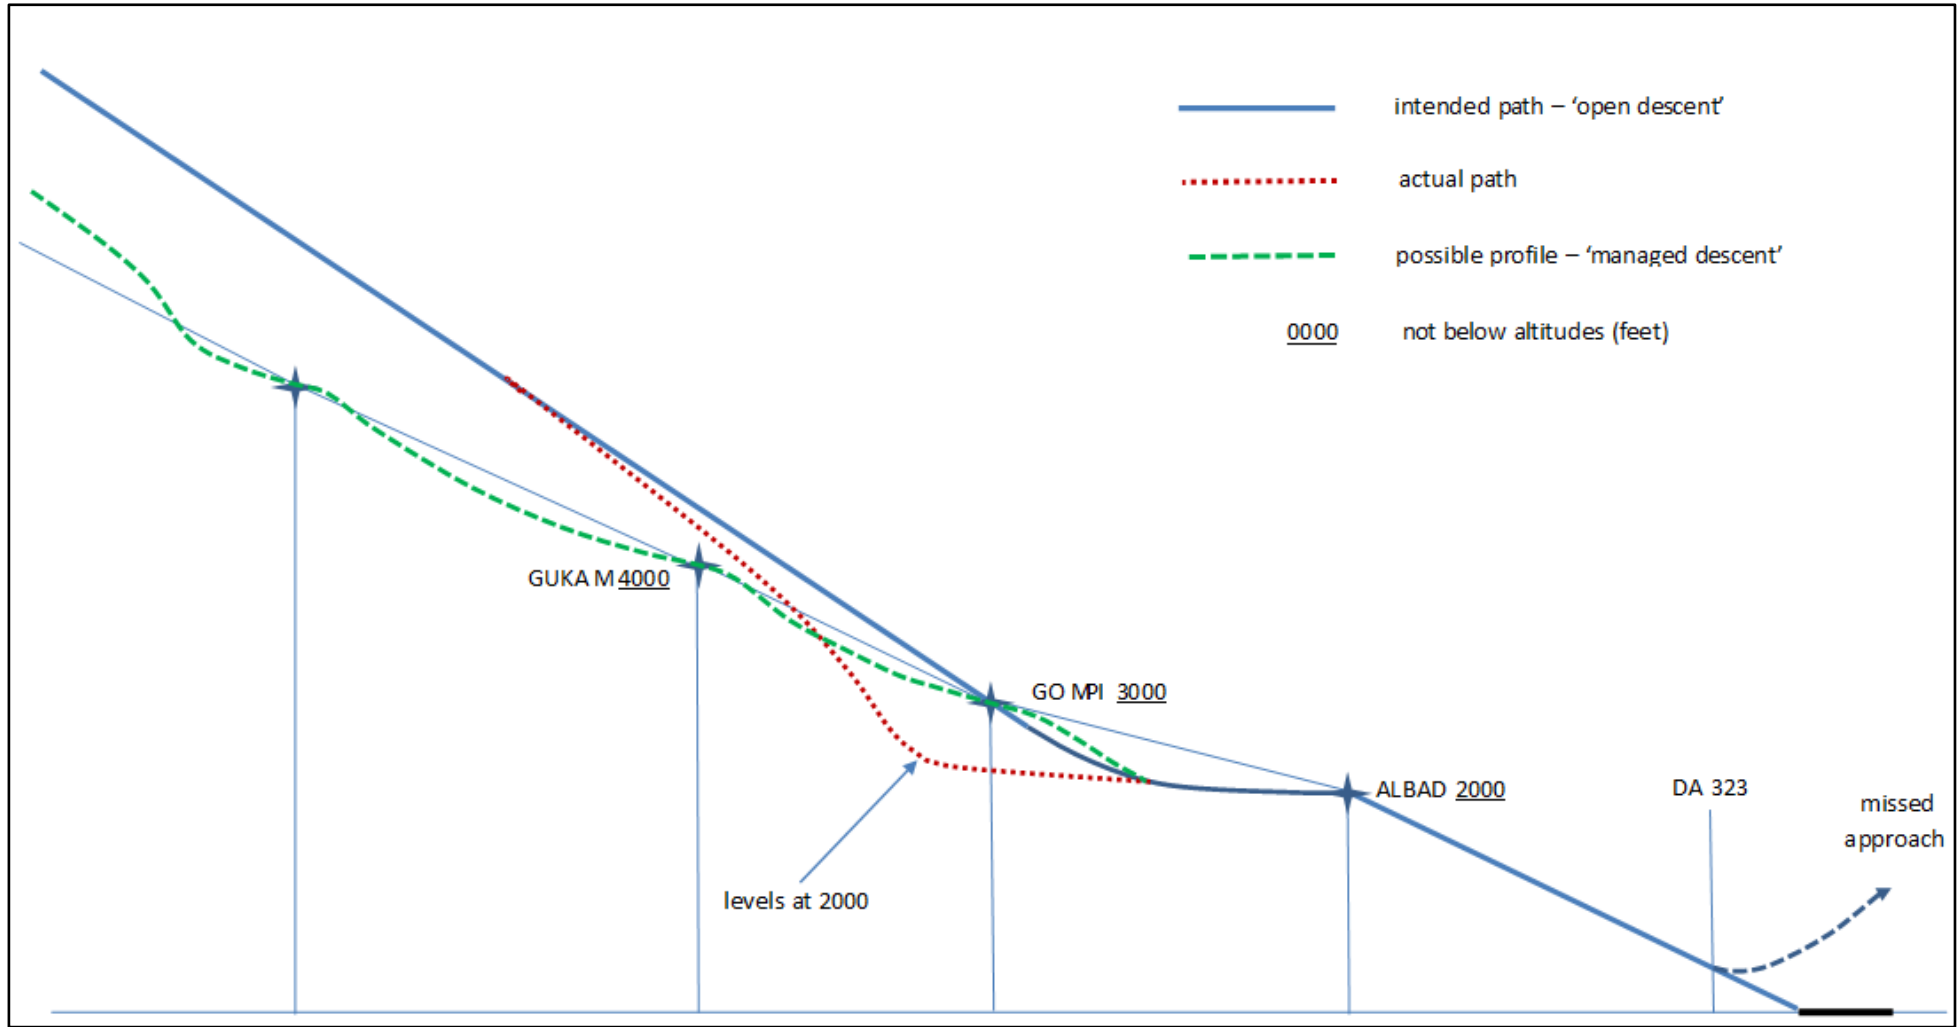
Figure 2  
Arrival profile  
(not to scale)

- 4.2.3. In open-descent mode the aeroplane was programmed to descend directly to the altitude set in the FCU (2,000 feet), ignoring the intermediate altitude restrictions contained in the standard arrival route. The first officer had used this descent profile previously at Christchurch and was confident of being able to maintain a steady descent to the commencement altitude for the instrument approach.

- 4.2.4. However, on this occasion the aeroplane descended below the intended profile and consequently below the 3,000-foot minimum altitude limit between GUKAM and GOMPI, and also below the 2,500-foot minimum safe altitude limit until past GOMPI. The 3,000-foot limit was a procedure limit, while the 2,500-foot minimum safe altitude limit provided separation from terrain along the GUKAM-to-GOMPI track.

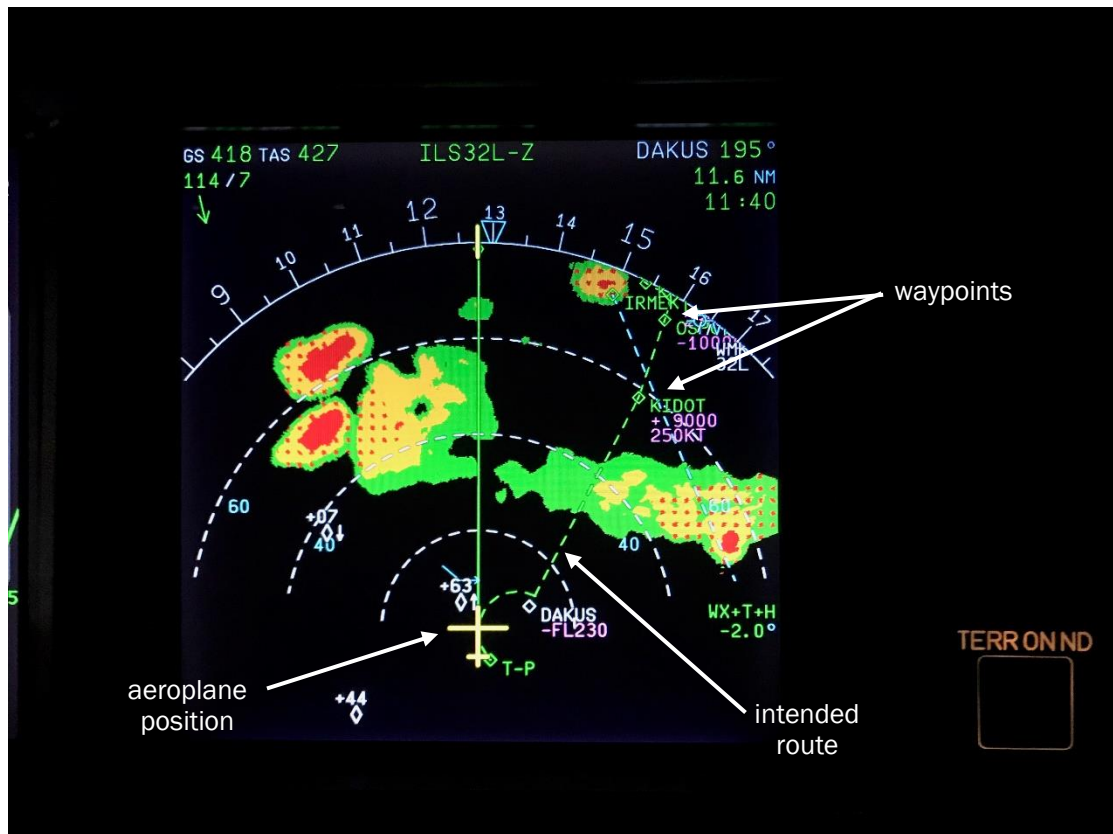
Figure 4  
Navigation display

- 3.3.4. In 'selected descent' mode, pilots controlled the aeroplane's descent using the FCU located on the instrument panel. The operator's standard operating procedures stated that pilots could use one of two modes for selected descents: open descent or vertical speed. In open-descent mode an aeroplane would descend to the altitude selected by the pilots on the FCU. The FMGS would then disregard any intervening altitude restrictions that had been pre-programmed into the FMGS as part of the arrival procedure. However, the restrictions would continue to be shown on the navigation displays and the aeroplane would remain on the pre-programmed route (see Figure 4).

- 4.3.8. The FMGS and the auto-flight system are intended to ease a pilot's workload, allowing the crew to focus on ensuring the continued safe operation of the aeroplane. In managed-descent mode the FMGS follows a programmed procedure. However, in some conditions the aeroplane may deviate from the planned flight path. To protect against this, pilots need to monitor the performance of their aeroplane continually, and intervene to avoid any potential limit exceedance. For the A320, this monitoring information is presented to the pilots by a number of means, primarily the navigation display.
