Transport Accident
Investigation
Commission

Aviation inquiry AO-2018-006

Robinson R44, ZK-HTB

Loss of control

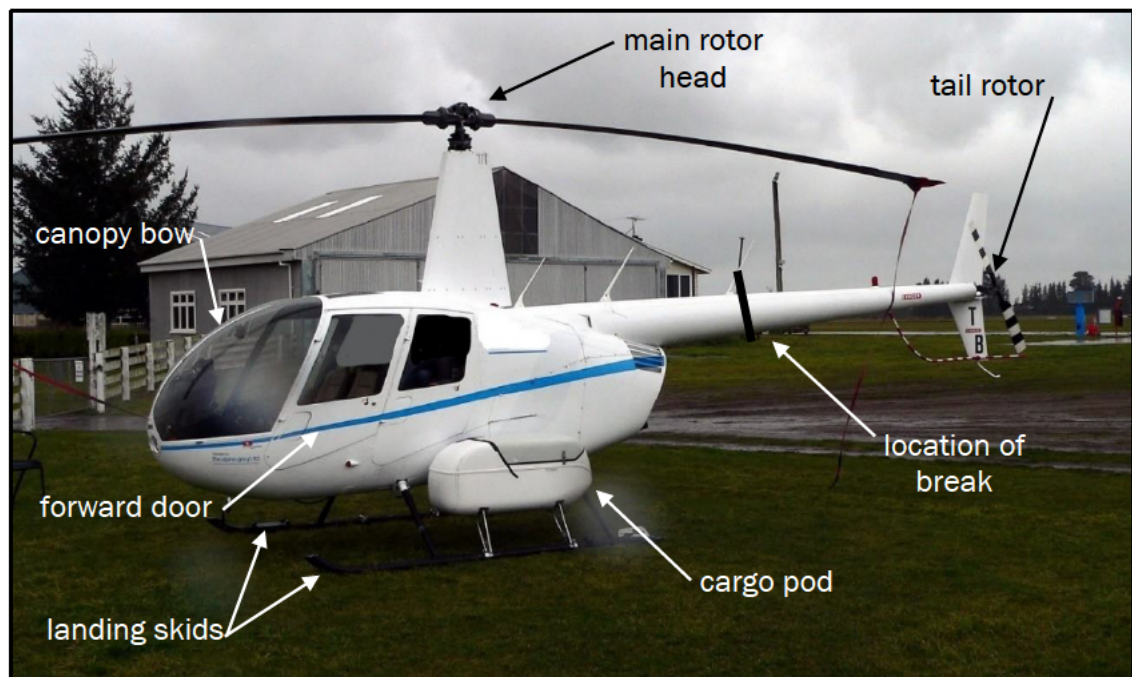
Figure 4: R44 ZK-HTB

- 2.19. The wreckage was located on the lake floor approximately 500 m north-north-west of Stevensons Island at a depth of 47 m. Approximately 95% by weight of the helicopter was initially recovered and available for examination. The main items missing included the Perspex® windows, a section of the front-left door frame, sections of both landing skids, and the cargo pod (see Figure 4). Some of the cargo was also not recovered.

- 2.23. The helicopter fuselage was severely damaged, with hydrodynamic deformation (crushing) evident on the front-left side. The line of deformation corresponded with the line of force applied to the front of the fairing¹⁴ covering the main rotor mast. The cargo pod also displayed deformation on the front, with the lid being torn off at its hinges. However, the lid remained connected by a spring used to assist in the closing of the lid. The three attachment points for the cargo pod showed the pod had been forced upwards and backwards. See Appendix 1 for a summary of the damage, including photographs.

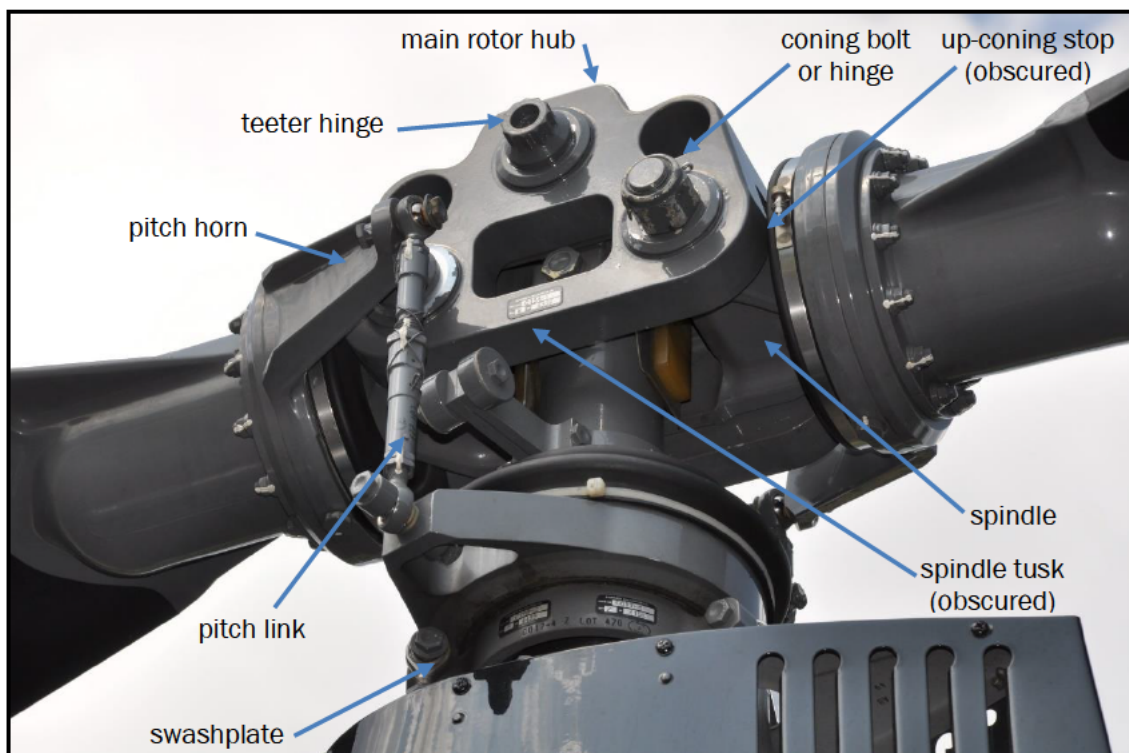
Figure 5: Main rotor hub assembly

- 2.28. The pitch links, which connected the main rotor pitch horns to the swashplate, and the flight control push rods had failed (see Figure 5). The teeter stops for both main rotor blades were crushed. The crushing had been of sufficient force to split the teeter stops in two. Both of the spindle tusks, one for each blade, were bent downwards by about 10°. Indentations corresponding to the profile of the spindle were visible on the adjacent surface of the up-coning stop, on the underside of the main rotor hub.

3.17. The term 'mast bumping' is associated with helicopters fitted with a 'semi-rigid' rotor head design, and describes the inboard end of a main rotor blade striking the main rotor shaft. This is caused by the main rotor hub swinging or teetering excessively about the teeter hinge (see Figure 5).

3.18. The observed damage to the teeter stops in this accident indicated that mast bumping had occurred. The teeter stops were crushed through and both spindle tusks were bent downwards, which showed that the mast bumping was severe. However, evidence of mast bumping does not necessarily mean it was an initiator of an accident sequence. Mast bumping can, for example, occur as a result of a main rotor striking an object while still rotating.

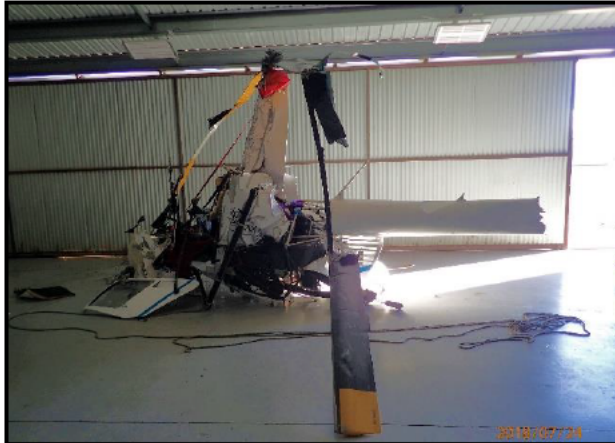
Wreckage soon after retrieval

The fuselage of the helicopter was severely disrupted, with evidence of more extensive crushing to the front-left corner of the cabin. In comparison, the tail section, comprising the rear section of the tail boom and empennage, was virtually undamaged other than where it had separated at the tail boom.

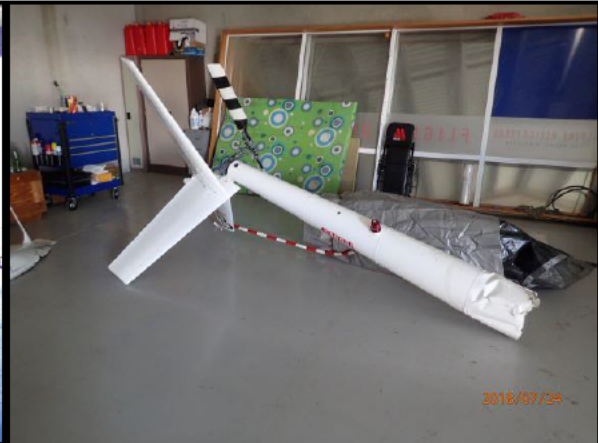
Tail section

- 2.24. The tail section, aft of where it had separated, displayed no obvious damage. The tail rotor rotated freely when examined. The direction in which the tail boom separated was to the left looking from the rear. The tail rotor drive tube displayed torsion or twisting-induced buckling. There was, however, no evidence of the tube contacting the inside of the tail boom after separating.

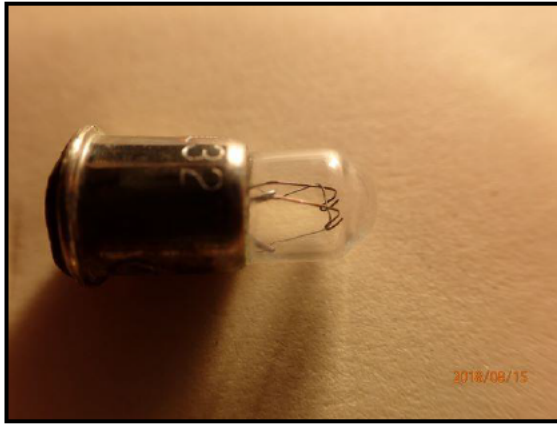
The flight instrument panel had become dislodged, but remained attached by cabling. The warning lights were examined for indications of hot stretch. The filaments for both the 'Low Rotor RPM' and the 'Clutch' showed evidence of hot stretch. The indication lights for 'Low Fuel', 'Alternator', 'Oil Pressure – Engine' and 'Carbon Monoxide' displayed tight coils. The remaining lights were too damaged to determine their state.

Main rotor temperature light – tight coil

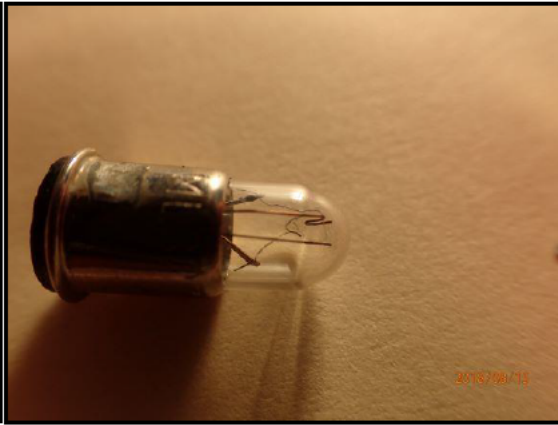
- 2.31. Both the 'Clutch' and the 'Low Rotor RPM' (low rotor revolutions per minute) warning and caution lights at the top of the panel displayed evidence of hot stretch.¹⁵ The remaining warning and caution lights either showed no evidence of hot stretch or were too damaged to provide any information.

Low rotor RPM light – hot stretch

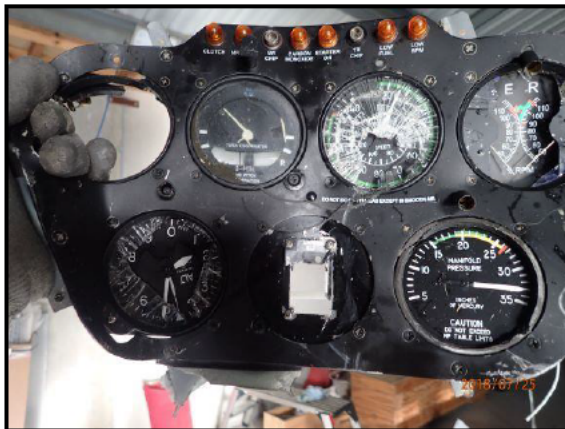
Instrument panel

The altimeter retained a trapped reading of 1,510 feet (460 m). The rear casing of the instrument was broken and internal connections were damaged.

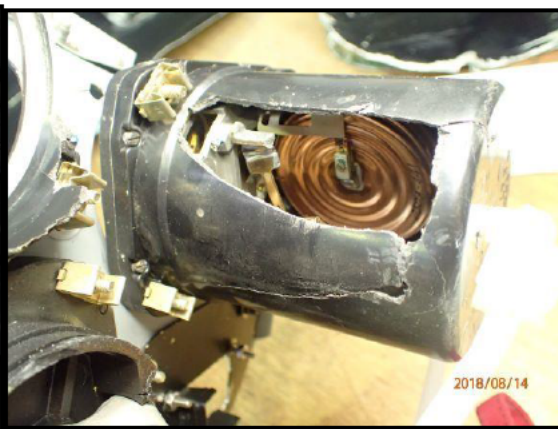
Back of altimeter

- 2.32. The glass face of the altimeter was broken and a section of its rear casing was missing. The missing section was on the upper side of the casing, exposing the internal mechanism. The initial examination found that much of the internal gearing, linkages and shafts either were damaged or had seized. The 10,000-foot (3,000 m) needle or indicator

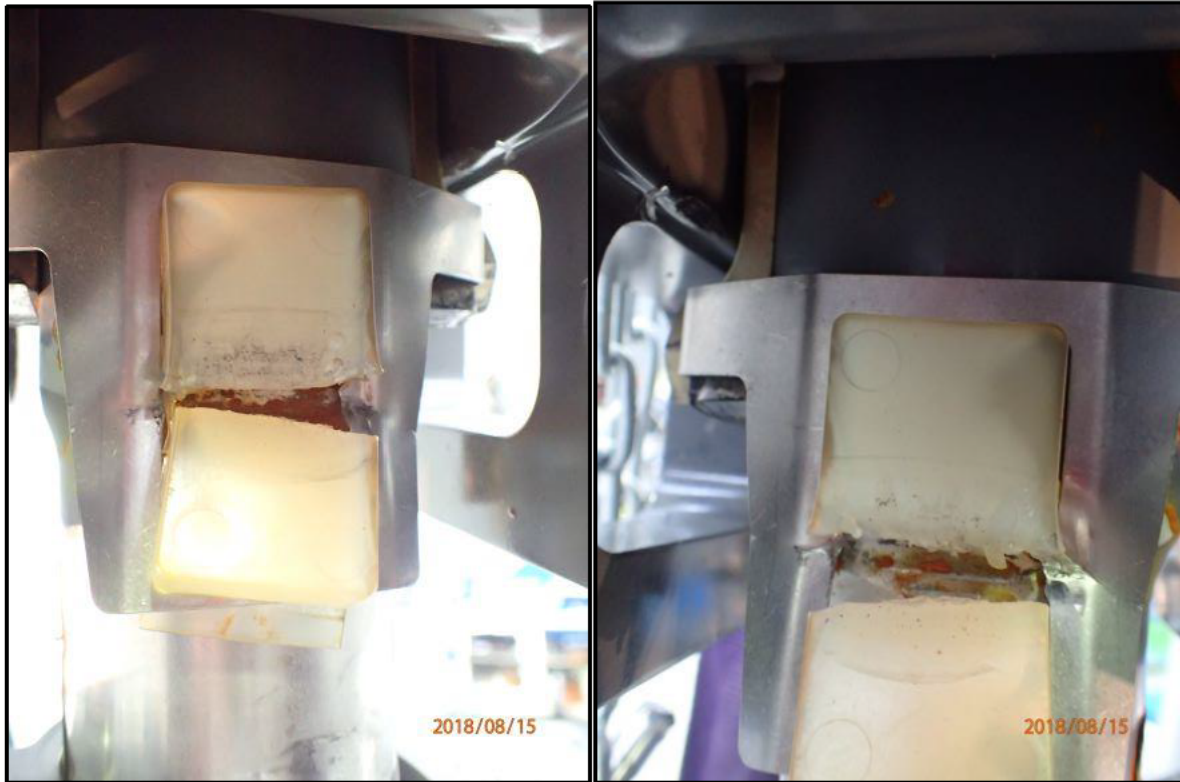
Teeter stops

Both main rotor blades remained attached to the hub. The pitch links that connected the main rotor blade pitch horn to the swashplate were both broken. Both blades had rotated about 180° to an upside-down position. The teeter stops for both blades were crushed through. The spindle tusks for both blades were bent downwards by about 10°.

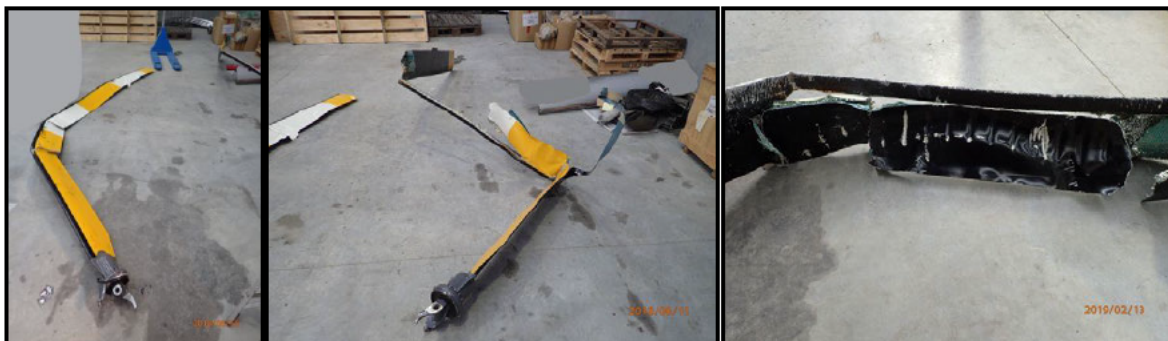
One main rotor blade (serial number 7061) was relatively flat in plane with three rearward bends. There were no chordwise (leading edge to trailing edge) crease marks to indicate the blade had bent excessively upwards or downwards.

The other main rotor blade (serial number 7065) had two nearly 90° bends along its length. The first, approximately 1.4 m from the hub, was upwards. The second, approximately 3 m from the hub, was downwards. There were no chordwise crease marks to indicate excessive or sustained flexing of the blade. An approximately 0.9 m section of blade skin and honeycomb from behind the leading-edge spar and in-board of the second 90° bend was missing. The two pieces of blade found washed ashore on Stevensons Island matched the missing section. The two pieces displayed evenly spaced chordwise dents on the lower surfaces. The dents started behind the leading-edge spar. The spacing of the dents matched the spacing of the screws on the windshield centre bow.

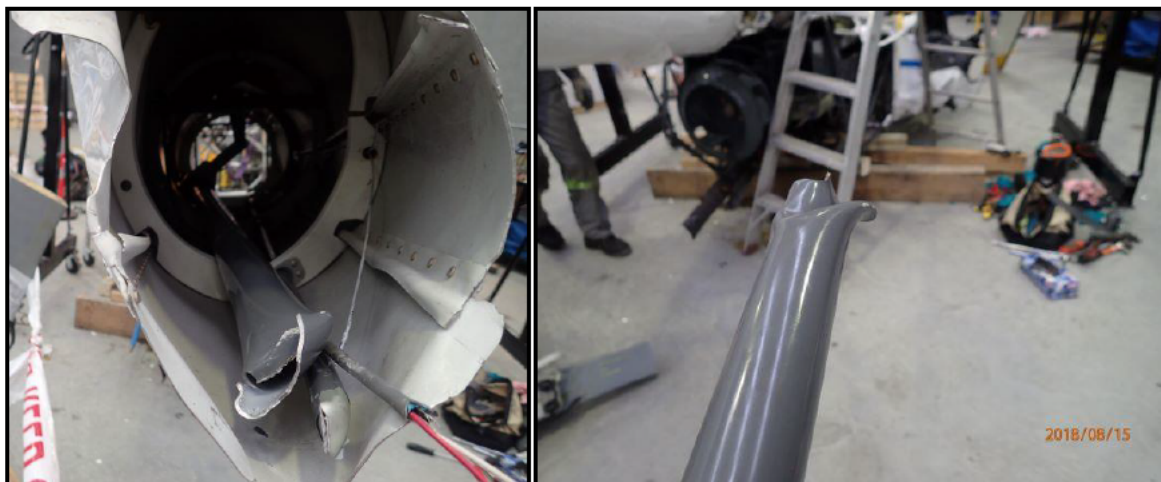
Tail rotor drive

The direction of break was to the left. There was no internal damage to indicate that the tail rotor drive had continued to turn as the tail boom separated. The direction of twist of the tail rotor drive indicated that the drive from the transmission had stopped and the tail rotor had continued trying to rotate.

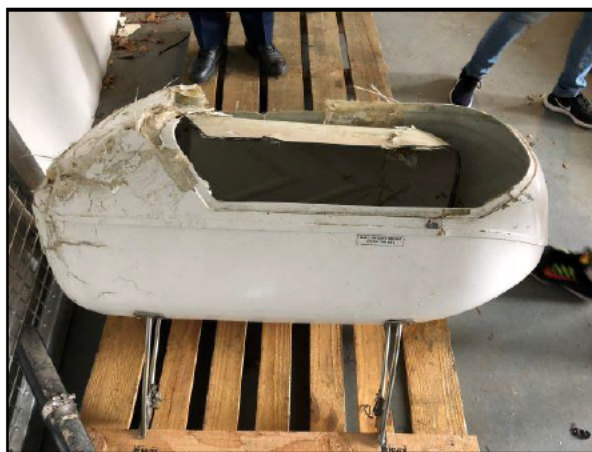
Cargo pod

- 3.10. It was exceptionally unlikely that the cargo pod, located on the left side of the helicopter, came loose in flight and caused a loss of control. The pod was found on the lakebed within a few metres of the main wreckage. This, combined with damage to the front of the pod and its attachment fittings, confirms that the pod very likely separated as the helicopter struck the water nose-first.
