Interim Report AO-2018-006: Robinson R44, ZK-HTB,
Stevensons Arm, Lake Wanaka, 21 July 2018

Aviation inquiry A02018-006
Robinson R44, ZK-HTB
Stevensons Arm, Lake Wanaka
21 July 2018

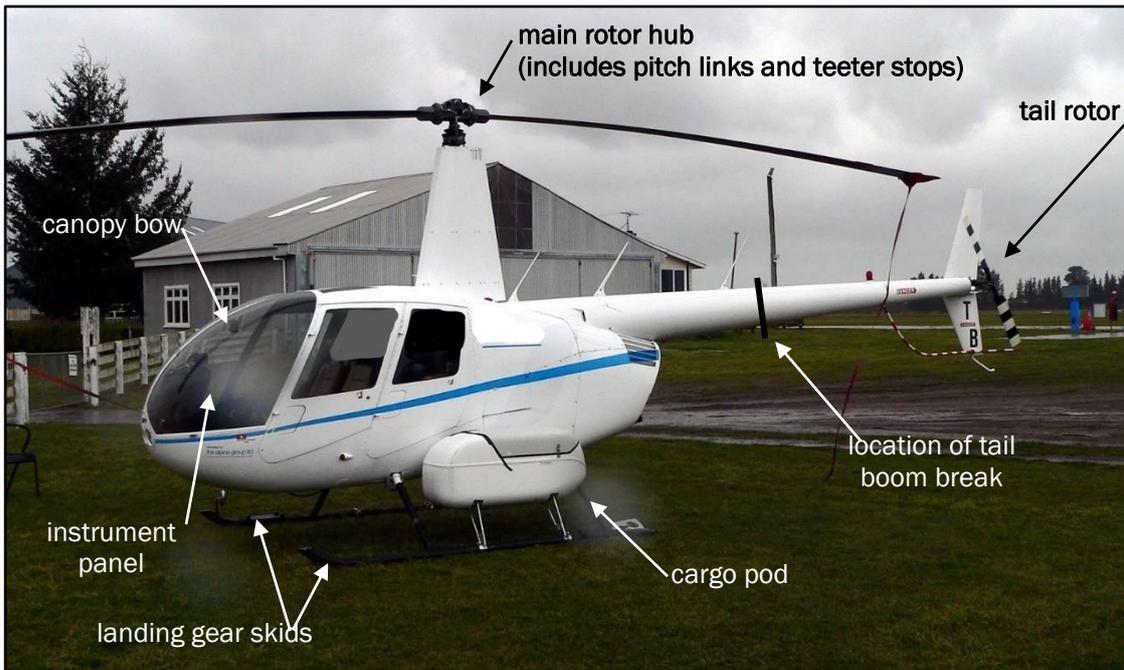
Figure 2
 Robinson R44 ZK-HTB
 (Photograph courtesy of David Paull – NZCIVAIR)

- 2.3.2. As the helicopter was lifted to the surface, the tail section, including the horizontal and vertical stabilisers and complete tail rotor assembly, was observed to be attached to the main wreckage by electrical cabling only (see Figure 2). Residual fuel was drained from the helicopter after it was lifted onto a barge and in preparation for transportation⁵.

- 2.3.6. There were evenly spaced score marks on the underside of the main rotor blade that had the missing section. These marks matched the distance between the screws on the canopy bow⁹. The canopy bow was found with the main wreckage. The paint coating on some of the screw heads on the canopy bow had been scoured.

- 2.3.8. The signature marks on the underside of the main rotor blade that matched the spacing of the screws on the canopy bow, and the damage sustained by the altimeter and the 'captured' altimeter reading, indicated that the main rotor blade had struck and entered the cabin in flight.

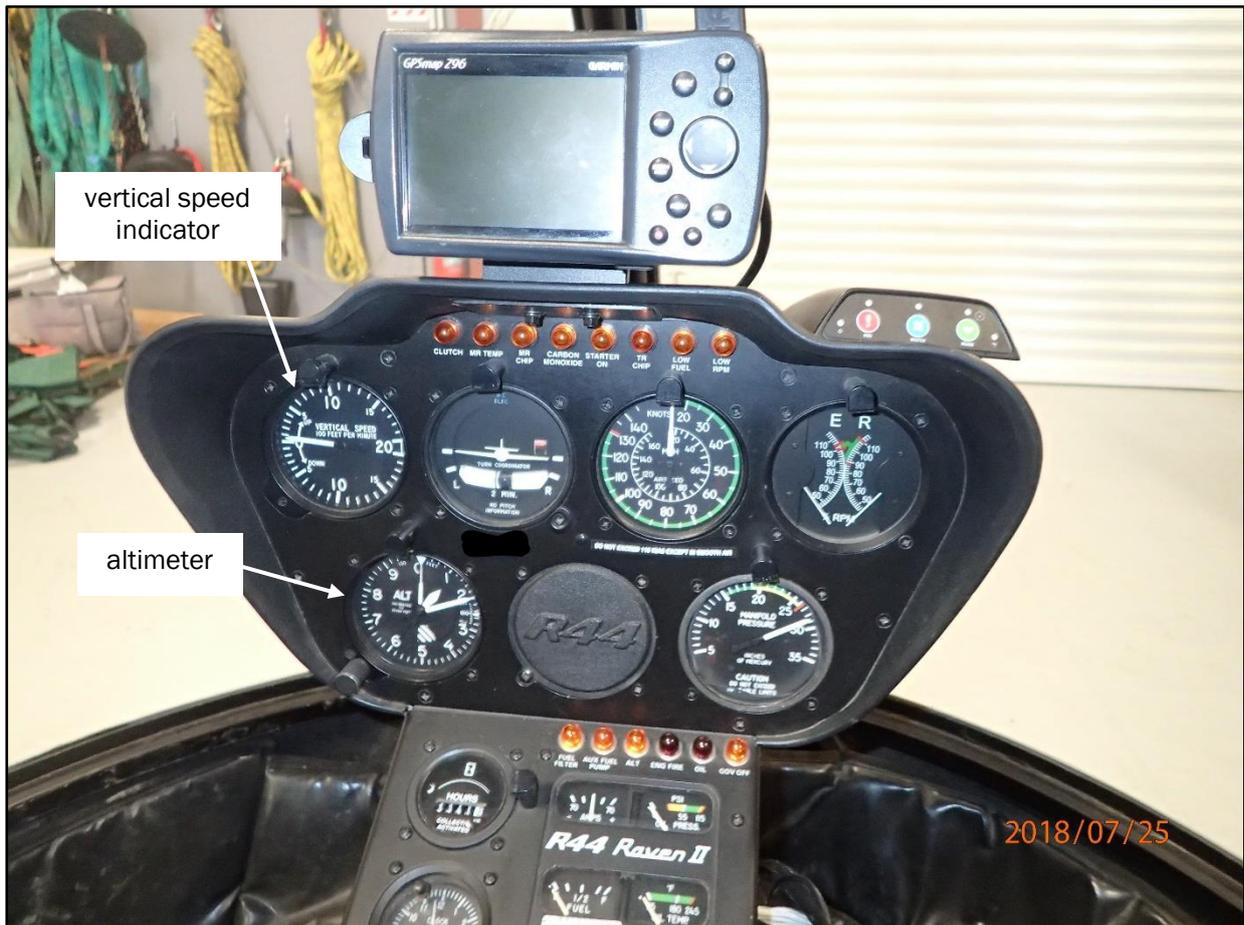
Figure 3
 Typical R44 flight instrument panel

- 2.3.7. The flight instruments panel was normally mounted above the centrally mounted engine instruments panel (see Figure 3). It had been dislodged, but remained attached by electrical cabling. The vertical speed indicator, normally mounted above the altimeter, and the rear instruments panel cover were missing. The casing behind the face of the altimeter was damaged. An independent examination of the altimeter by instrument technicians found that the gearing, linkages and shafts for two of the indicator needles were broken or jammed. The jammed needles captured a reading on the altimeter face of 1,510 feet (460 m). This closely matched the altitude obtained from the last flight tracking report.
