Transport Accident
Investigation
Commission

Final report

Aviation inquiry A0-2019-002
Bombardiers DHC-8-311, ZK-NEH and ZK-NEF
'Loss of separation' near Wellington,
New Zealand
12 March 2019

April 2022

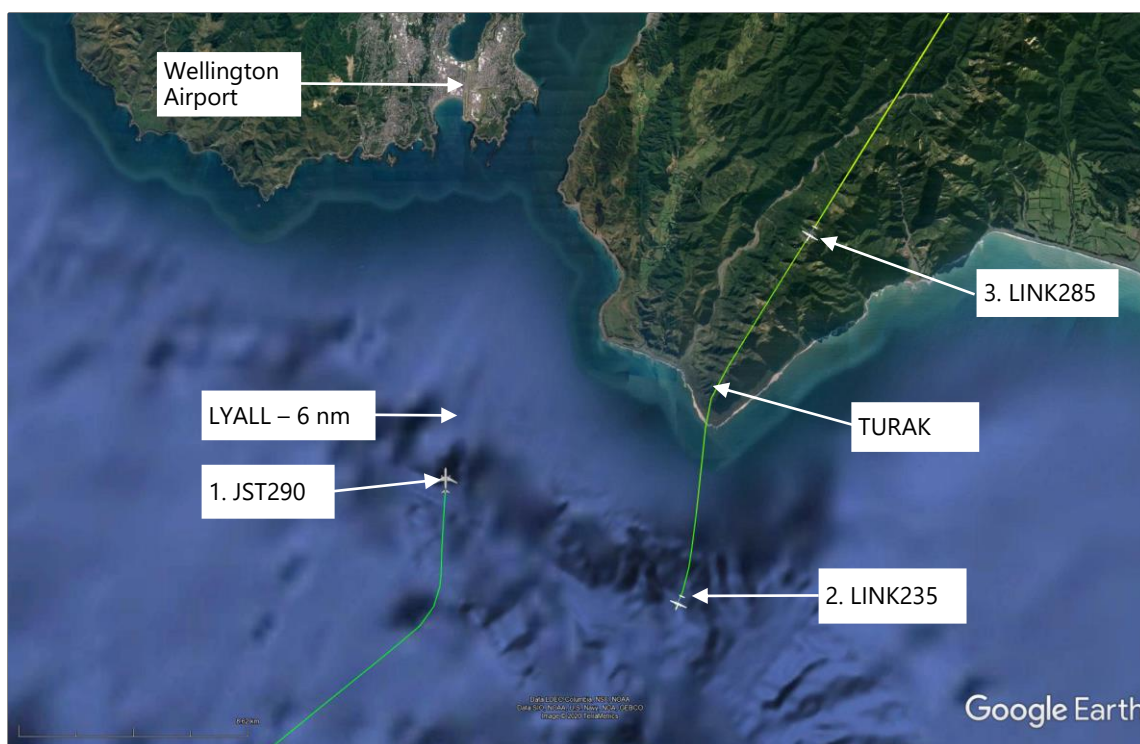
Figure 4: Positions of JST290, LINK235 and LINK285 at 1730:45

2.5. The following descriptions are of the aircraft positions at 1730:45 as shown in Figure 4. A more detailed timeline is provided for reference in Appendix 2.

- 2.10. After passing over the TURAK waypoint, LINK235 turned onto a southerly heading to extend downwind to sequence behind JST290. At 1730:45 LINK235 was approximately 3.5 nm south of TURAK at an altitude of 3,950 feet.

north-east via the DOGAD THREE ALFA STAR. At 1730:45 LINK285 was 4.3 nm north-east of TURAK, on a south-westerly heading at 6,800 feet.

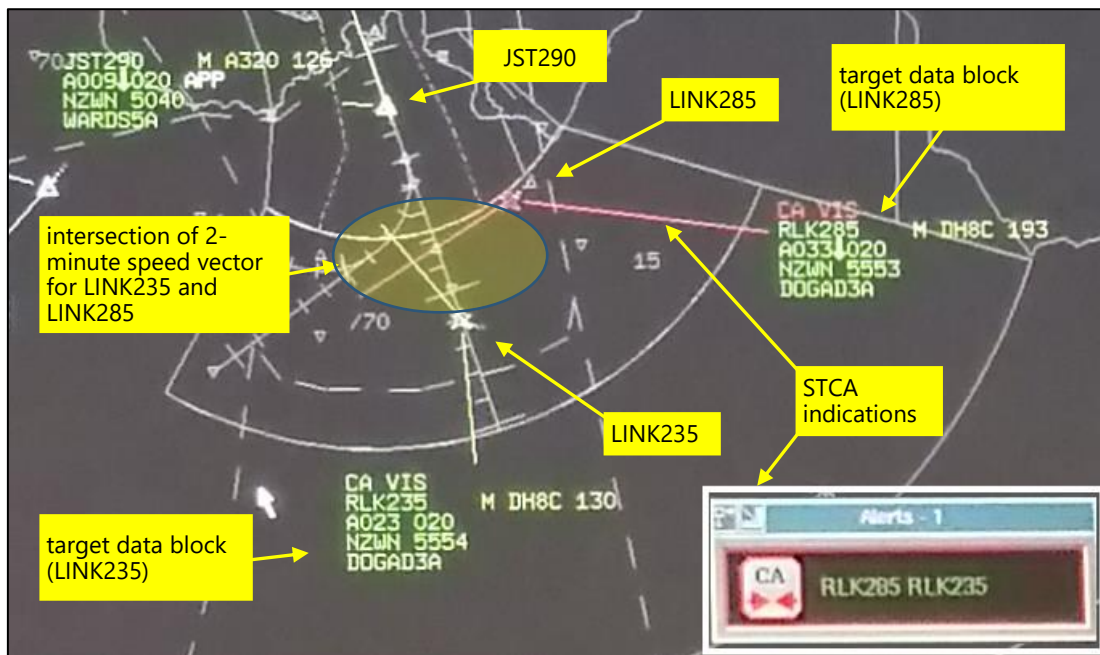
Figure 5: Positions of aircraft at STCA 1732:45

- 2.17. LINK285's right turn onto the base leg brought it into potential conflict with LINK235. The conflicting flight paths triggered short-term conflict alerts (STCAs) at 1732.45 on the approach controller's and Wellington tower controller's screens, which drew their attention back to LINK285.
- 2.18. Approach and tower controller radar displays (see Figure 5) show outlines of the terrain overlaid with the controlled airspace boundaries. Aircraft within an approach controller's area of responsibility are displayed as moving targets, representing their actual positions. A data block was displayed for each target with relevant information related to that target (such as the flight call sign, altitude, speed, aircraft type, destination, flight plan and controller's notes). A two-minute speed vector shows where the target will be in two minutes at the current speed and heading.

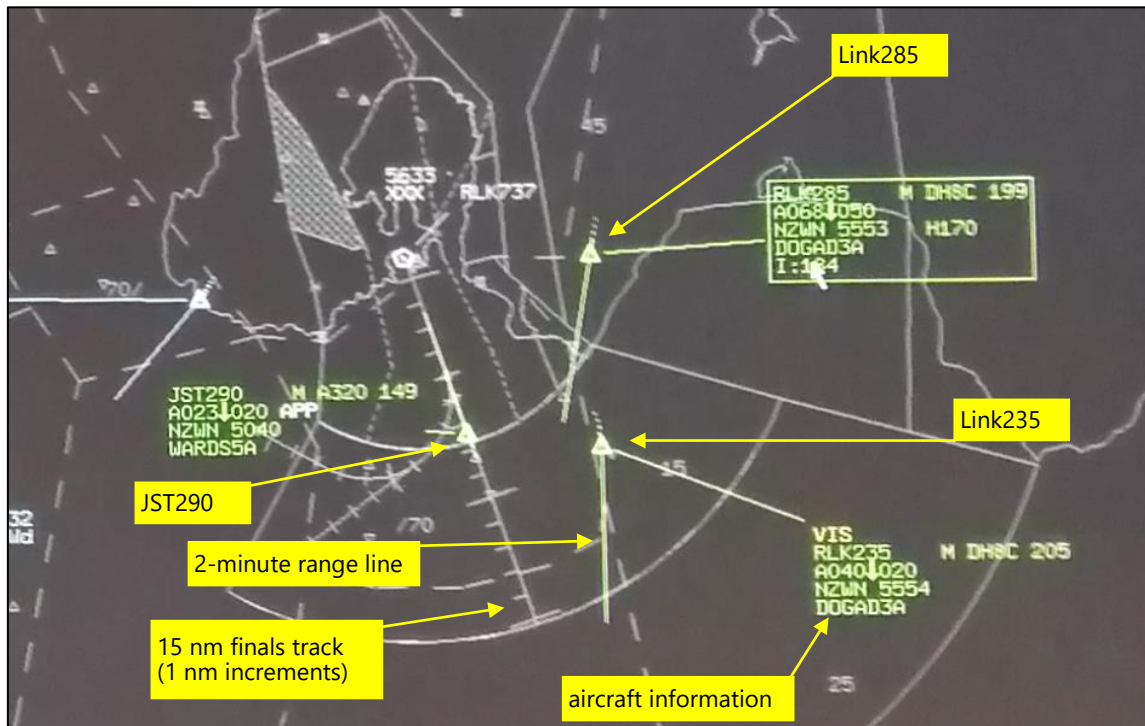
Figure 7: Airways radar – positions of JST290, LINK235 and LINK285 at 1730:45

- 3.29. While the relative positions of aircraft on the radar screen were clear to the approach controller, the pilots in LINK285 did not have the same perspective.

- 3.30. At 1730:45, when the LINK285 flight crew stated they had LINK235 in sight ahead, the sun was approximately 24° above the horizon and to their right. The pilot flying recalled that conditions were suitable for a visual approach. There was some cloud around but the sun was low in the sky and it was clearer of cloud to the south. The pilot monitoring had noted that colour clarity was poor.
