Transport Accident  
Investigation  
Commission

# Final report

***Aviation inquiry AO-2019-003  
Diamond DA42 aeroplane, ZK-EAP  
Controlled flight into terrain  
Kaimanawa Range, near Taupō  
23 March 2019***

November 2021

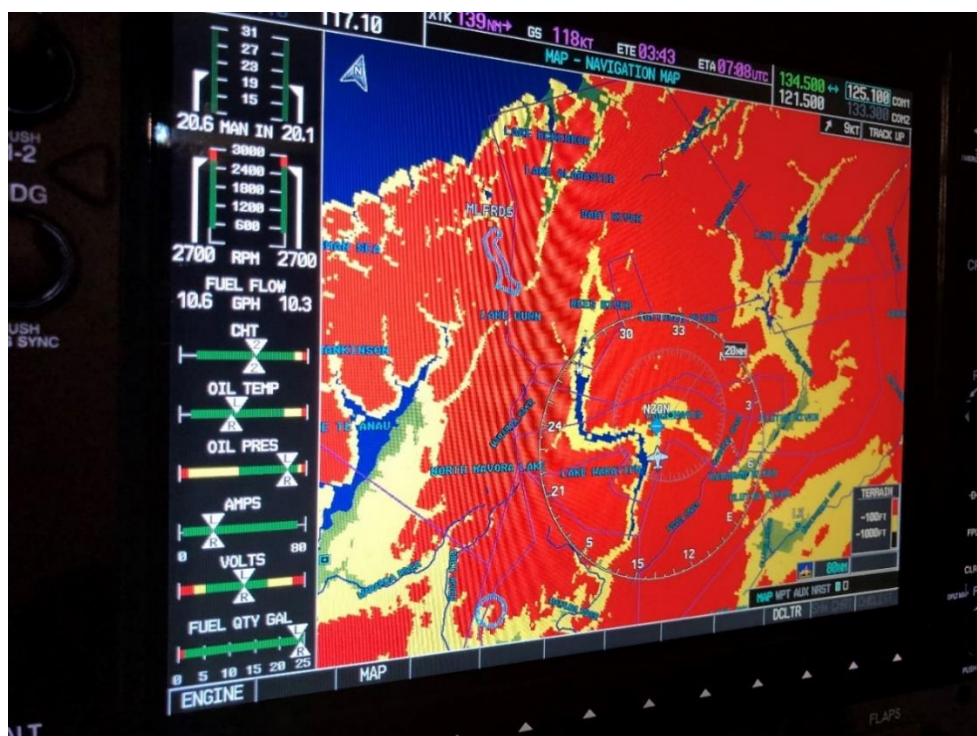
- 2.30. Yellow on the map signified that the terrain elevation was within 1,000 feet (304 m) of the aeroplane's GPS altitude. Red signified that the terrain elevation was within 100 feet (30 m) of the aeroplane's GPS altitude (see Figure 5). The terrain conflict proximity functionality could be selected on and off by the pilot. In night or low-light flight the displays could be dimmed to reduce the glare generated by the display units.

**Figure 5: The G1000 multifunctional display moving map, showing a graphical presentation of the terrain-conflict-proximity function (not representative of the flightpath of the accident aircraft)**

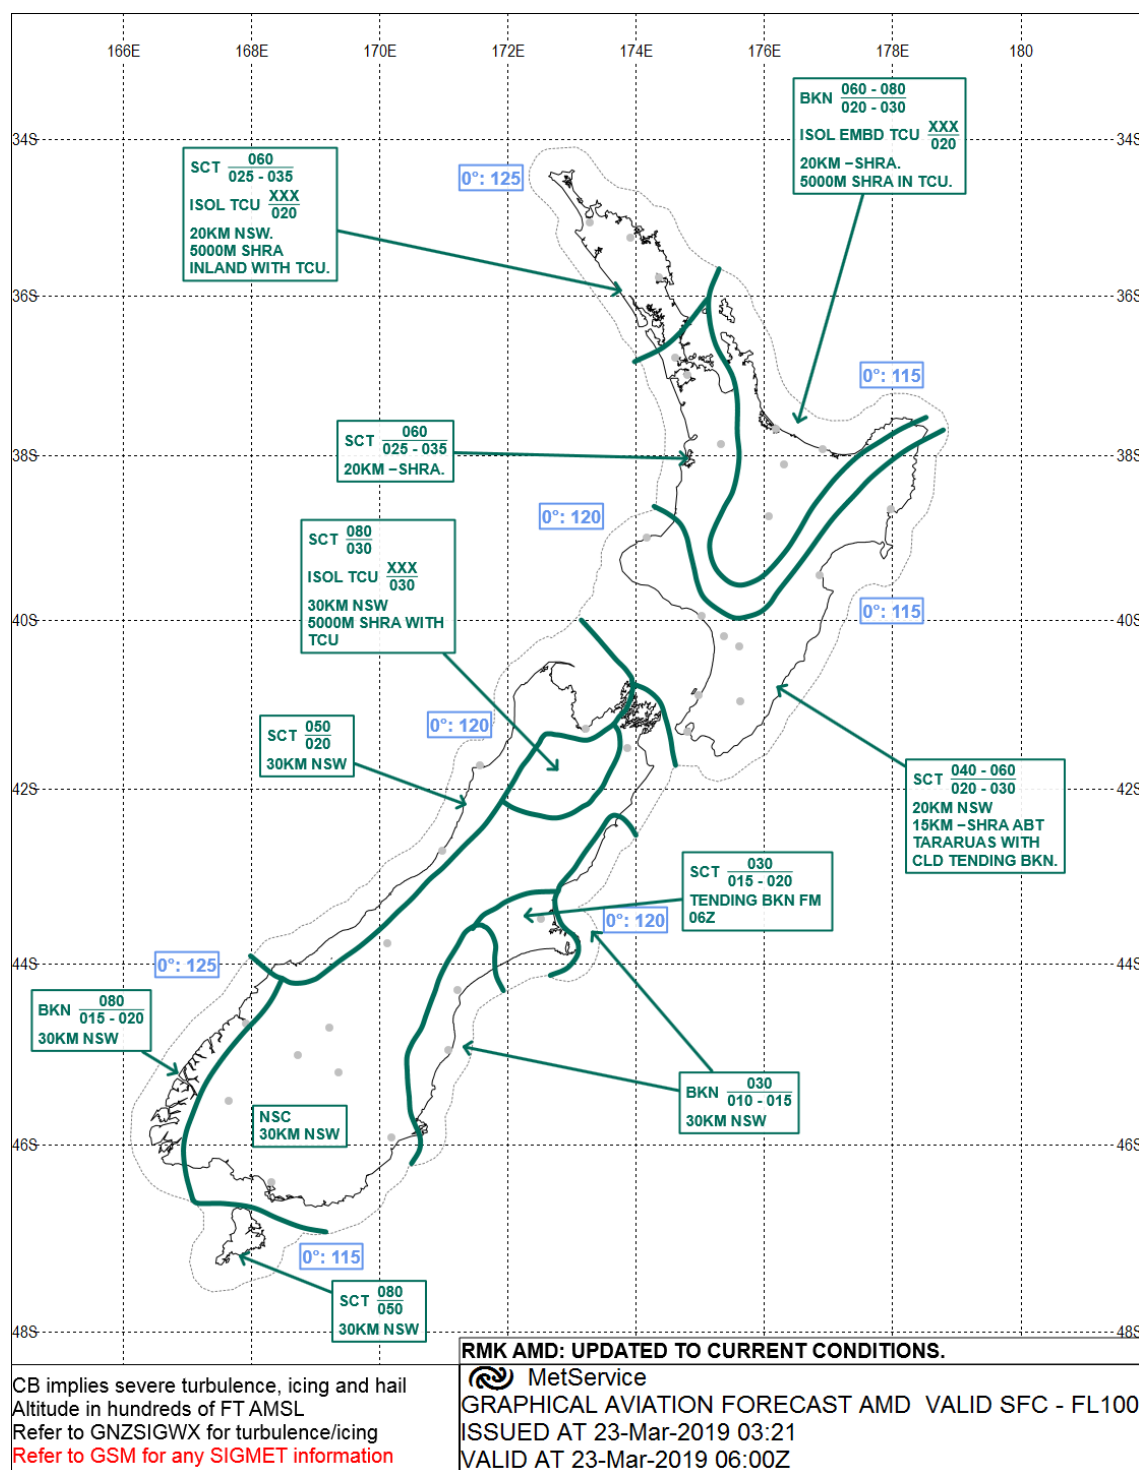
**Figure 6: GAFOR before the accident**

- 2.32. The graphical aviation forecast (GAFOR) valid for approximately three hours prior to the time of the accident (see Figure 6) specified for the Bay of Plenty and Taupō area broken cloud<sup>21</sup> between 2,000–3,000 feet (609–914 m) and 6,000–8,000 feet (1,828–2,438 m), isolated embedded towering cumulonimbus above 2,000 feet, 20 km visibility with showers and rain and 5 km visibility with showers and rain in towering cumulonimbus cloud.

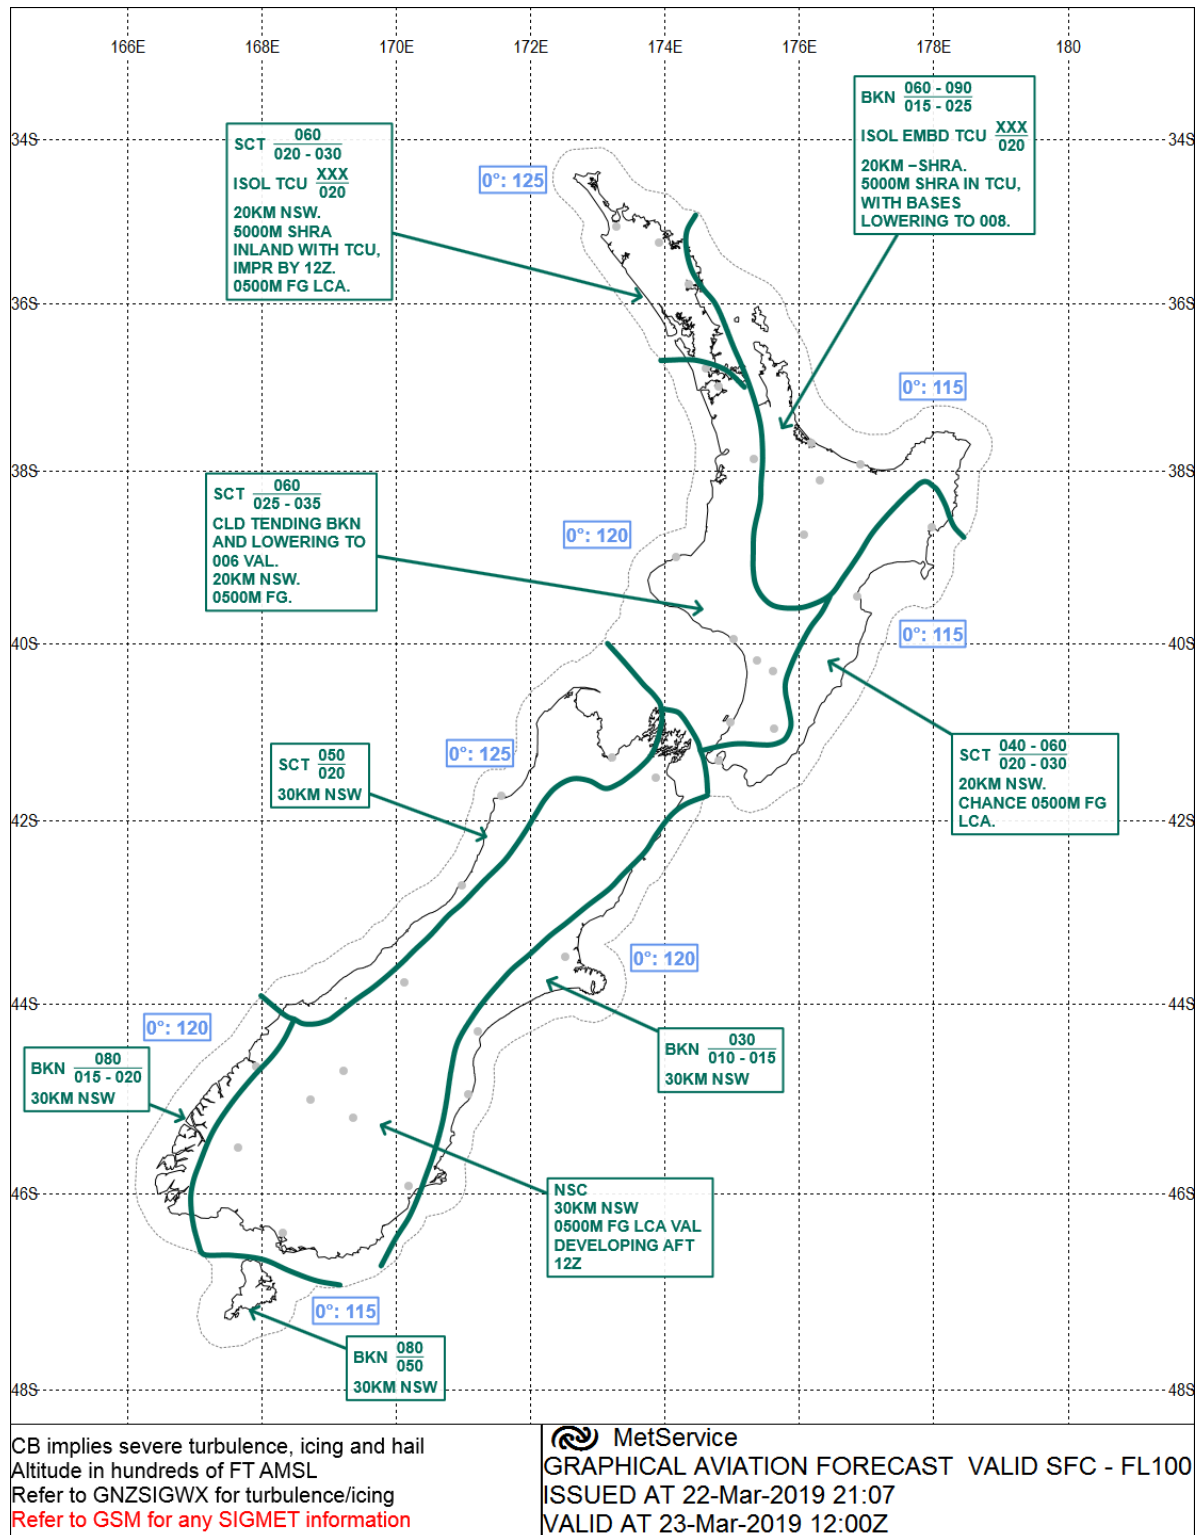
Figure 7: GRAFOR after the accident

The GRAFOR valid for approximately three hours after the time of the accident (see Figure 7) detailed broken cloud between 1,500-2,500 feet (457-762 m) and 6,000-9,000 feet (1,828-2,745 m), isolated embedded towering cumulonimbus above 2,000 feet (609 m), visibility 20 km with showers and rain and 5 km visibility with showers and rain in towering cumulonimbus cloud, with cloud bases lowering to 800 feet (243 m).

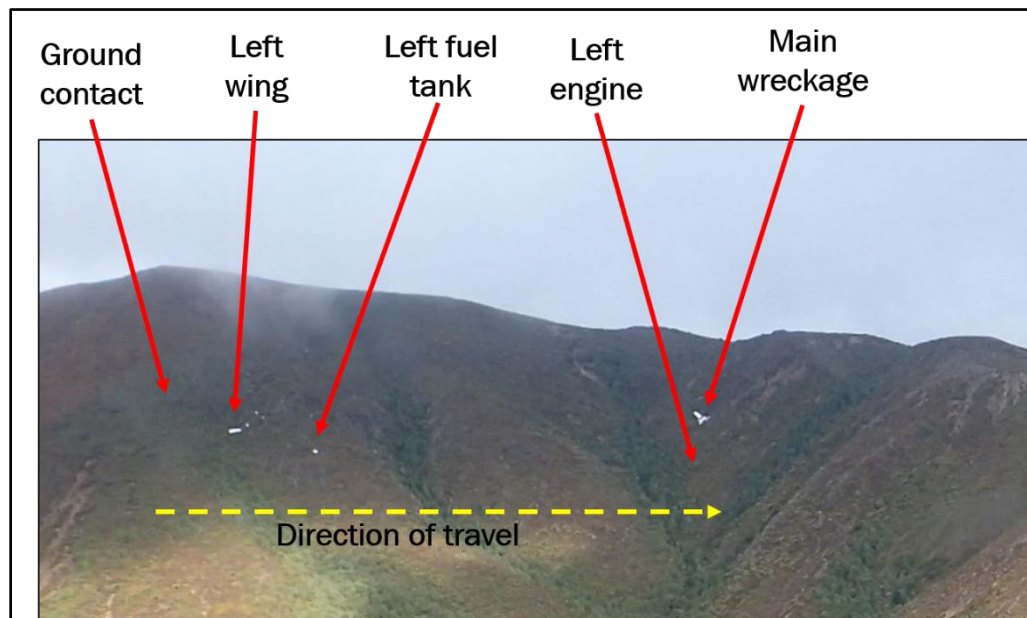
**Figure 8: Accident site**

- 2.36. The accident scene was situated at 4,500 feet (1,371 m) on sloping ground in the Kaimanawa Range, approximately 38 km south of Taupō Aerodrome (see Figure 2).
- 2.37. The aeroplane had first hit the ground with the left wing tip. The left wing had separated as a result. With the terrain sloping away, the remainder of the aeroplane had continued in the general direction of the original flightpath for a further approximately 250 m before striking the northern face of a gully. The initial ground scar made by the left wing tip and the location of the wreckage showed that the aeroplane had been in about a straight and level attitude when the ground strike occurred (see Figure 8).

- 2.38. The blades on the left and right propellers had shattered, and shards of wood had been dispersed widely throughout the first 100 m of the accident scene. The main portion of the aeroplane comprising the fuselage, right wing and right engine indicated the end of the wreckage trail. The right engine had separated structurally from the wing but remained attached to the wing by electrical cables. The left engine was found embedded in the ground nearby. There was no evidence of a fire having occurred.

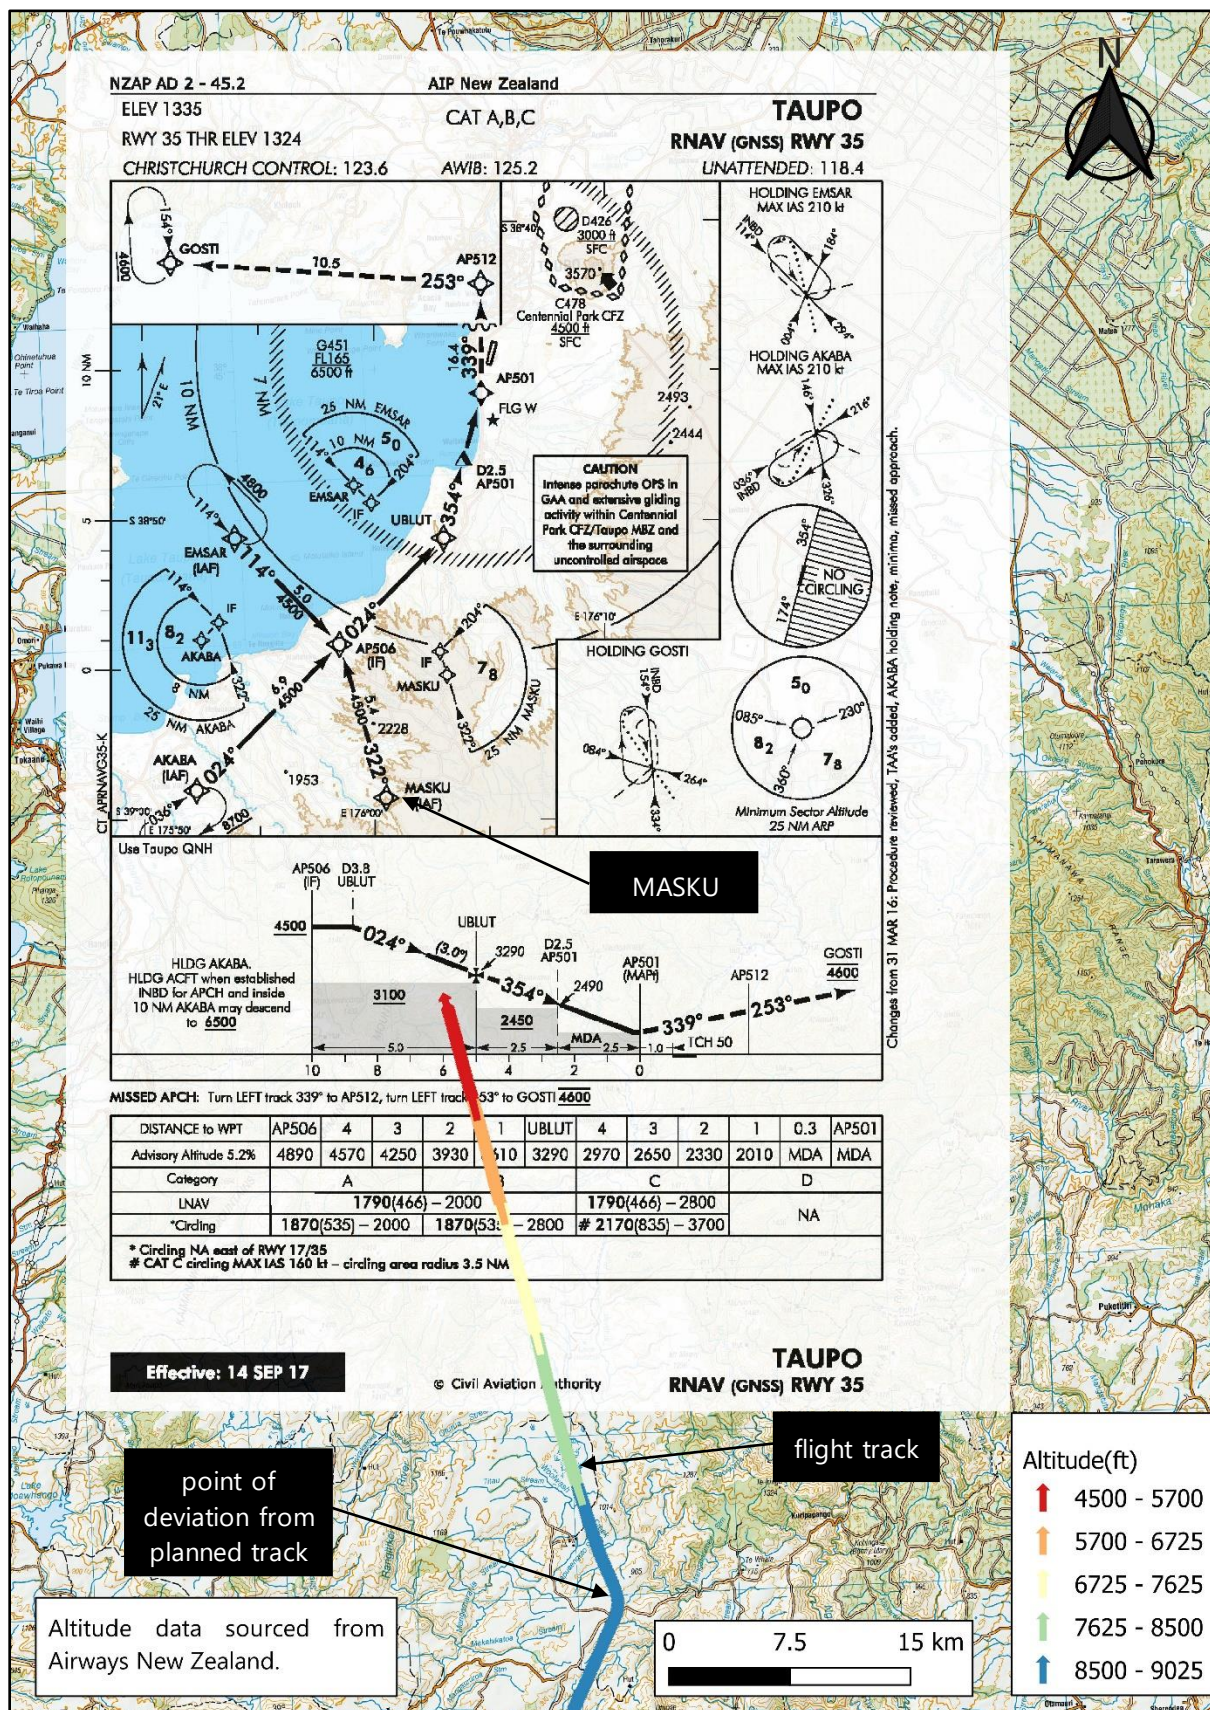
- 3.18. The reason for the change in flightpath could not be fully established; however, it was **very likely** influenced by the weather, both current and forecast. The weather report passed by the Ōhakea controller at 2152 was the first confirmation of the actual weather conditions at Taupō since the aeroplane had left Ardmore. Up until this time the pilot would not have been sure of which runway was in use at Taupō – runway 35 or runway 17.

**Figure 9: Taupo RWY 35 RNAV Aeronautical Information Publication Approach Plate scaled, georeferenced and superimposed on LINZ Topo250 map, with surveillance data showing deviation and track direct to reporting point MASKU**

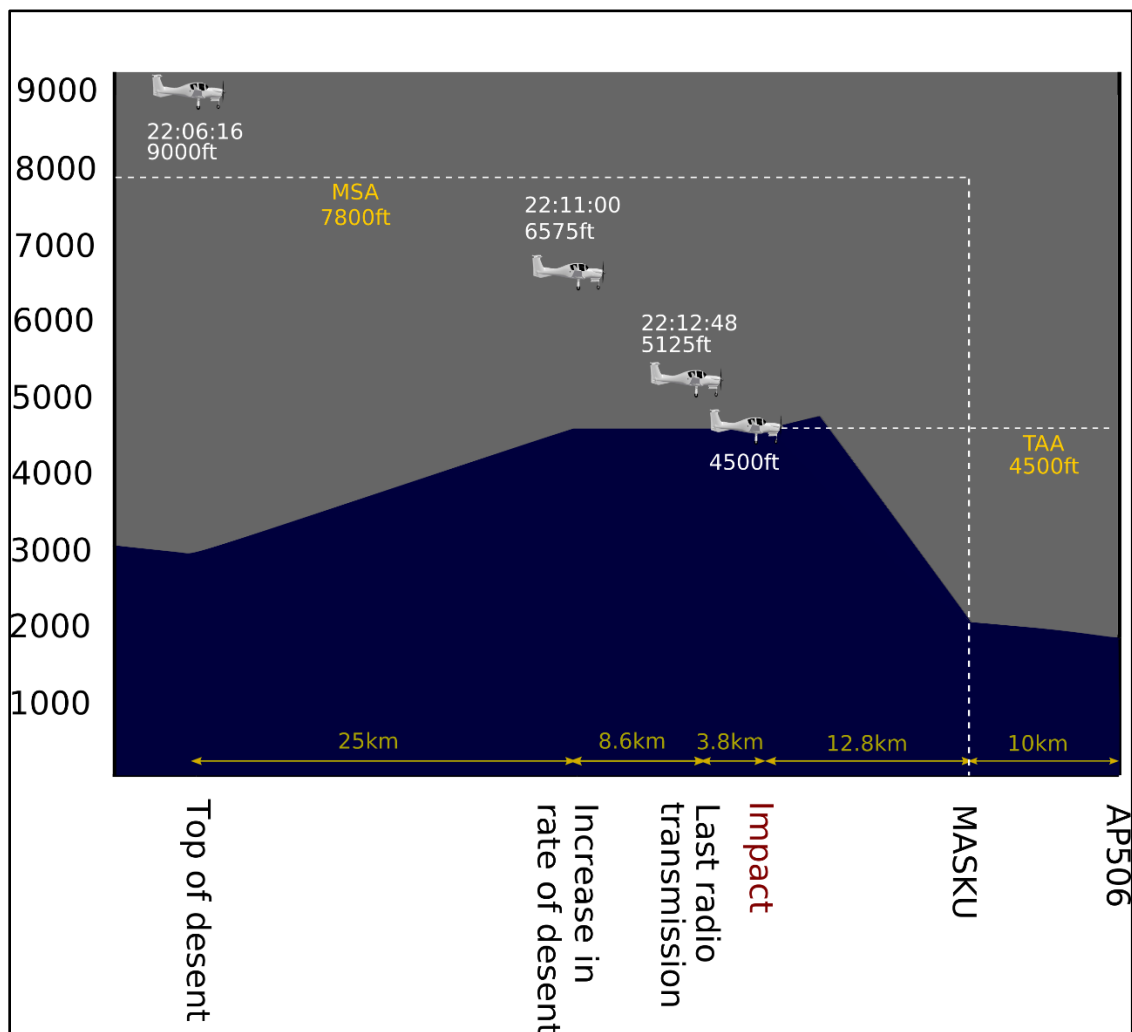
3.33. When considering the forecast weather conditions and the weather reports from the searching helicopter pilots, it was **very likely** that the aeroplane was descending in cloud from 6,000 feet (1,828 m) to the point of collision with the terrain. The pilots therefore would have not been able to visually assess the proximity of the aeroplane to the terrain. The darkness further compounded the situation.

Figure 10: Relationship between flight profile and MSA/terminal arrival altitude

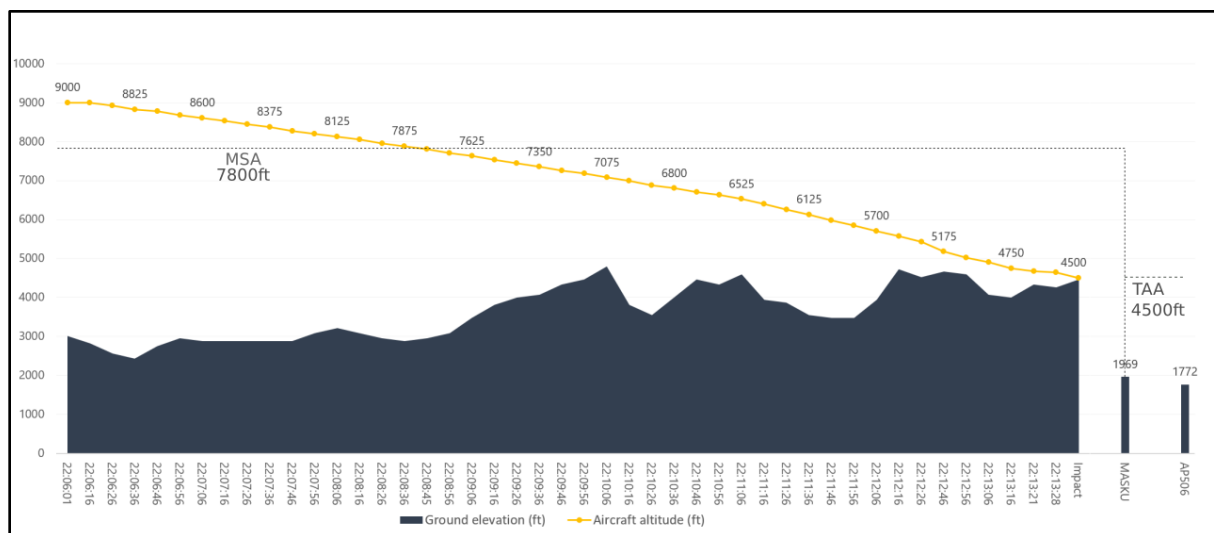
Figure 11: Flight profile from top of descent to ground impact
