Transport Accident
Investigation
Commission

Final report

***Aviation inquiry A0-2019-003
Diamond DA42 aeroplane, ZK-EAP
Controlled flight into terrain
Kaimanawa Range, near Taupō
23 March 2019***

November 2021

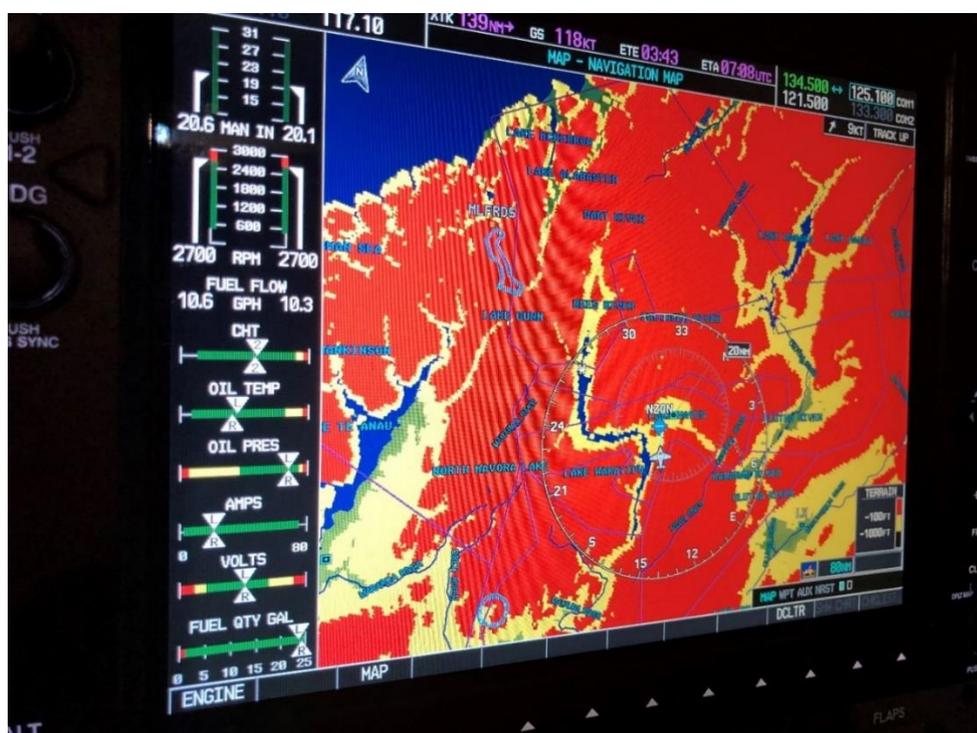
- 1.6. The Commission **found** that the aeroplane was equipped with a terrain proximity awareness capability but that it was very likely not used by the pilot.

Figure 5: The G1000 multifunctional display moving map, showing a graphical presentation of the terrain-conflict-proximity function (not representative of the flightpath of the accident aircraft)

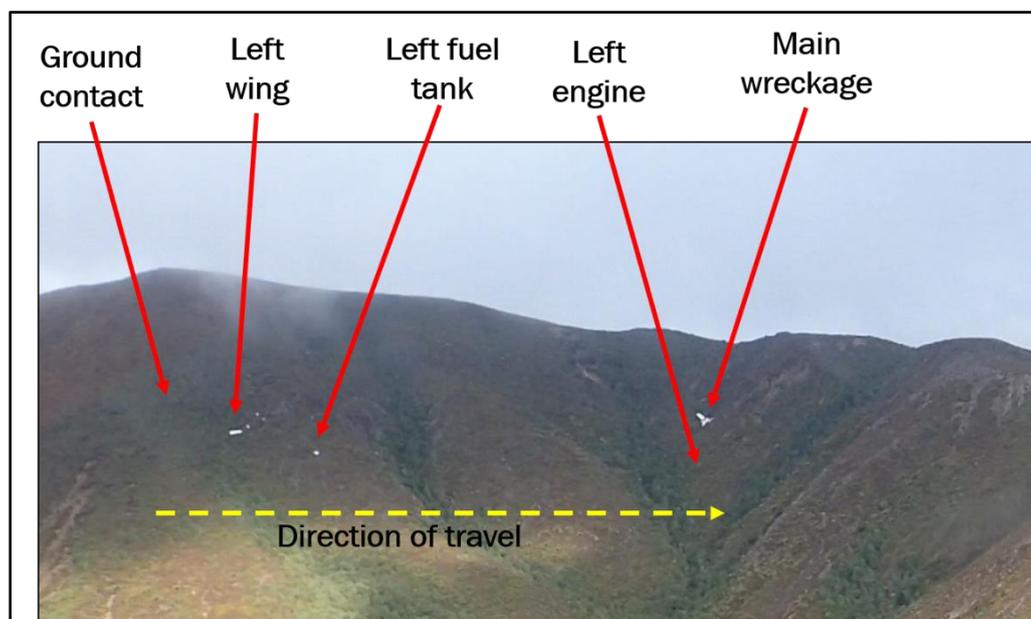
Figure 8: Accident site

- 2.36. The accident scene was situated at 4,500 feet (1,371 m) on sloping ground in the Kaimanawa Range, approximately 38 km south of Taupō Aerodrome (see Figure 2).
- 2.37. The aeroplane had first hit the ground with the left wing tip. The left wing had separated as a result. With the terrain sloping away, the remainder of the aeroplane had continued in the general direction of the original flightpath for a further approximately 250 m before striking the northern face of a gully. The initial ground scar made by the left wing tip and the location of the wreckage showed that the aeroplane had been in about a straight and level attitude when the ground strike occurred (see Figure 8).

- 2.38. The blades on the left and right propellers had shattered, and shards of wood had been dispersed widely throughout the first 100 m of the accident scene. The main portion of the aeroplane comprising the fuselage, right wing and right engine indicated the end of the wreckage trail. The right engine had separated structurally from the wing but remained attached to the wing by electrical cables. The left engine was found embedded in the ground nearby. There was no evidence of a fire having occurred.

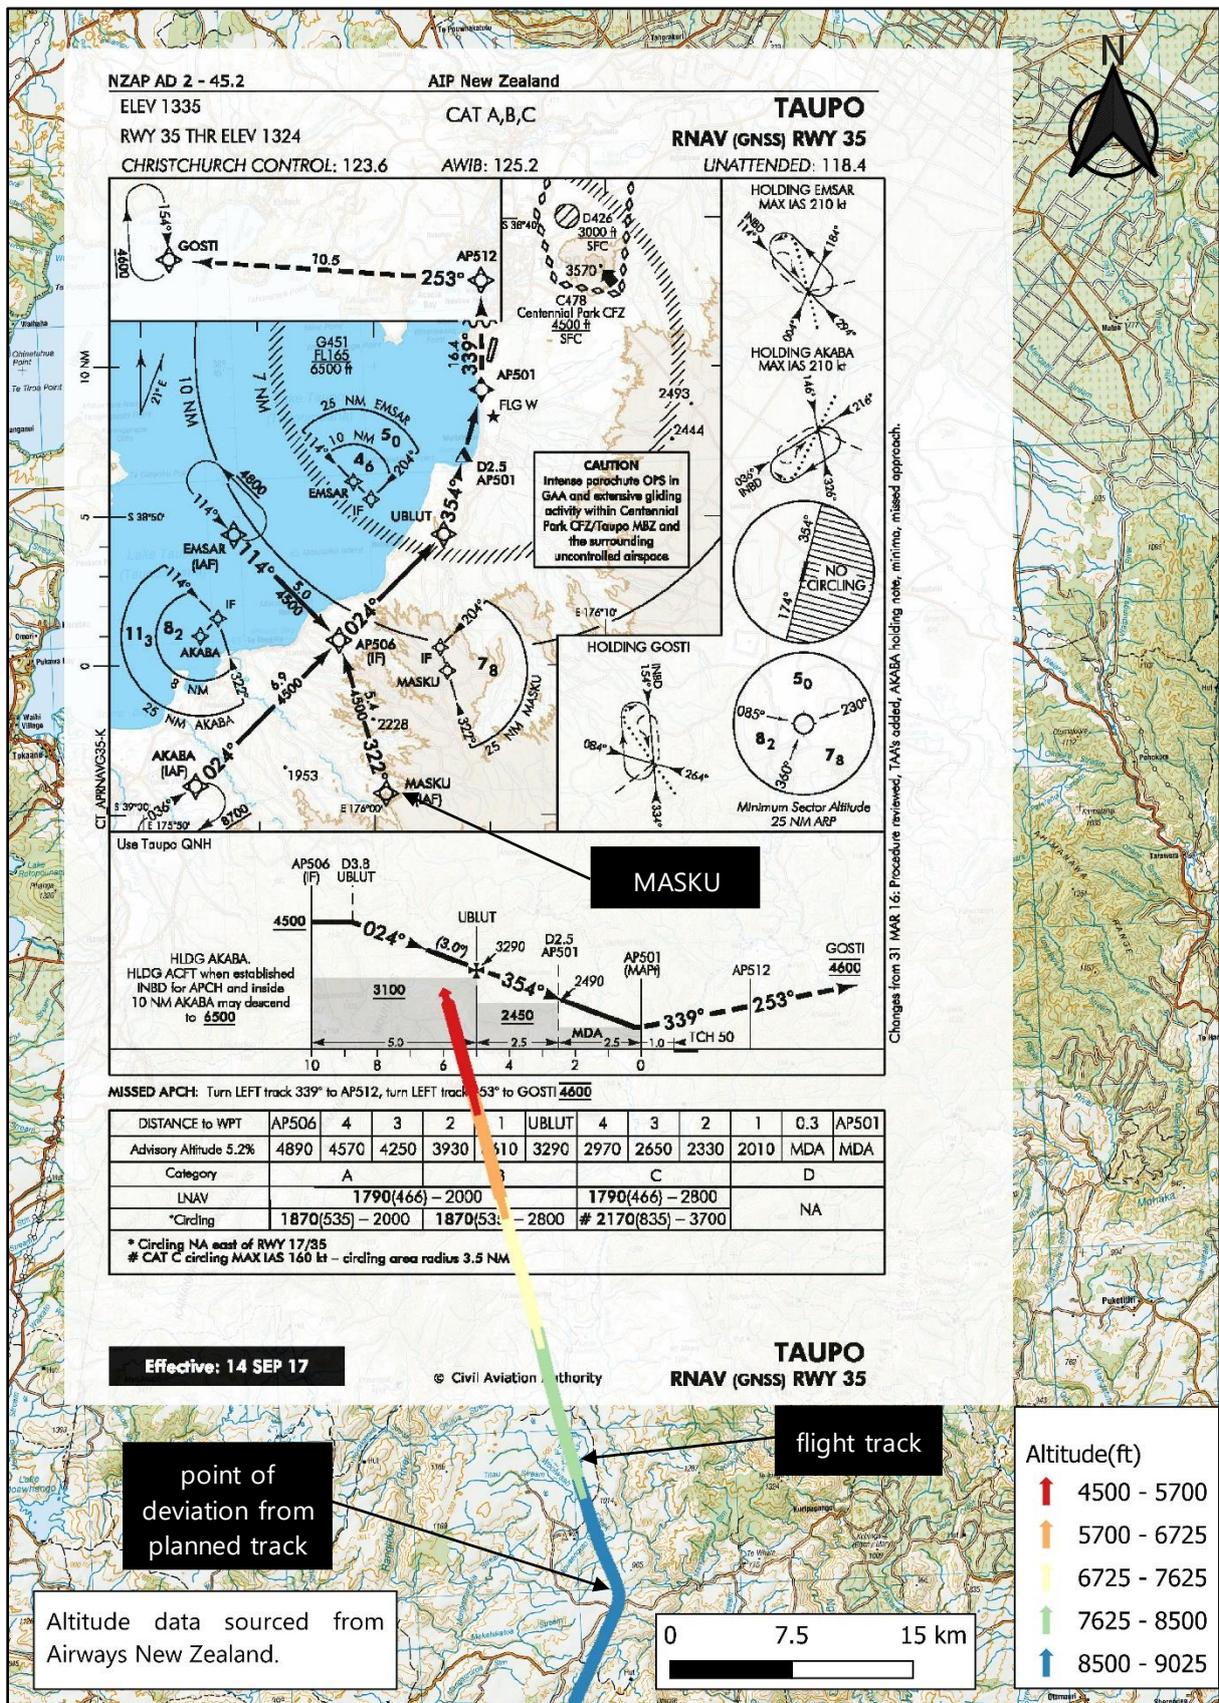
- 3.18. The reason for the change in flightpath could not be fully established; however, it was **very likely** influenced by the weather, both current and forecast. The weather report passed by the Ōhakea controller at 2152 was the first confirmation of the actual weather conditions at Taupō since the aeroplane had left Ardmore. Up until this time the pilot would not have been sure of which runway was in use at Taupō – runway 35 or runway 17.

- 3.21. The new routing from TARUA to MASKU also provided several advantages over the original route via TAIKI. Firstly, it was better orientated for the RNAV 35 approach. Secondly, it did not require the pilot to fly overhead Taupō and then head south before turning back to intercept the inbound track from reporting point AP506. And thirdly, because it was a shorter route, it offered a not-insignificant timing saving. The forecast deterioration in weather conditions during the late evening would also have had an influence.

Figure 9: Taupo Rwy 35 RNAV Aeronautical Information Publication Approach Plate scaled, georeferenced and superimposed on LINZ Topo250 map, with surveillance data showing deviation and track direct to reporting point MASKU

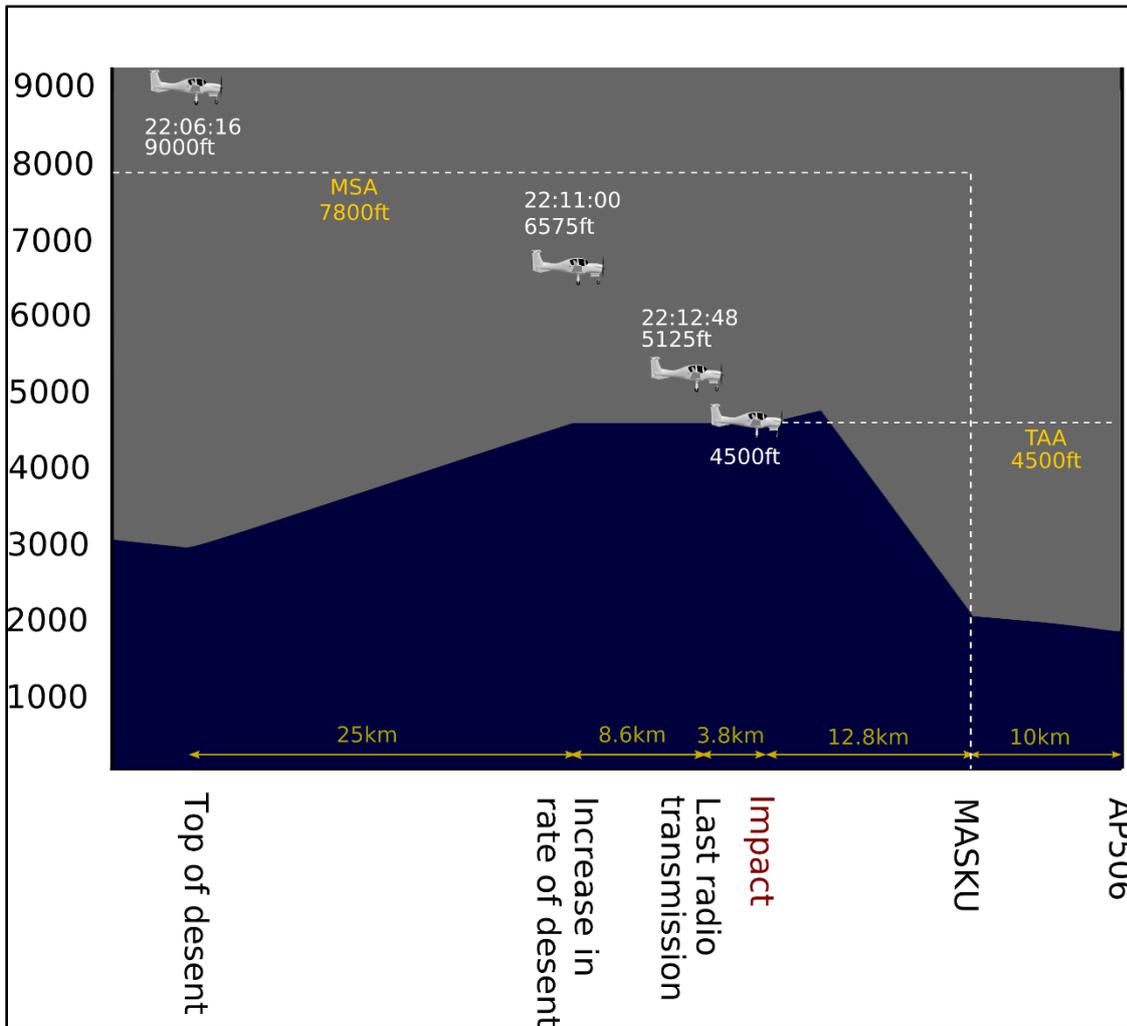
- 1.3. The Transport Accident Investigation Commission (Commission) **found** that the pilot descended the aeroplane below the specified minimum safe altitude for the area in which the aeroplane was being flown, and a controlled flight into terrain occurred.

Figure 10: Relationship between flight profile and MSA/terminal arrival altitude

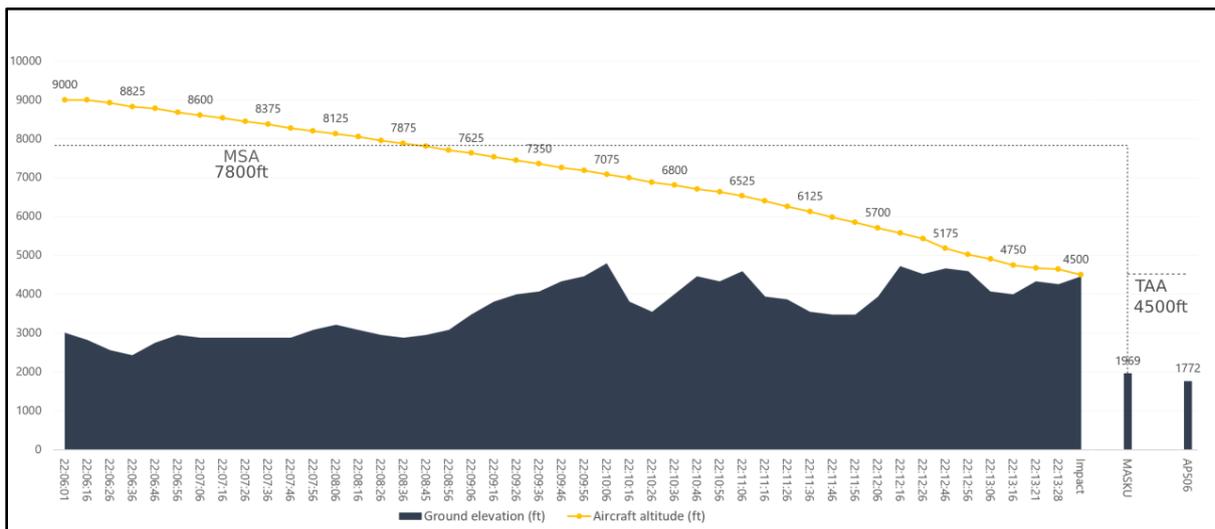
3.33. When considering the forecast weather conditions and the weather reports from the searching helicopter pilots, it was **very likely** that the aeroplane was descending in cloud from 6,000 feet (1,828 m) to the point of collision with the terrain. The pilots therefore would have not been able to visually assess the proximity of the aeroplane to the terrain. The darkness further compounded the situation.

Figure 11: Flight profile from top of descent to ground impact
