Transport Accident
Investigation
Commission

Final report

Aviation inquiry AO-2019-006
Cessna 185A, ZK-CBY and
Tecnam P2002, ZK-WAK
Mid-air collision, near Masterton
16 June 2019

November 2022

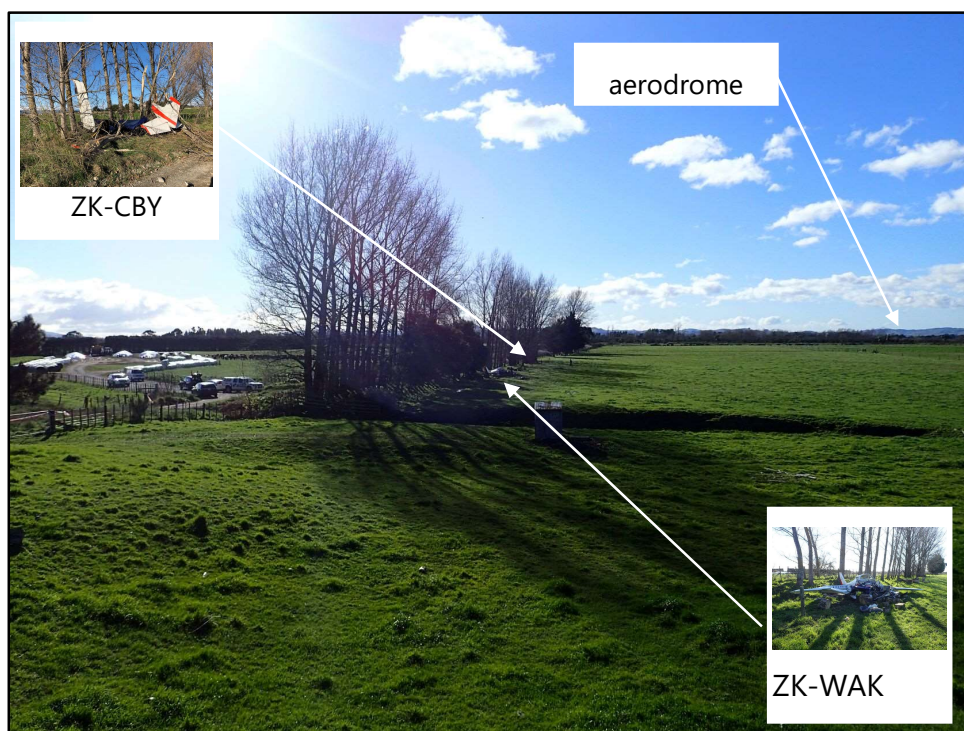
Figure 5: Accident site

- 2.6. At 1112:32, the pilot of ZK-WAK radioed advising "Masterton traffic, Whisky Alpha Kilo is on final for runway 06, full stop Masterton". ZK-WAK and ZK-CBY collided immediately on completion of this transmission.
- 2.7. The pilot of the helicopter reported not hearing the landing call from ZK-WAK, but did see the two aeroplanes collide and spiral to the ground. ZK-CBY caught fire as it impacted the ground. The pilot of the helicopter landed nearby and, along with several witnesses, attempted to assist the occupants. The two pilots suffered fatal injuries (see figure 5).

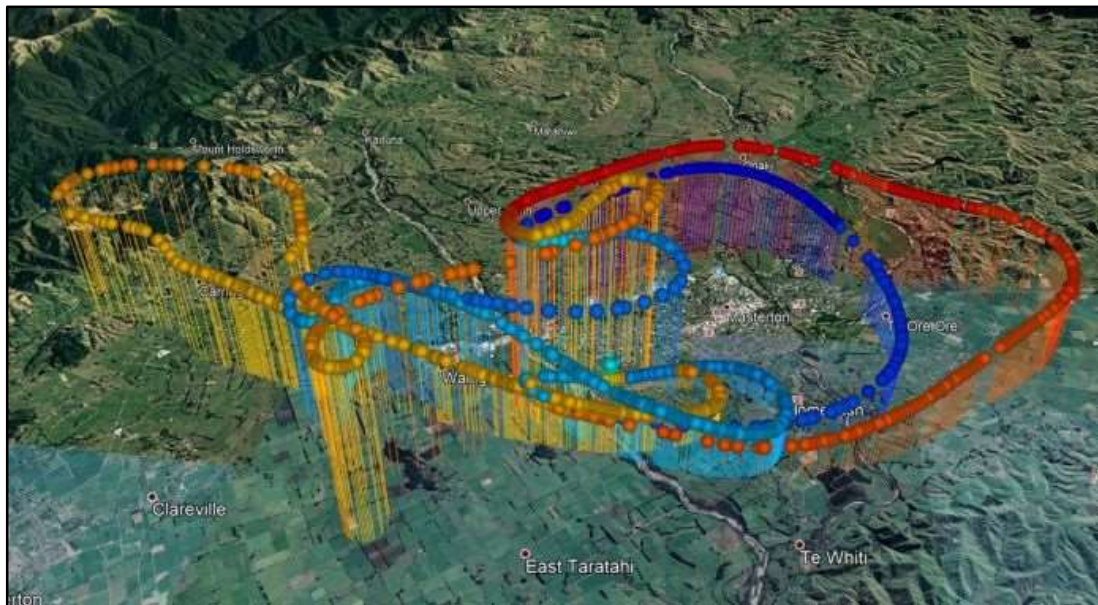
Figure 6: FLARM flightpath

- 2.31. The FLARM tracking data from ZK-CBY for the approximately 30 previous flights were obtained as part of the investigation. The data provided an accurate record of the flightpaths of ZK-CBY from power-up to shut down, including all of the accident flight information (see figure 6).

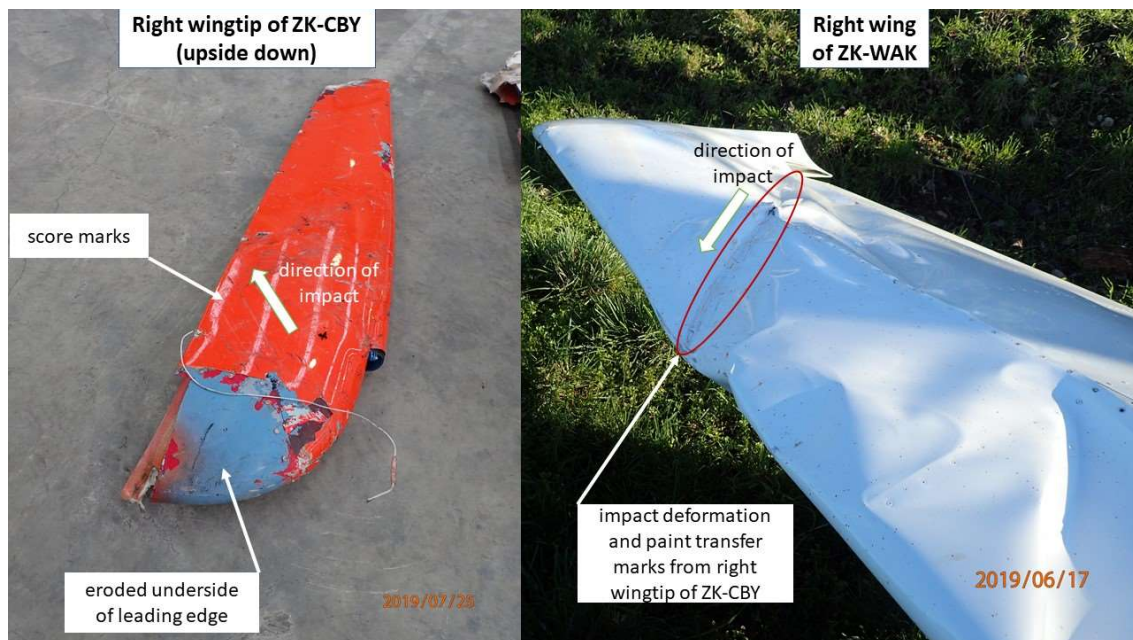
Figure 9: Collision evidence

- 2.52. Examination of ZK-WAK identified rubber transfer marks on the right side of the cabin area, about in line with the aeroplane's seating. Paint transfer was also evident on the right upper wing surface, between 1 and 2 metres in from the wingtip. There were gouging or dents coincidental with the paint transfer marks. The transfer marks were of a pale red or orange colour. This colour matched the colour painted on ZK-CBY. The damage on the upper surface of the right wing of ZK-WAK was also consistent with the damage sustained by the right wingtip of ZK-CBY (see figure 9).

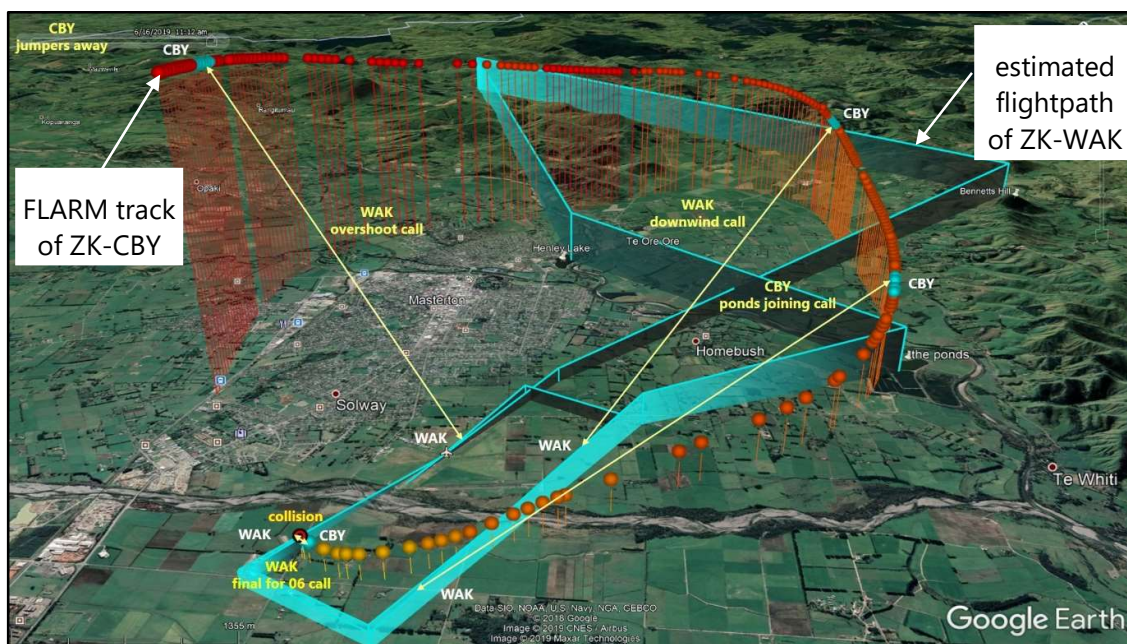
Figure 11: Flightpaths of ZK-CBY and ZK-WAK

Note: The location of ZK-CBY when the calls were made (the blue dots) is based on the FLARM data matched to the recorded timing of the calls so is considered to be accurate. The position of ZK-WAK at these times is approximate.

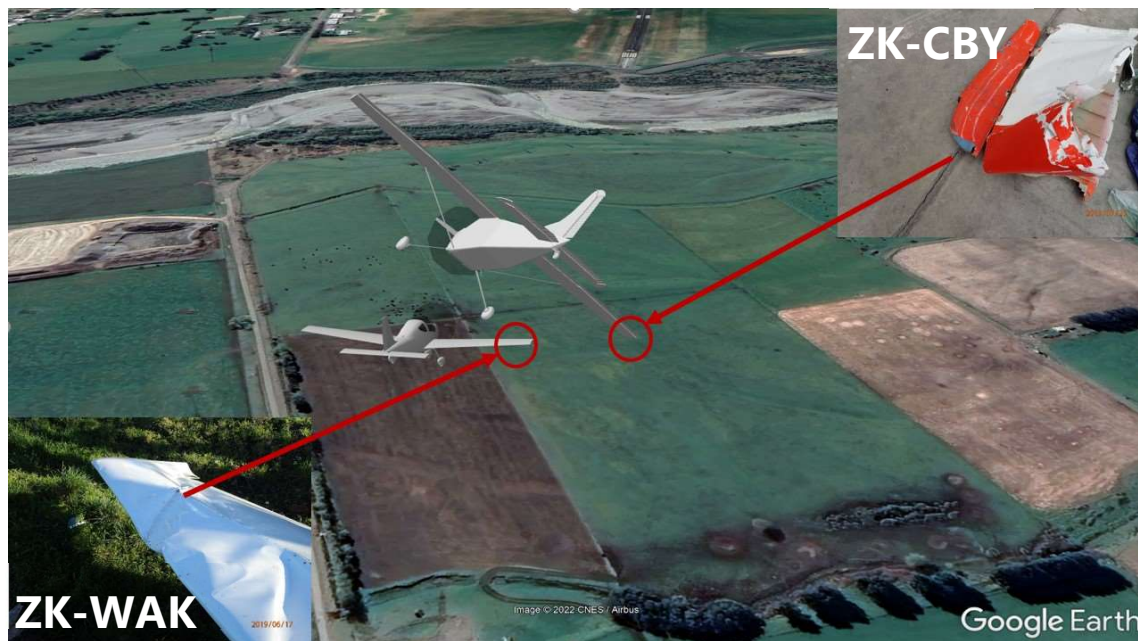
Figure 12: Relative positions shortly before collision
(approximate only)

wing struck the right side of the cockpit and right wing, respectively, of ZK-WAK (see figure 12). The two aeroplanes collided heavily and initially tangled before separating and spiralling to the ground.

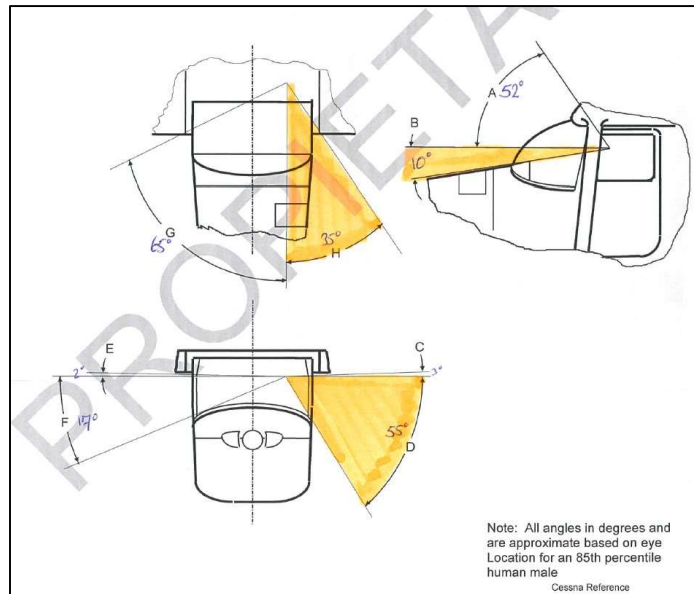
Figure 13: Cessna 185 visibility diagram
(Credit: Cessna Aircraft Company)

- 3.20. Working back from the known collision point and impact angle, the recorded approach path and speed of ZK-CBY and the likely approach speed of ZK-WAK,³⁰ it was possible to determine the approximate relative bearings of the two aeroplanes leading up to the collision. From this, it was determined to be **very likely** that the pilot of ZK-CBY's view of ZK-WAK would have been obscured by the aeroplane's engine cowling in the approximately 15–20 seconds leading up to the collision.
- 3.21. During training, pilots are taught about blind spots and the need to check these areas to ensure they are free of potential hazards. This may be by moving the head and upper body, or by manoeuvring the aircraft. To assist in locating and identifying other aircraft, pilots can also use their radios if fitted.
