Transport Accident  
Investigation  
Commission

***Aviation inquiry AO-2020-001***

***Pacific Aerospace Cresco 08-600, ZK-LTK***

***Impact with terrain***

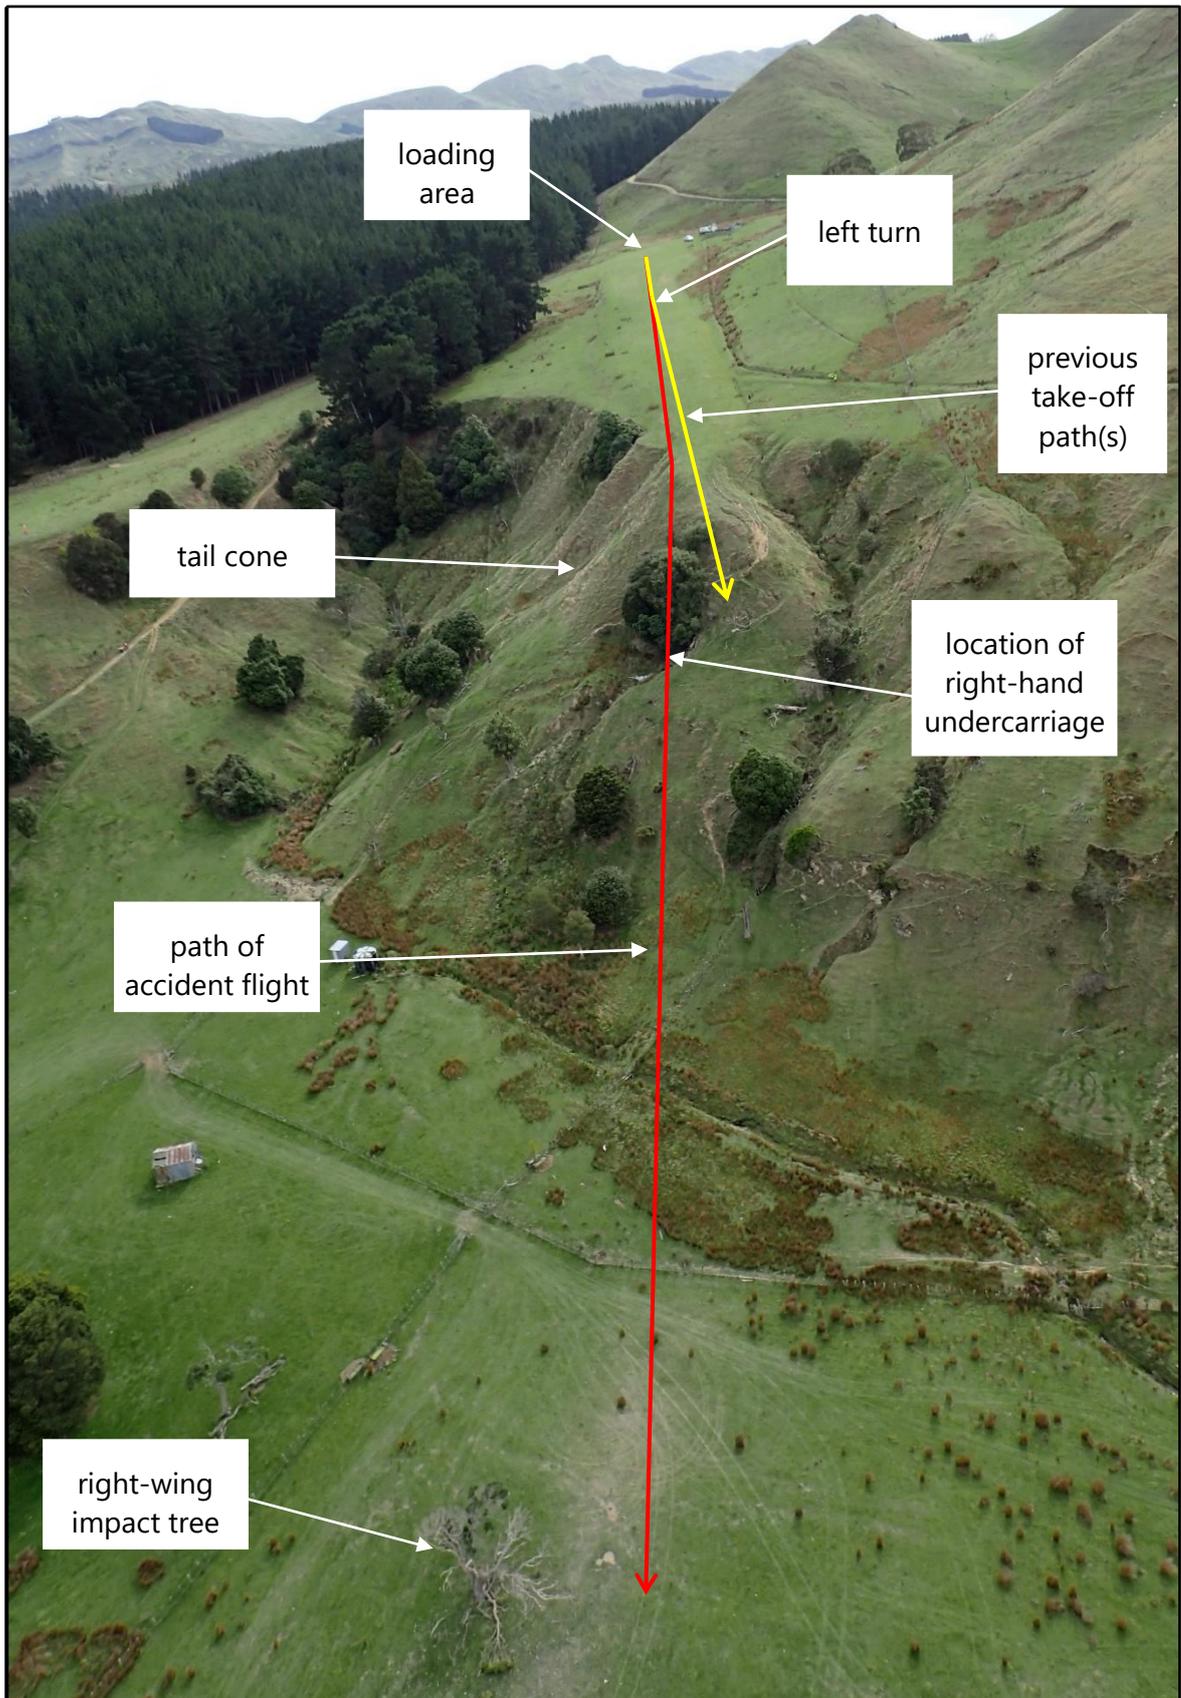
**Figure 3: Reverse view of airstrip**

- 2.2. Spreading operations commenced at 0700, with the first and second flights taking about four minutes each, with about a one-minute turnaround to reload between flights. The loader driver reported talking to the pilot on the radio during the first two flights. The take-off path used for the first two flights had a left turn of about 5 degrees, approximately a third of the way down the take-off roll<sup>4</sup> from the loading point (see Figure 3).

- 2.3. The third flight take-off roll commenced at about 0710 with the same weight of product as loaded in the previous two flights. The aeroplane was observed by witnesses to accelerate normally. Wheel marks on the airstrip indicated the aeroplane did not turn left as required. Rather it continued in a straight line from the loading point area, crossing increasingly uneven and rough terrain.

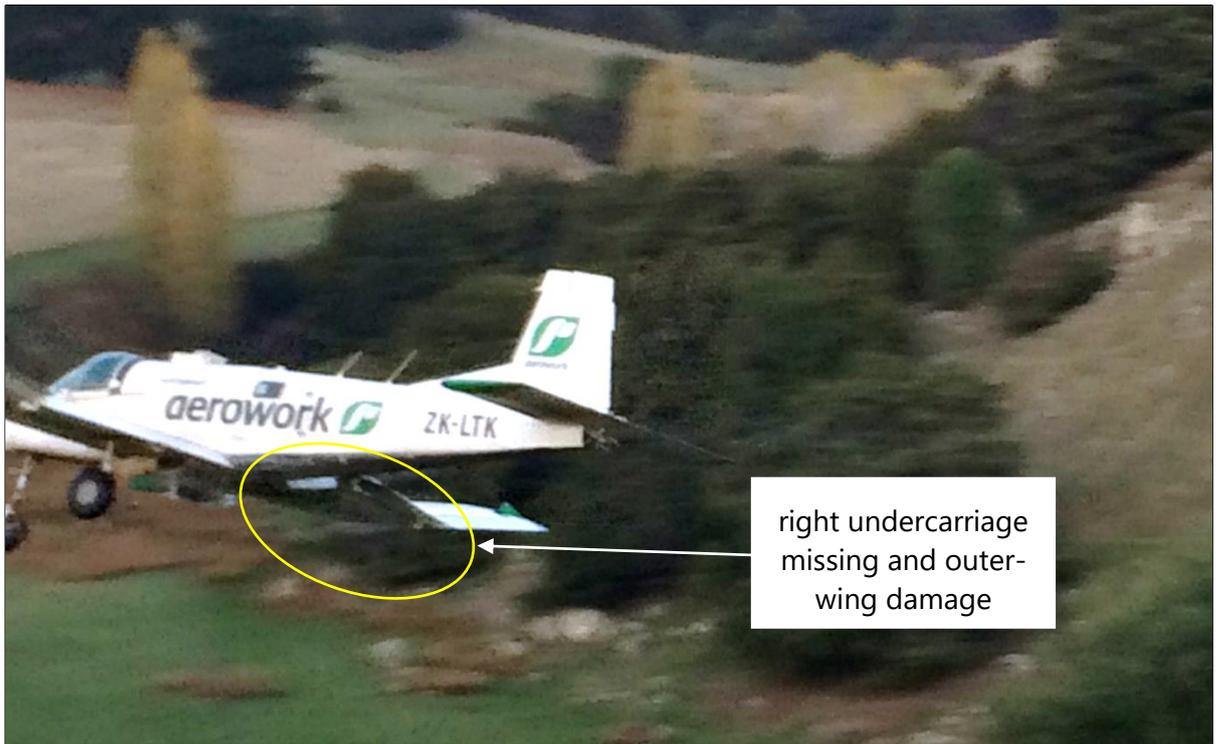
- 1.8. The aeroplane's veering off the airstrip and striking rough terrain caused the right main undercarriage attachment bolts to break and the complete undercarriage assembly to separate. The undercarriage assembly then struck and partially dislodged the right wing flap.

**Figure 7: Undercarriage missing and right-hand-wing damage  
(Credit: G Saunders)**

- 2.26. The right main undercarriage separated from its mount point in the right wing as a whole assembly early in the accident sequence. To establish the likelihood of this being a causal factor in this accident, a specialist in metallurgy examined the right main undercarriage. The specialist determined that:

...The leg failed from the wing structure as a result of the wheel being forced backwards and upwards into the wing structure as a result of a single high load impact. Failure will have occurred to the lower support clamp before a significant bending load was applied to the upper bolts. There was no evidence of any pre-existing damage to the clamping system such as fatigue or significant loss of section due to corrosion.

- 3.11. Undercarriage. An expert analysis of the undercarriage attachment points showed that the undercarriage had been dislodged in a single high-impact event during the accident sequence and had been a result of the accident and not a causal factor. According to pilots experienced on this aircraft type, the subsequent damage to the control surfaces on the right-hand wing, and the dissymmetry of lift that resulted, would have made the aeroplane uncontrollable from that point onwards.

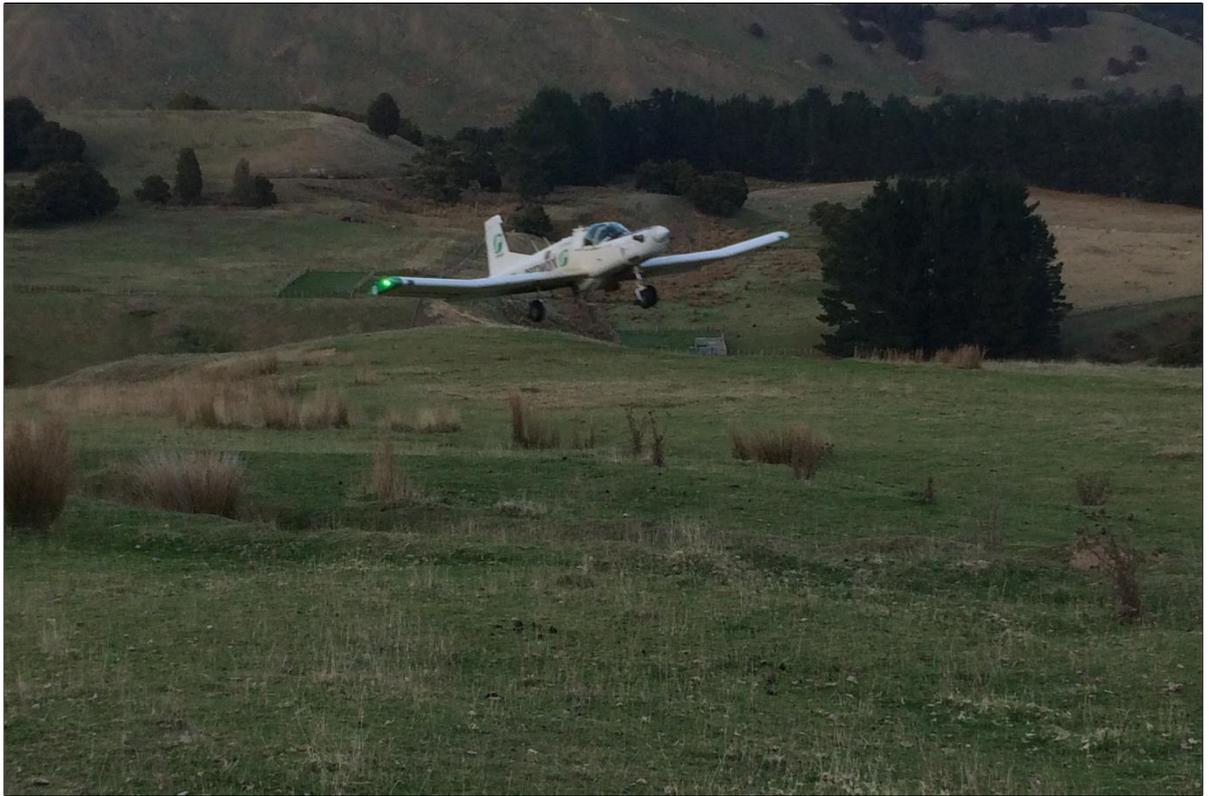
**Figure 8: ZK-LTK landing immediately prior to accident flight  
(Credit: G Saunders)**

- 3.6. Sunstrike. The early time of day<sup>12</sup>, combined with high ground to the east of the airstrip and the high overcast cloud, resulted in flat light conditions at the time of the accident (see Figure 8). This made it **exceptionally unlikely** that the pilot suffered sunstrike during the accident sequence – noting that this was their third take-off in 10 minutes and there had been no previous problems reported or observed.
