Transport Accident
Investigation
Commission

Aviation inquiry AO-2020-001

Pacific Aerospace Cresco 08-600, ZK-LTK

Impact with terrain

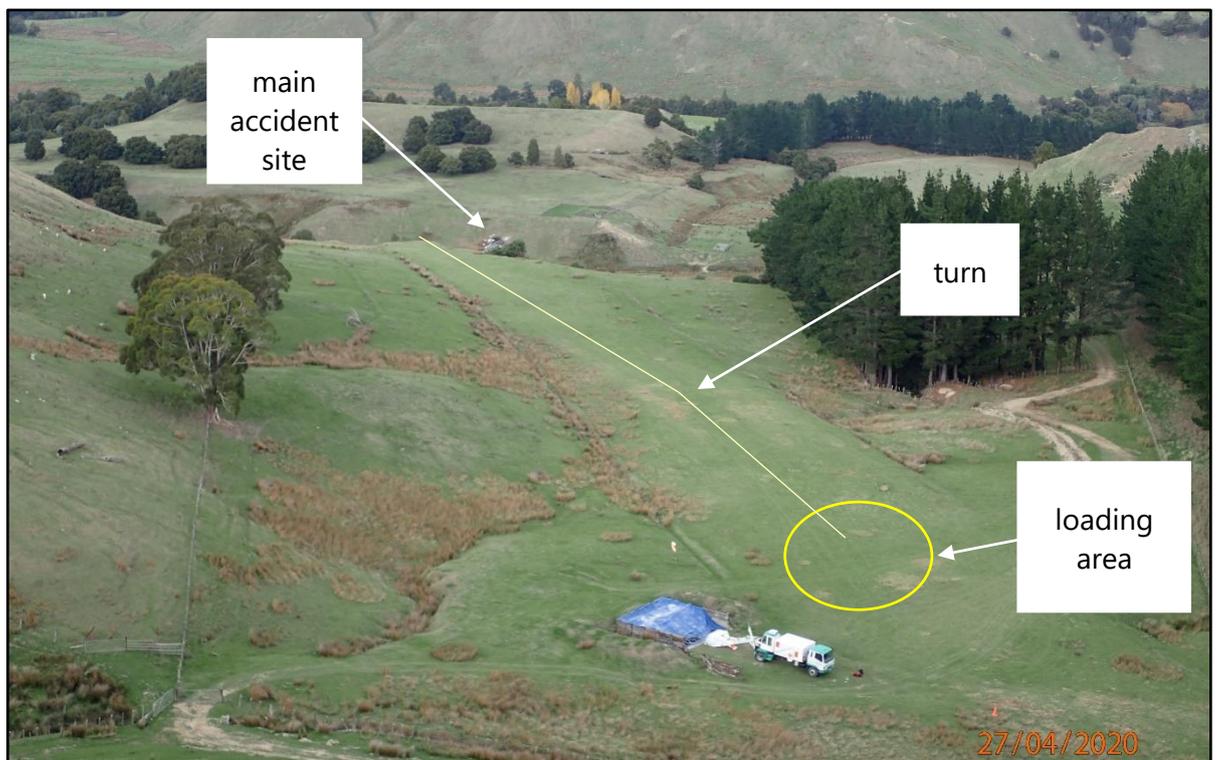
Figure 4: The airstrip from behind the loading area

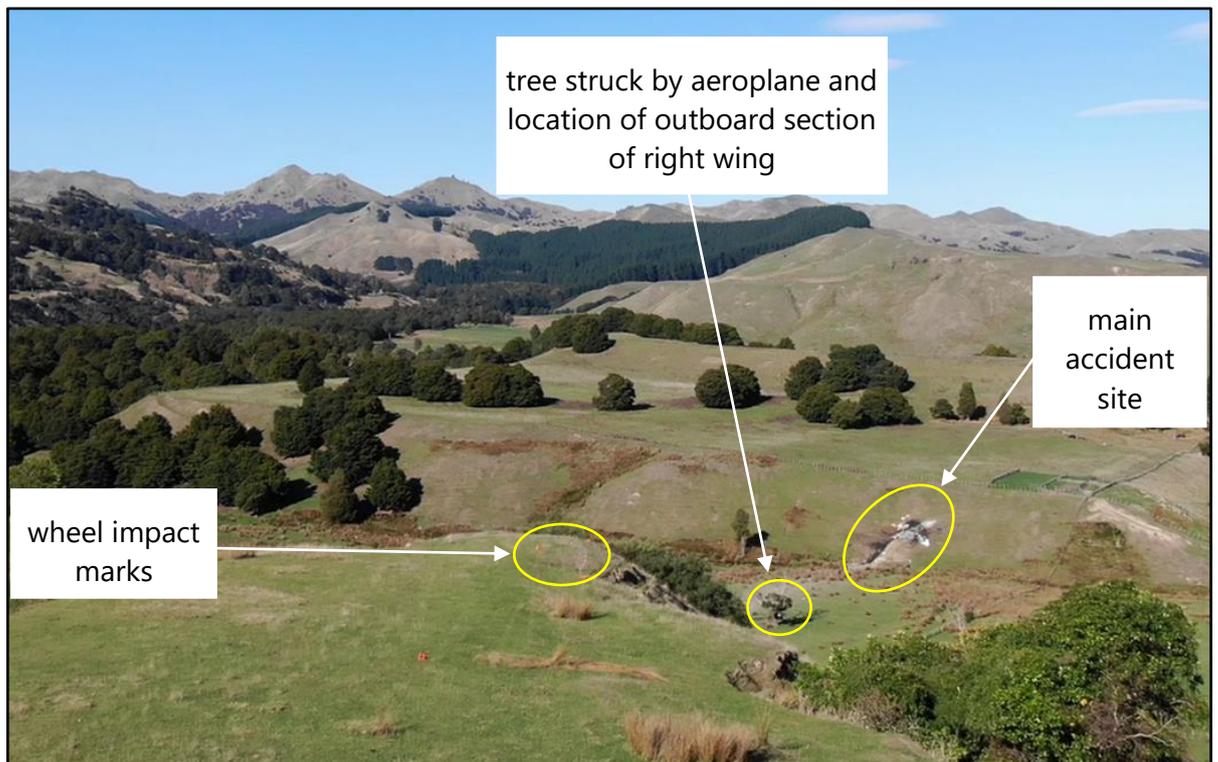
- the aeroplane was found inverted about 20 metres up slope from the final impact point
- all available flight-control-system components were assessed for control continuity and function, with no pre-existing defects identified
- the propellor blades, located at the final point of impact, showed rotational damage, indicating the engine was delivering power at the time of ground impact
- the outboard portion of the right wing was found near a tree located about 70 metres before the main wreckage site
- the right undercarriage leg and wheel, as a complete assembly, were found at the base of the slope at the end of the airstrip
- the tail cone was found down the slope, next to the end of the airstrip on the right-hand side (see Figure 3).

Figure 5: Accident site from the end of the airstrip

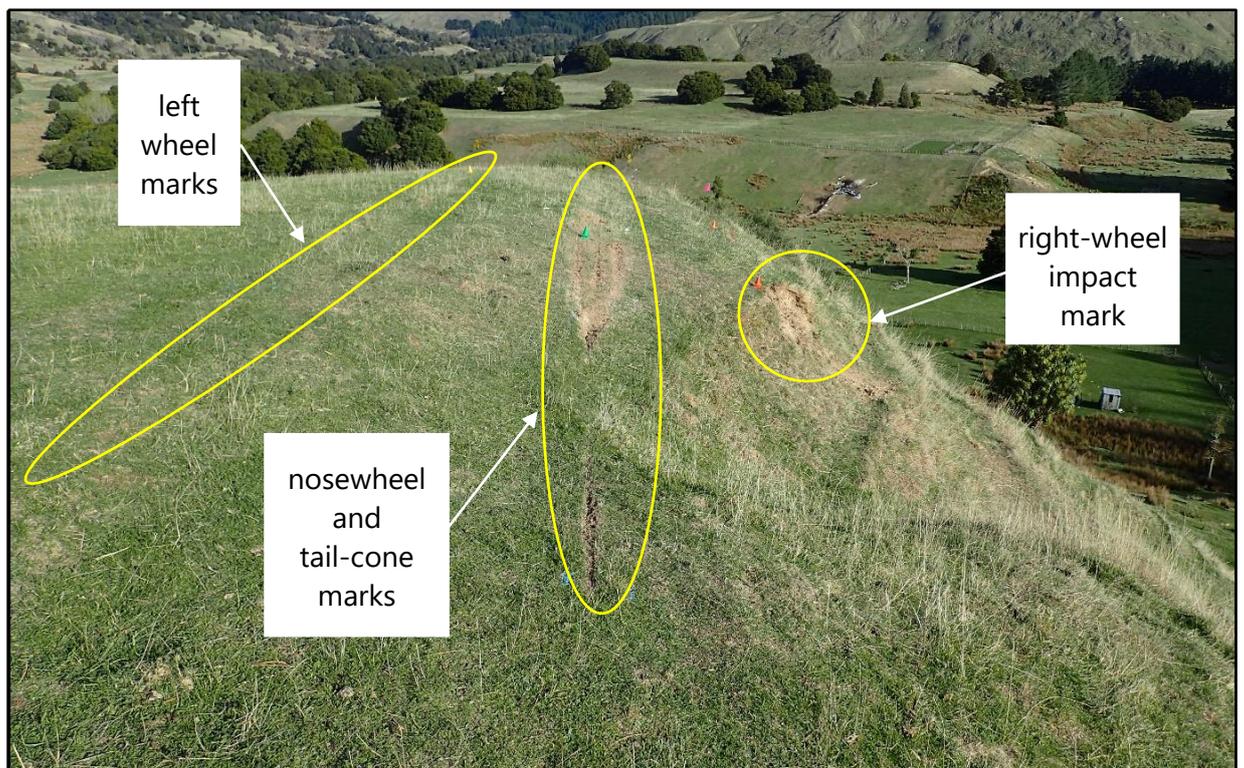
- 2.3. The third flight take-off roll commenced at about 0710 with the same weight of product as loaded in the previous two flights. The aeroplane was observed by witnesses to accelerate normally. Wheel marks on the airstrip indicated the aeroplane did not turn left as required. Rather it continued in a straight line from the loading point area, crossing increasingly uneven and rough terrain.

Figure 6: Ground scars at the end of the airstrip
