Aviation inquiry AO-2020-003

Eurocopter EC120-B, ZK-HEK

Loss of control in flight and collision with terrain

March 2023

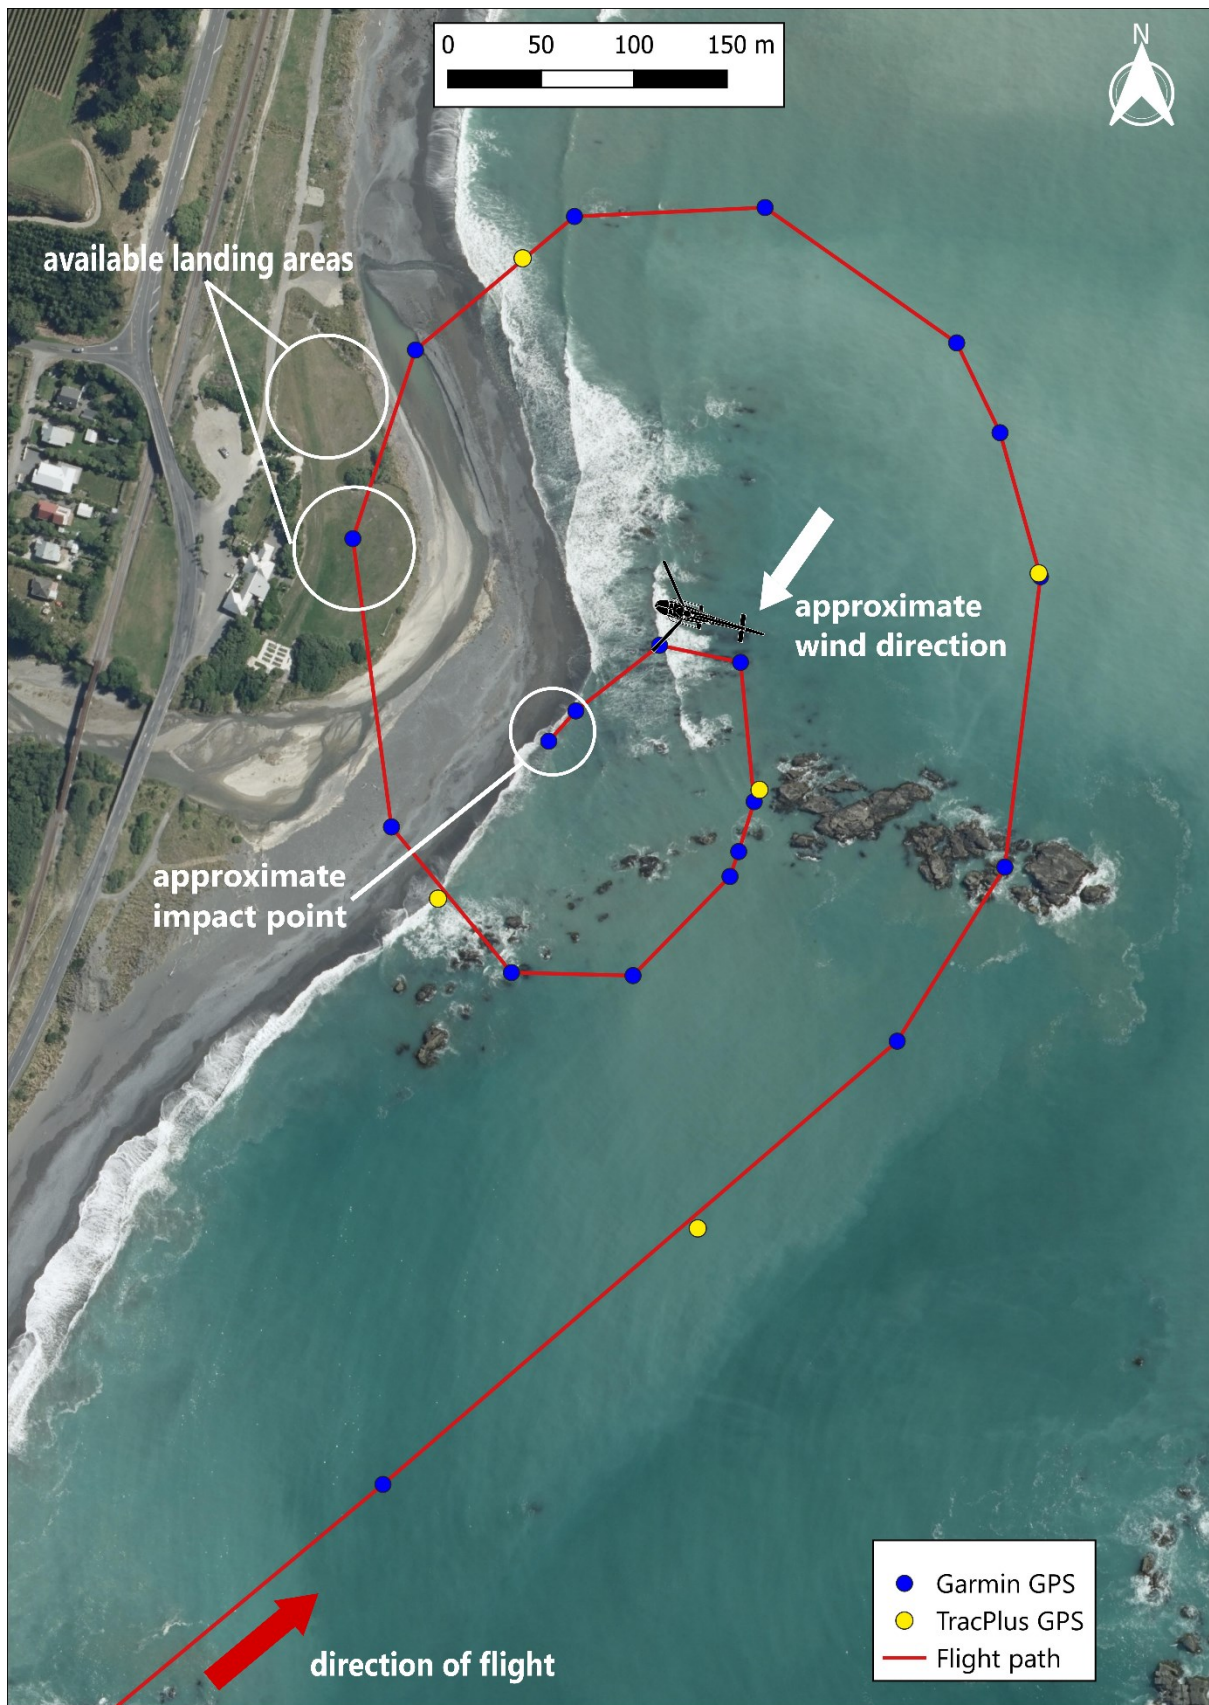
Figure 3: Flightpath of ZK-HEK

³ For figure 3, the tracking information was sourced from the onboard Garmin GPS and TracPlus™ tracking systems and Airways New Zealand's tracking data. The EC120-B helicopter pictured in the diagram is not to scale but demonstrates the orientation of the helicopter relative to the wind direction as it conducted the second orbit.

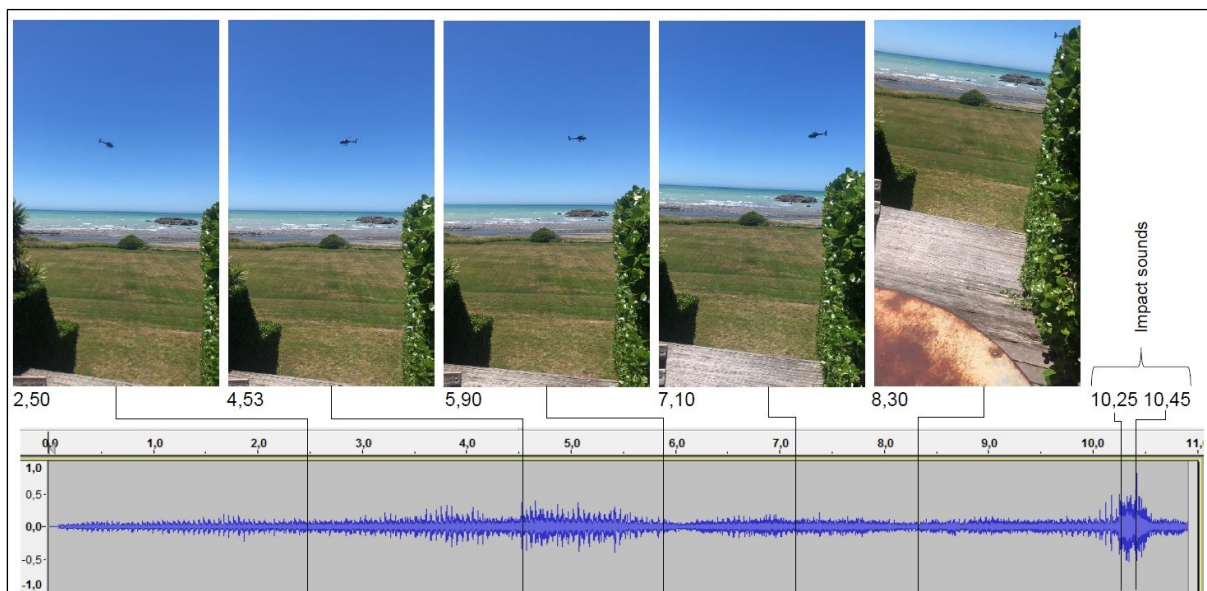
Figure 4: Images and soundtrack from video recording

- 2.28. Two witnesses to the accident collectively took three short video clips of the helicopter as it approached the beach, and as it started to spin and descend onto it. The two witnesses were on the eastern side of the café and had an unobstructed view of the helicopter until it disappeared behind some bushes.
- 2.29. The three video recordings also included audio. The final video captured the sound of the helicopter as it descended behind the bushes and crashed on the beach. The audio clips were analysed to identify, among other things, the main rotor and tail rotor speeds (see figure 4).

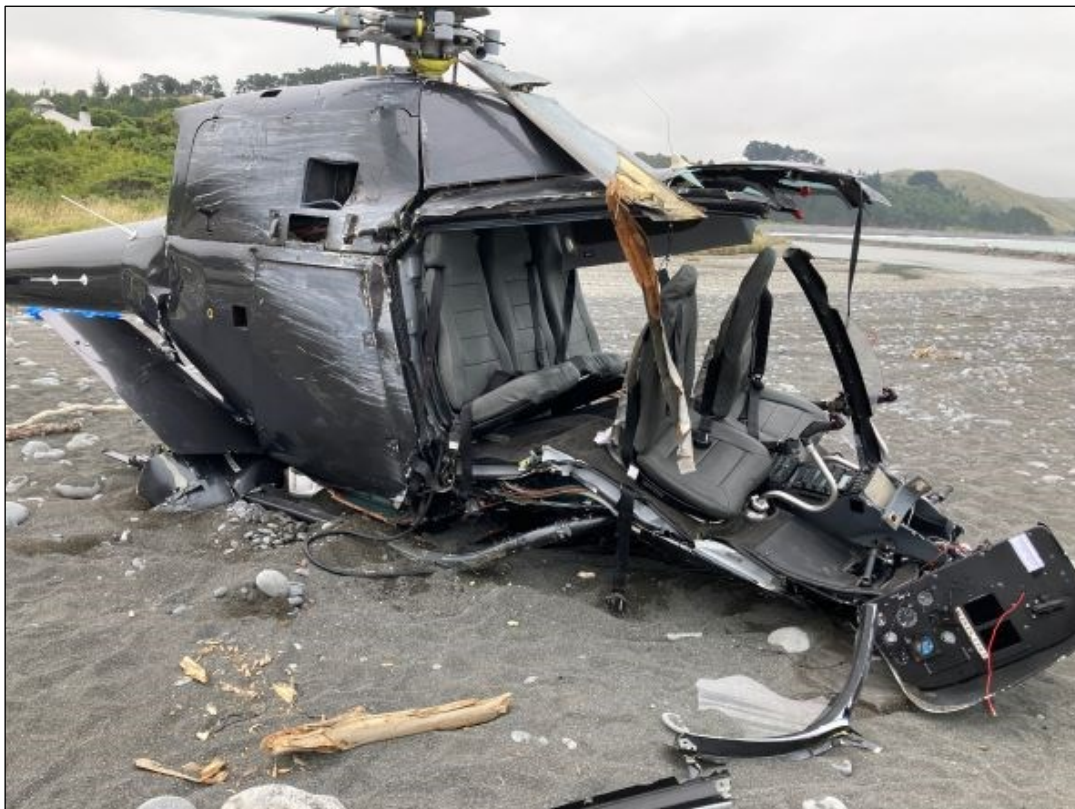
Figure 5: Righted wreckage

- 2.36. The helicopter was lifted upright for safer access and eventual removal (see figure 5). The fuel tank was confirmed intact and still contained fuel. Nearly 300 litres were later drained from the tank. The fuel was determined to be of the correct type with no identifiable contamination. The fuel supplier for the installation at Rangiora Aerodrome confirmed that following the accident the installation was examined and that testing of the fuel found no anomalies.

- 2.39. Both landing gear skids were splayed outwards and had broken at their rear cross-tube attachments, which were bent backwards. Scrape marks along the right side of the fuselage were consistent with the helicopter being towed up the beach on its right side.

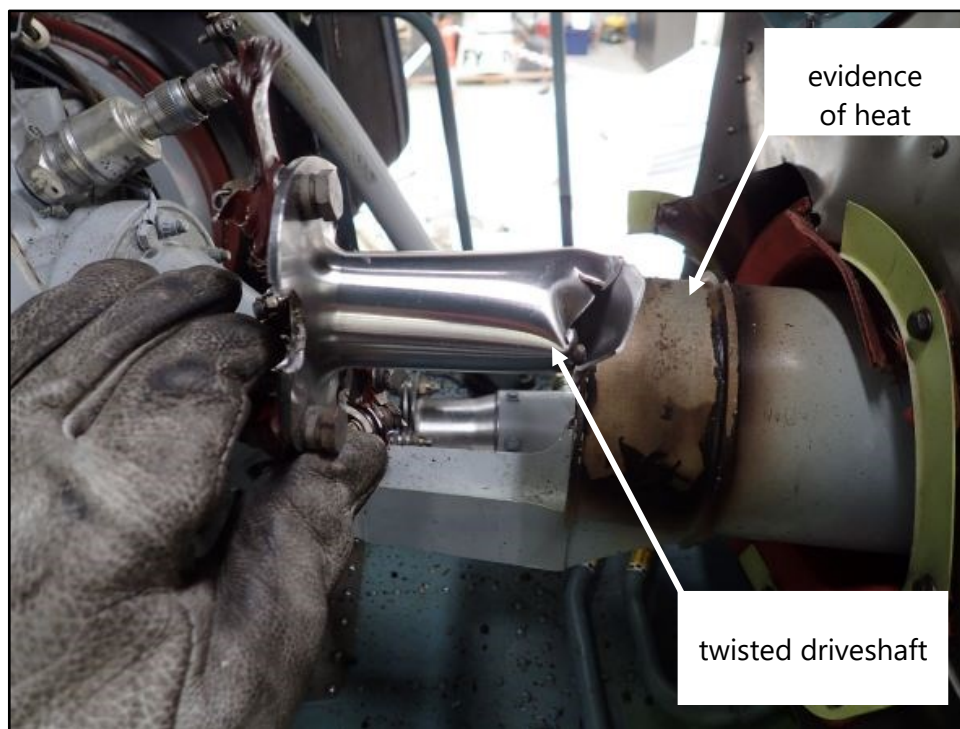
Figure 6: Engine-to-transmission driveshaft

- 2.43. The coupling between the engine and the transmission, termed the main gear box on the EC120-B, had broken. The direction of twisting of the coupling components was consistent with the engine continuing to try to drive the transmission (which in turn drives the main and tail rotor) until separation. There was evidence of heat damage at the engine end of the coupling as the now unrestrained engine oversped until it stopped. This was consistent with witness reports of hearing a high-pitched noise immediately after the accident and a light-coloured smoke coming from the engine bay area for a few minutes afterwards. There was no other evidence of fire (see figure 6).

- 3.11. Immediately after the main rotor blades struck the beach, the engine continued to try to drive the transmission, resulting in the coupling between the two breaking. The unrestrained engine then oversped. This resulted in the high-pitched noise, the transmission coupling displaying evidence of overheating and the light-coloured smoke observed by the witnesses immediately after impact.

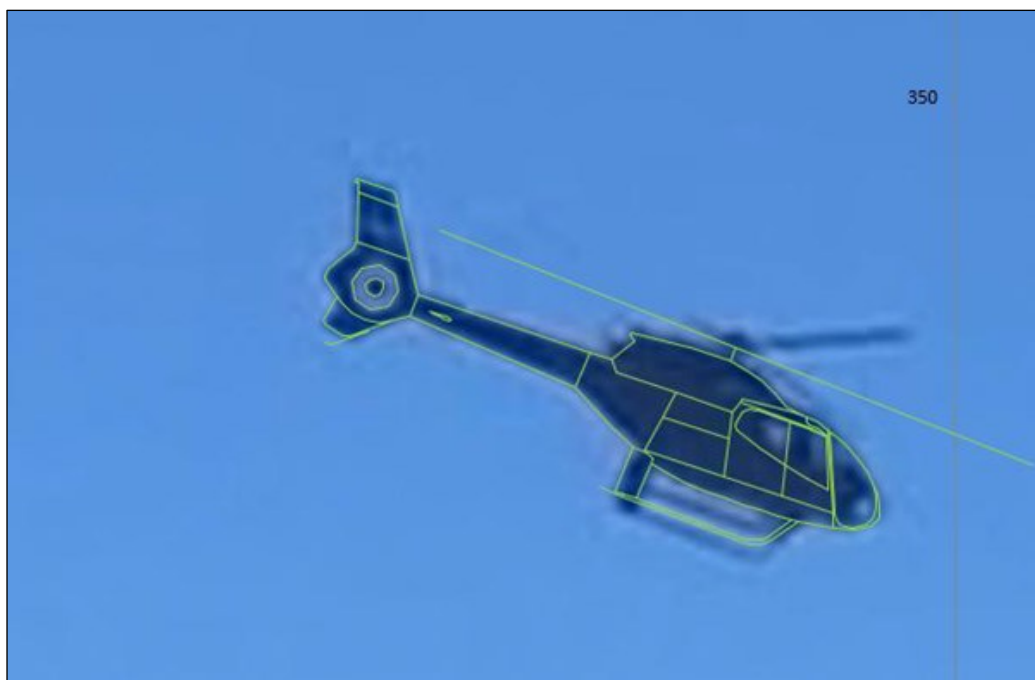
Figure 9: Helicopter attitude

- 3.49. In preparation for the flight the pilot had contacted staff at the café to confirm the weather conditions were suitable for it, which they were. The pilot had flown past Kekerengu before, but never landed there. So, after reaching the area the pilot positioned out to sea, turned left and completed one pass of the intended landing area. The helicopter was being turned back towards the beach a second time when it suddenly commenced yawing left. The video recordings show the helicopter was nose low as it started to yaw. A nose-down attitude is an indicator of a helicopter being accelerated into forward flight (see figure 9).

- 3.50. It was therefore considered **very likely** that the pilot was undertaking a second low-level reconnaissance of the landing site when the helicopter started to yaw. The pilot **likely** intended to fly to the south for a short distance before reversing the turn and approaching the landing area into the prevailing wind.

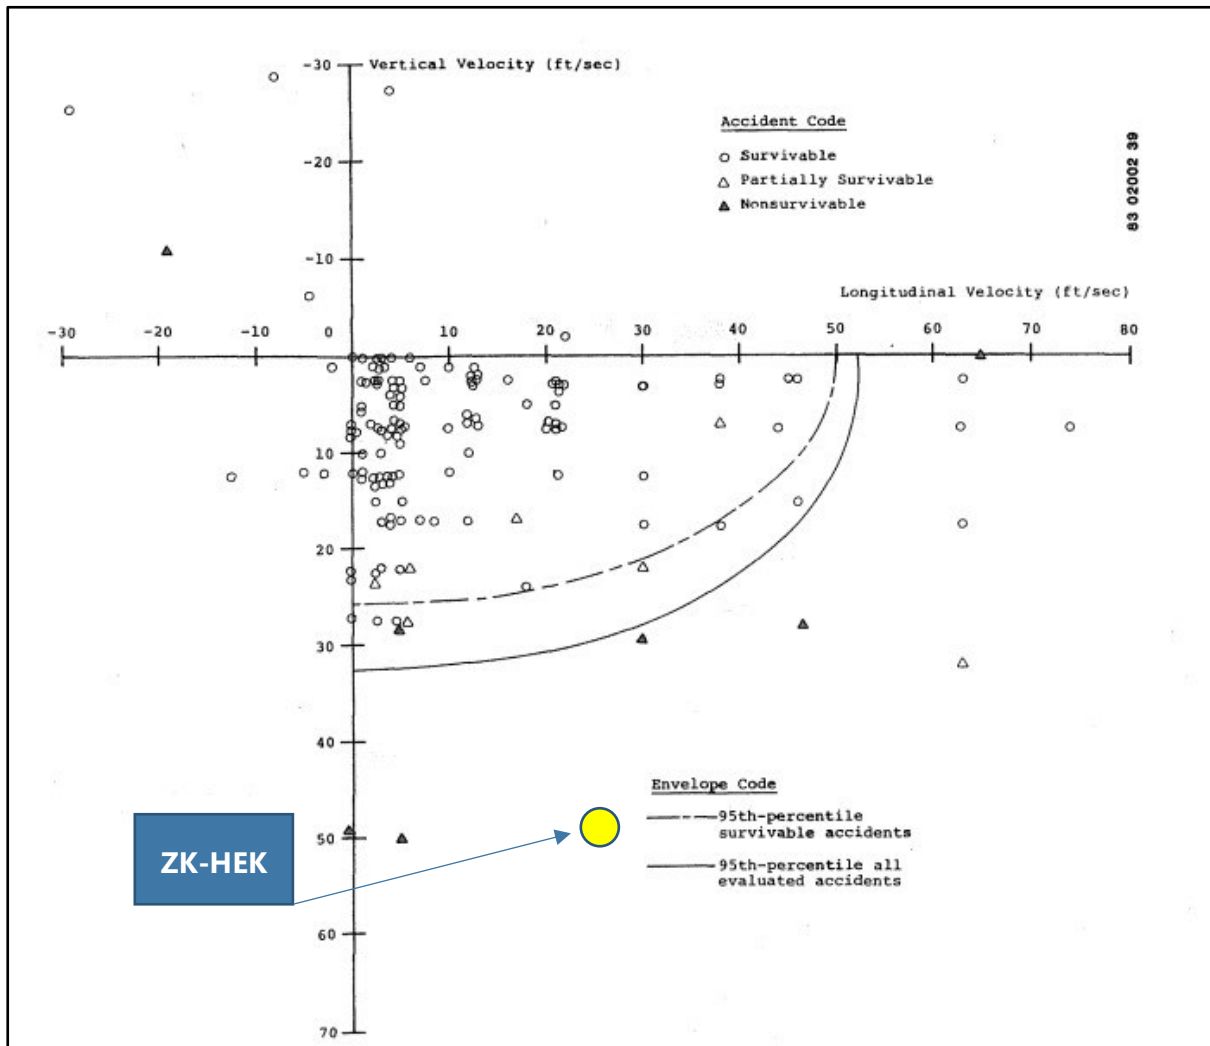
Figure 10: Impact forces
(Credit: United States Federal Aviation Administration, 1985)

- 3.59. The smaller physical size of the children meant that the disruption to the cabin was also not as critical. There was still survivable space available. Also, the smaller mass of the three children meant that their seats were able to better absorb the impact forces. Nevertheless, they still sustained a range of moderate-to-serious injuries. The prompt action of the witnesses and emergency services assisted in managing their injuries.
- 3.60. Airbus Helicopters' analysis of the damage determined that the impact forces were well beyond the level of crash protection for aircraft, including for helicopters, recommended by the United States Federal Aviation Administration (see figure 10).

- 4.5. The rate of yaw increased, and the pilot was unable to regain control before the helicopter struck the beach.
- 4.6. The impact forces far exceeded the recommended level of crash protection for aircraft.
