Transport Accident
Investigation
Commission

Final report

***Aviation inquiry A0-2021-001
Kavanagh Balloons E-260, ZK-FBK
Hard landing and ejection of occupants
Wakatipu Basin, near Arrowtown
9 July 2021***

May 2023

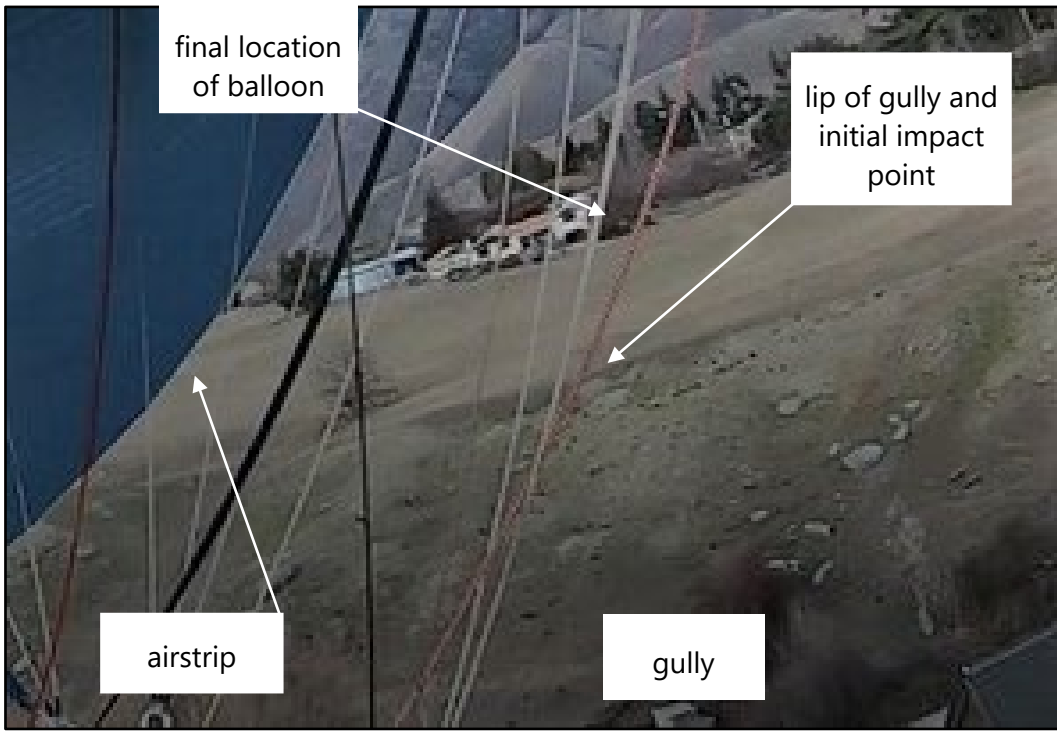
Figure 5: Approaching to land, taken from onboard video camera
(Credit: Sunrise Balloon Adventures)

- 3.9. The navigation and video recordings show that as the balloon approached the lip of the gully, the groundspeed reduced by a small amount. This would have been a direct result of the wind speed decreasing. It resulted in the descent path steepening. The balloon's proximity to the ground meant there was insufficient time for the pilot to add power (heat) to reduce the rate of descent and correct the approach profile. The steepened descent resulted in the basket striking the side of the gully just below the lip. This caused a sudden slowing of the basket, which then bounced and trailed behind the envelope. Two passengers were ejected from the basket during this time. The balloon then dragged for some 150 m, breaking through a deer fence and coming to rest near the farmhouse.

- 3.27. The fast groundspeed meant it was important to land as early and as safely possible on the flat portion of the paddock. However, given the gustiness of the wind it would have been prudent to have aimed to land a short distance, possibly 5-10 m further into the paddock. This would have ensured there was a margin of safety available should something unforeseen occur. It is standard aviation practice for any aircraft approach to have an aim point inset from the start of the landing area. This can be brought closer as conditions permit and a safe landing is assured.

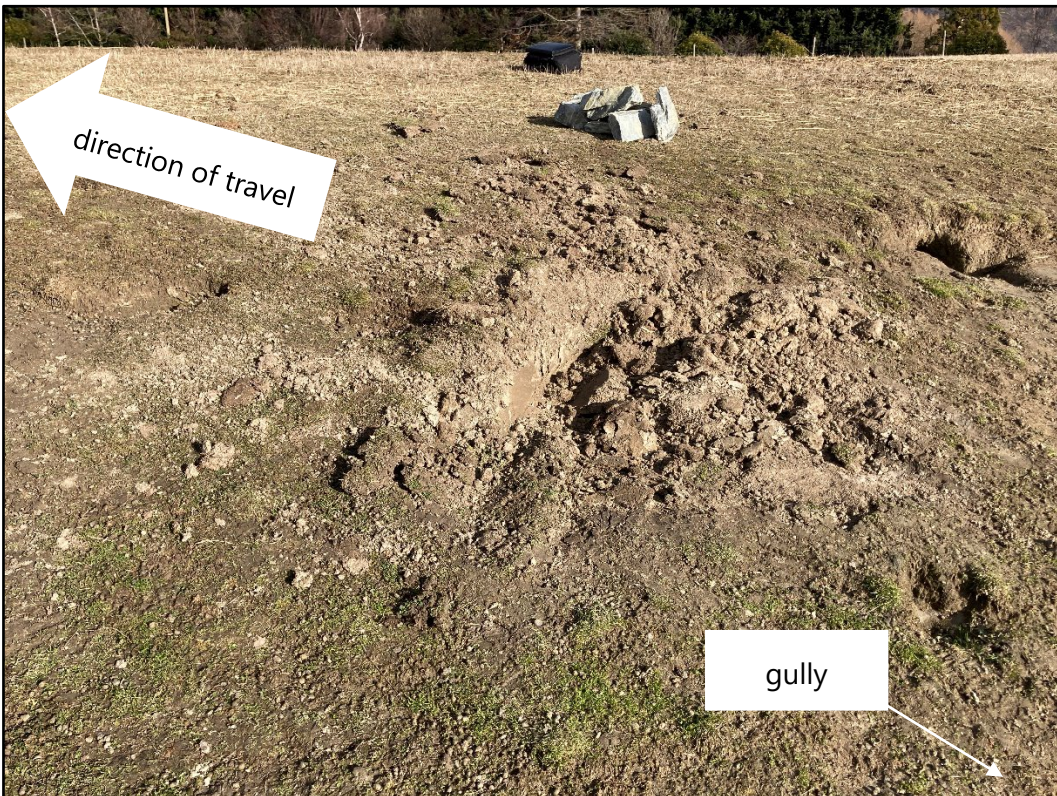
Figure 6: Impact point

- 4.5. The pilot was ejected from the basket because they were not wearing the restraint harness fitted to the basket.
- 4.6. A decrease in the wind speed in the last few seconds caused the balloon to dip and the basket to strike the lip of the gully.

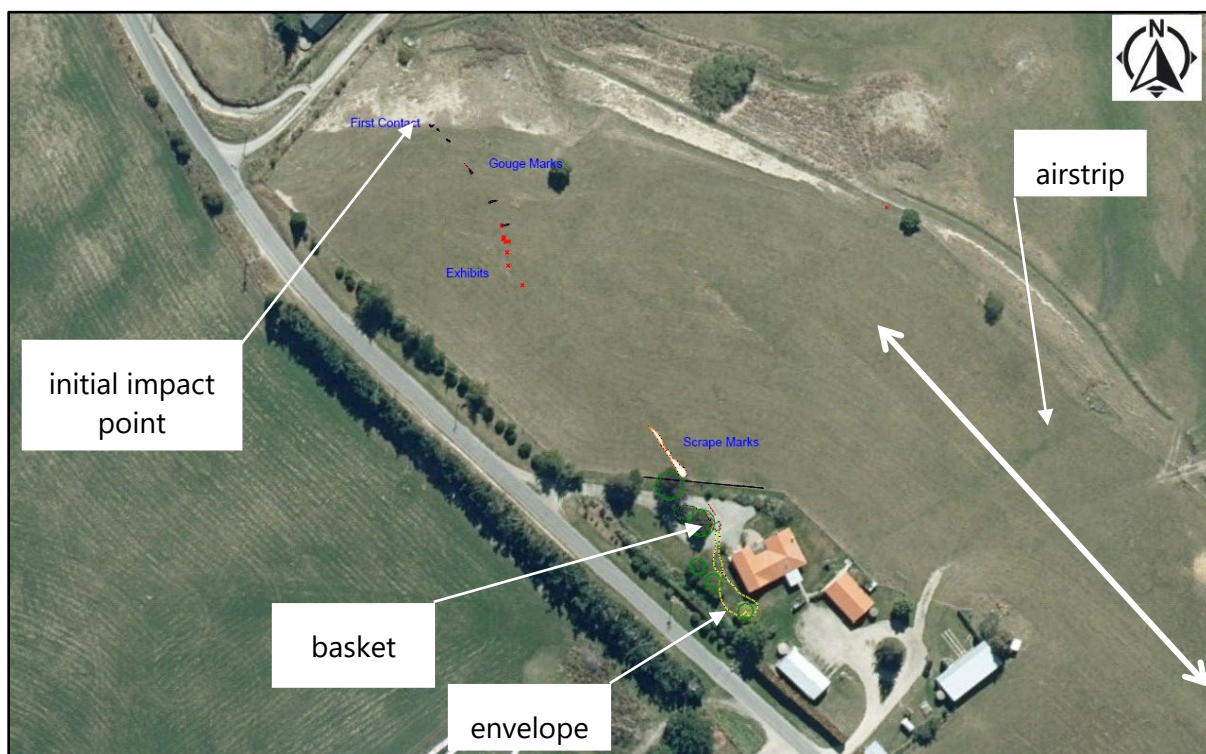
- 2.39. The balloon sustained minor damage, with several small tears in the envelope and some broken basket cane, and webbing along the rim of the basket tore near one corner.
- 2.40. The Commission investigators confirmed that the gas bottles were undamaged and still partially full post the accident.
- 2.41. On 13 August 2021, under the supervision of Commission investigators, the balloon underwent an inflation test. The test confirmed that all the burners and control lines²³ functioned as designed. Other than the damage detailed above, no faults were found.

Figure 8: Accident site
(Credit: New Zealand Police)

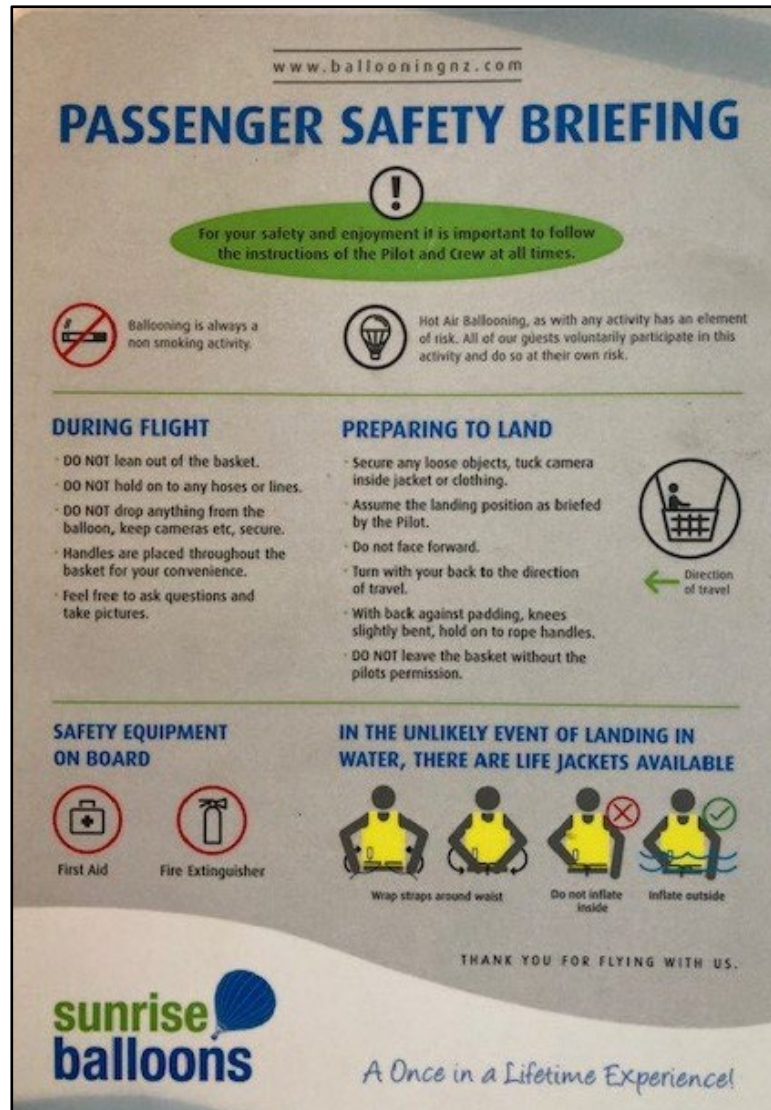
- 3.14. Once in the basket, the passengers were given passenger safety briefing cards. The cards consisted mainly of wording, with some small supporting figures, of which one accompanied the landing instructions. This showed a person appearing to be standing upright with their back to the direction of flight. The reverse side of the card repeated the information but in Mandarin (Chinese). See Figure 9.

Figure 9: Passenger briefing card
(Credit: Sunrise Balloon Adventures)
