Transport Accident
Investigation
Commission

Final Report

Aviation inquiry A0-2021-003
Airbus Helicopters AS350 B3e, ZK-ITD
Loss of control in flight
Lammerlaw Range,
40 km northwest of Dunedin Aerodrome
16 September 2021

November 2023

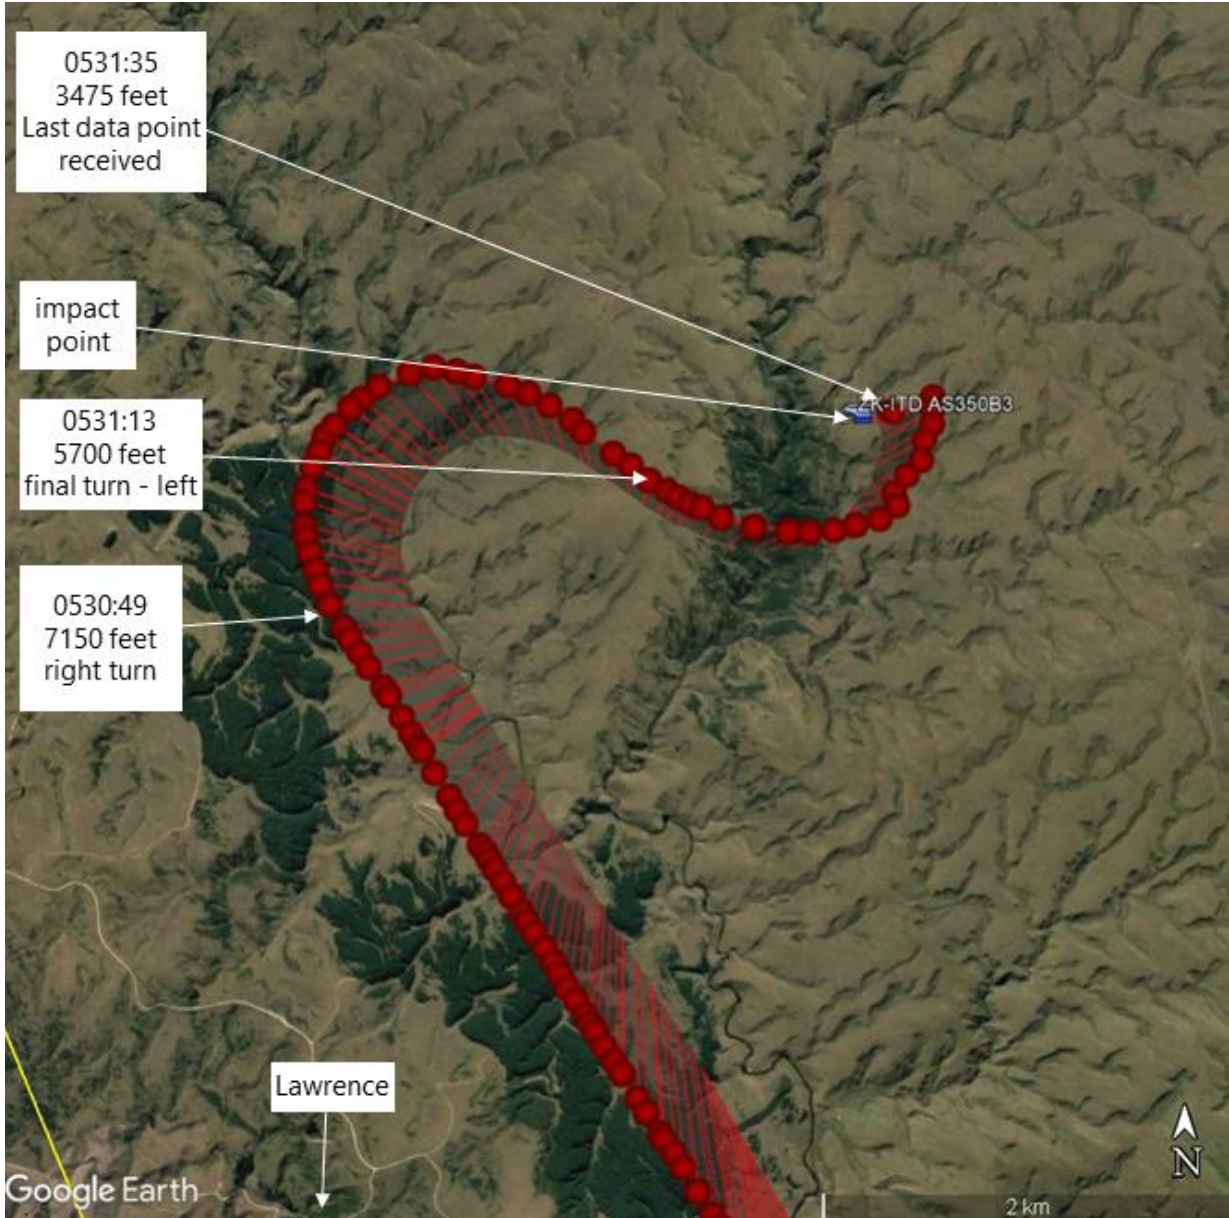
Figure 4: Final minutes of the flight path

2.3. The last ADS-B data point was received at 0531:35. At that time the helicopter was at an altitude of 3475 ft (1060 m) amsl and on a track of 293 degrees (see Figure 4). There were several data points recorded after this time; however, they were determined to be 'coasted'⁵ data points and not from the helicopter. Moments later the helicopter struck the ground in a near vertical nose-down attitude, at an elevation

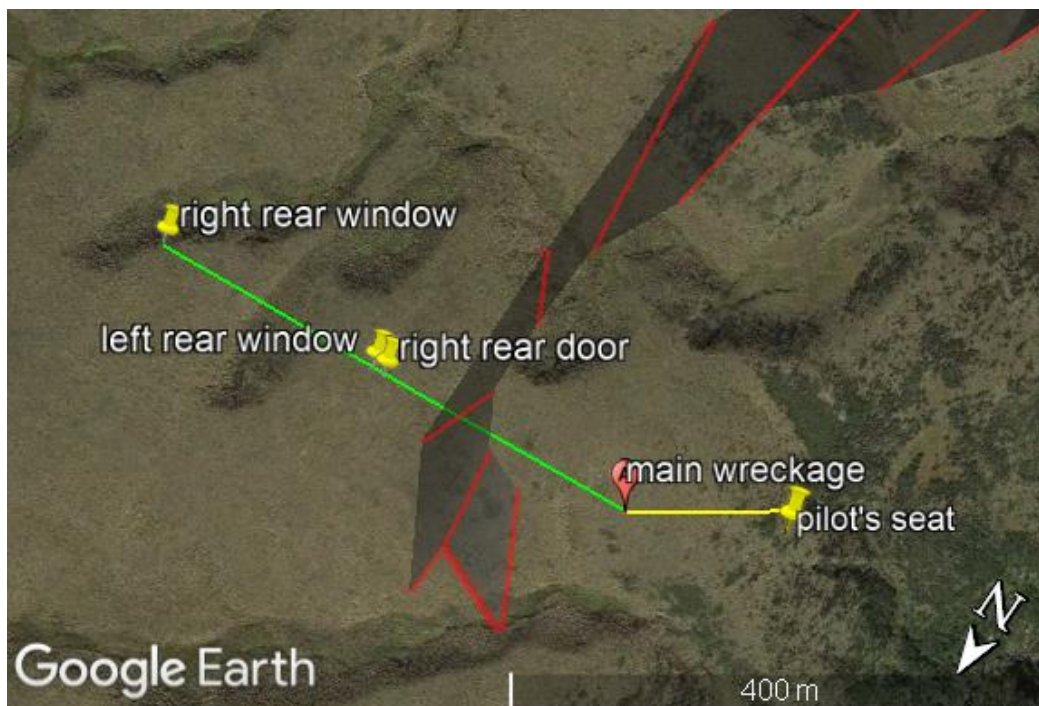
2.58. The rear section of the tail boom²³, including the tail rotor and tail rotor gearbox were largely intact with damage consistent with the impact forces received, and located to the north side of the initial impact point.

Figure 7: Location of main wreckage relative to rear door and windows (340 m to right rear window)

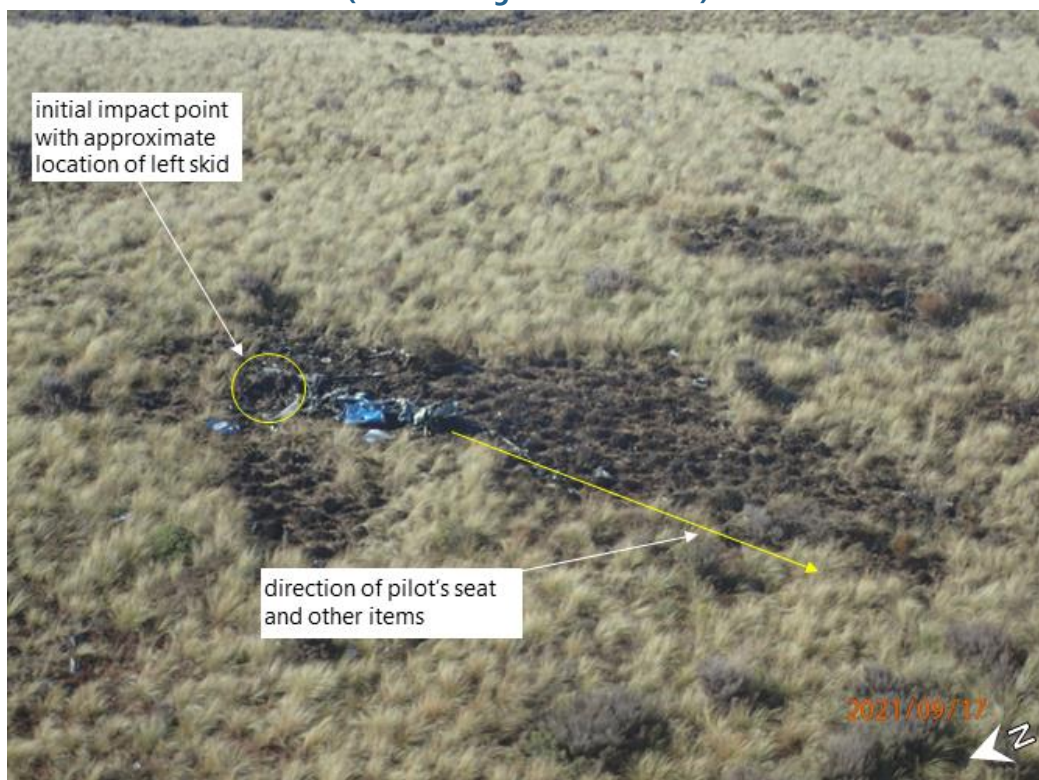
2.57. The impact of the helicopter removed the top layer of soil, leaving a small crater. The fuselage of the helicopter was lying next to the crater. The blades were still attached to the main rotor hub and were in the topsoil layer immediately in front of the nose impact point (see Figure 10). There were breakages in the Starflex™ main rotor hub and two of the three vibration damper springs were thrown clear of the wreckage.

Figure 8: Aerial view of main wreckage

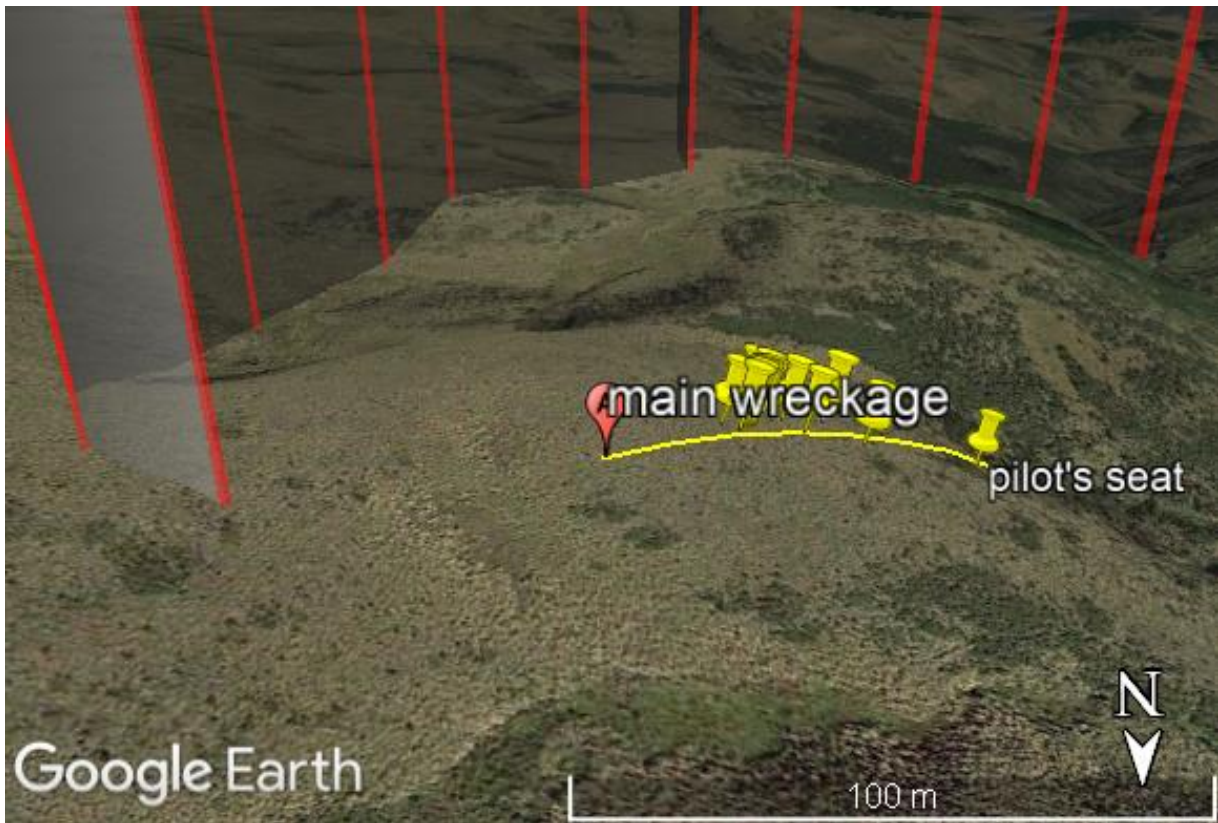
**Figure 9: Wreckage distribution
(about 130 m to pilot's seat)**

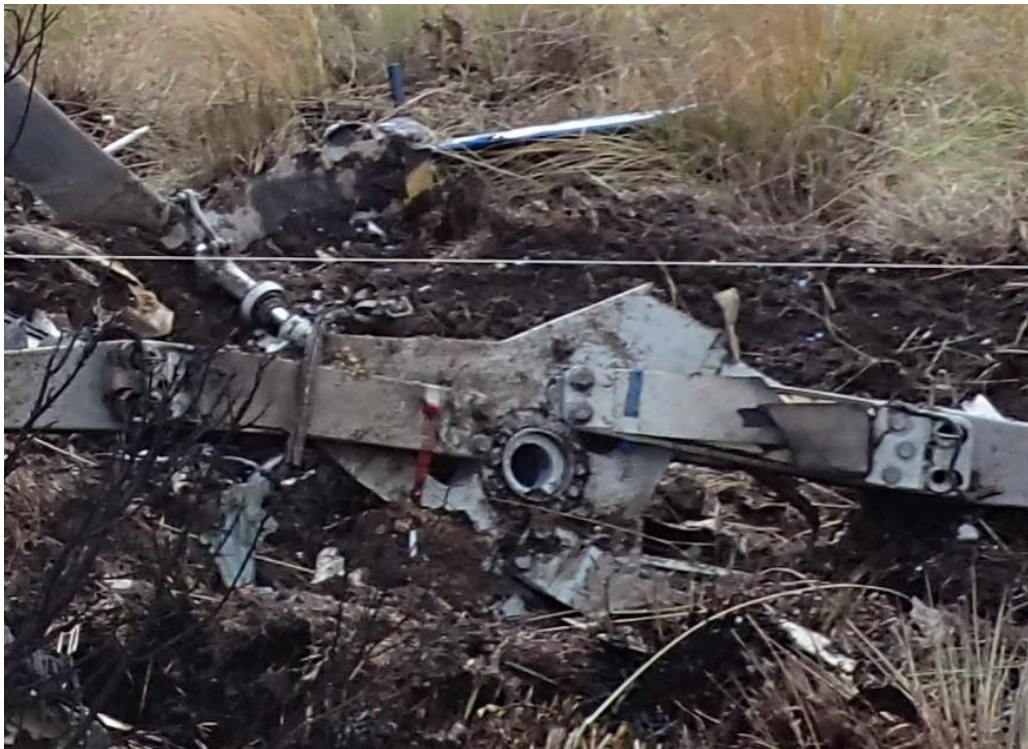
Figure 10: Main rotor hub with tail rotor in background

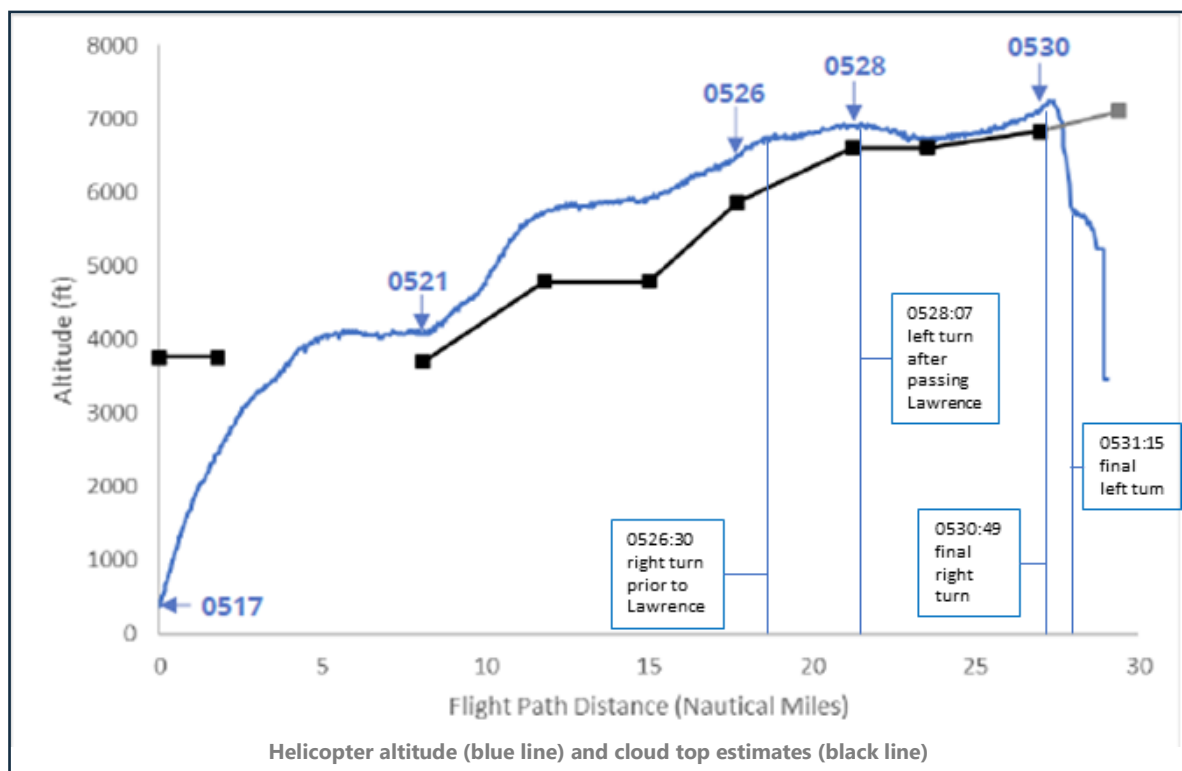
- 3.19. MetService observations and calculations relating to the weather conditions over Otago on 16 September 2021 detailed the sky was clear at the operator’s base at the time the helicopter departed. The first cloud would have been located about 8 nm (14 km) after departure, with the estimated cloud tops at about 3700 ft amsl, increasing in altitude to an estimated altitude of about 7100 ft amsl near the accident site (see Helicopter altitude (blue line) and cloud top estimates (black line))

Figure 11: Altitude of helicopter and cloud tops estimates along track

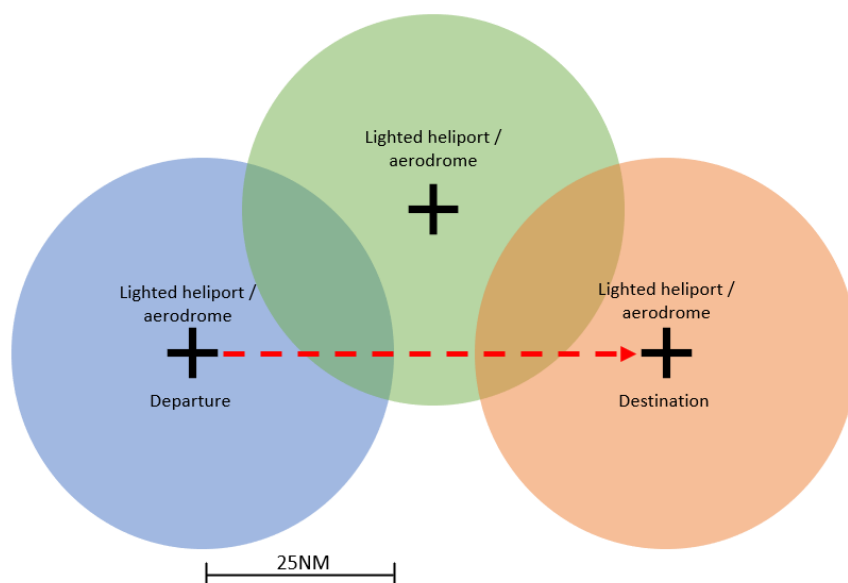
permitted to do. It is unclear whether such a pilot could transit from point A to point B provided they were always within 25 nm of any lighted heliport or aerodrome (ie, the departure and destination were within 50 nm). There is further ambiguity around whether a third intermediate lighted heliport or aerodrome could be used as a waypoint en route to facilitate even longer flights at night (see Figure 12).

Figure 12: Illustration of 25 nm restriction

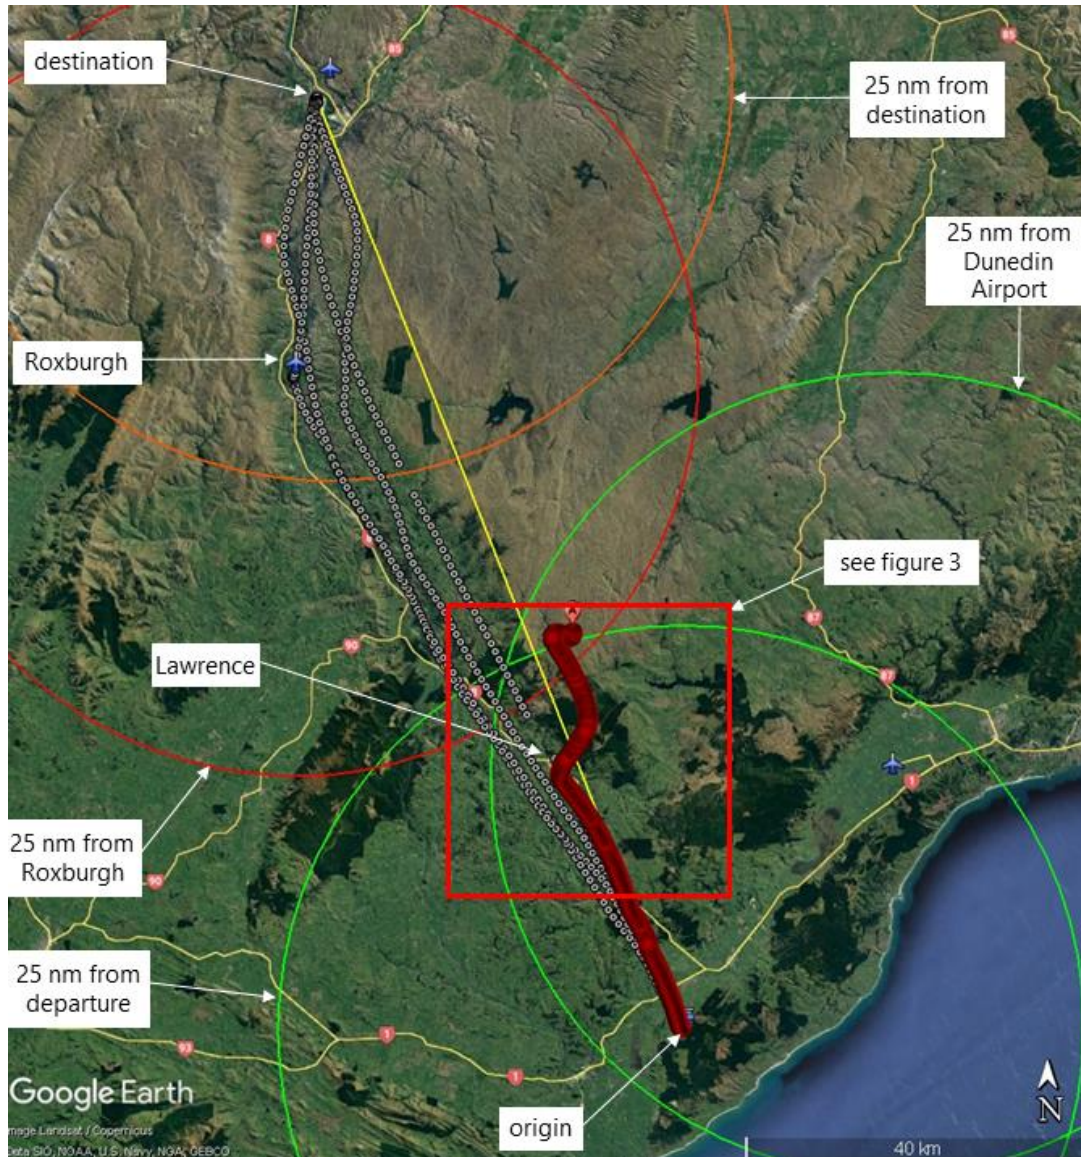
Figure 13: Flight path with 25 nm range rings
