# **Final Report**

***Aviation inquiry AO-2021-003***  
***Airbus Helicopters AS350 B3e, ZK-ITD***  
***Loss of control in flight***  
***Lammerlaw Range,***  
***40 km northwest of Dunedin Aerodrome***  
***16 September 2021***

**June 2025**

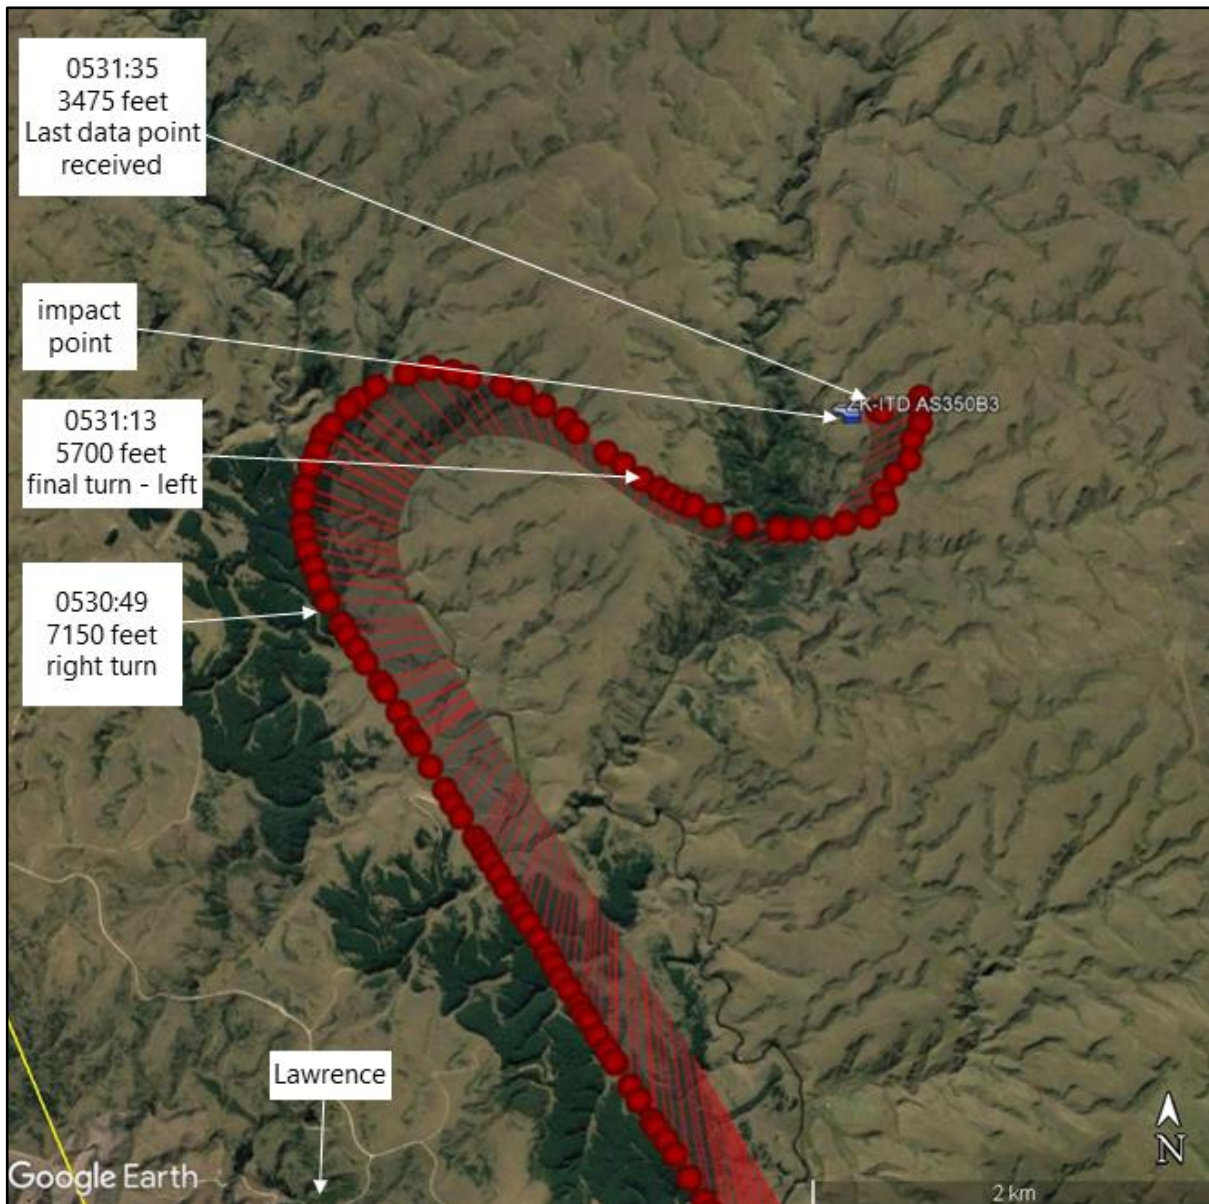
**Figure 4: Final minutes of the flight path**

- 2.3. The last ADS-B data point was received at 0531:35. At that time the helicopter was at an altitude of 3475 ft (1060 m) AMSL and on a track of 293° (see Figure 4). There were several data points recorded after this time; however, they were determined to be 'coasted'<sup>5</sup> data points and not from the helicopter. Moments later the helicopter struck the ground in a near vertical nose-down attitude, at an elevation of about 2430 ft (740 m). See Figure 5 for the flight timeline, with altitude and airspeed.

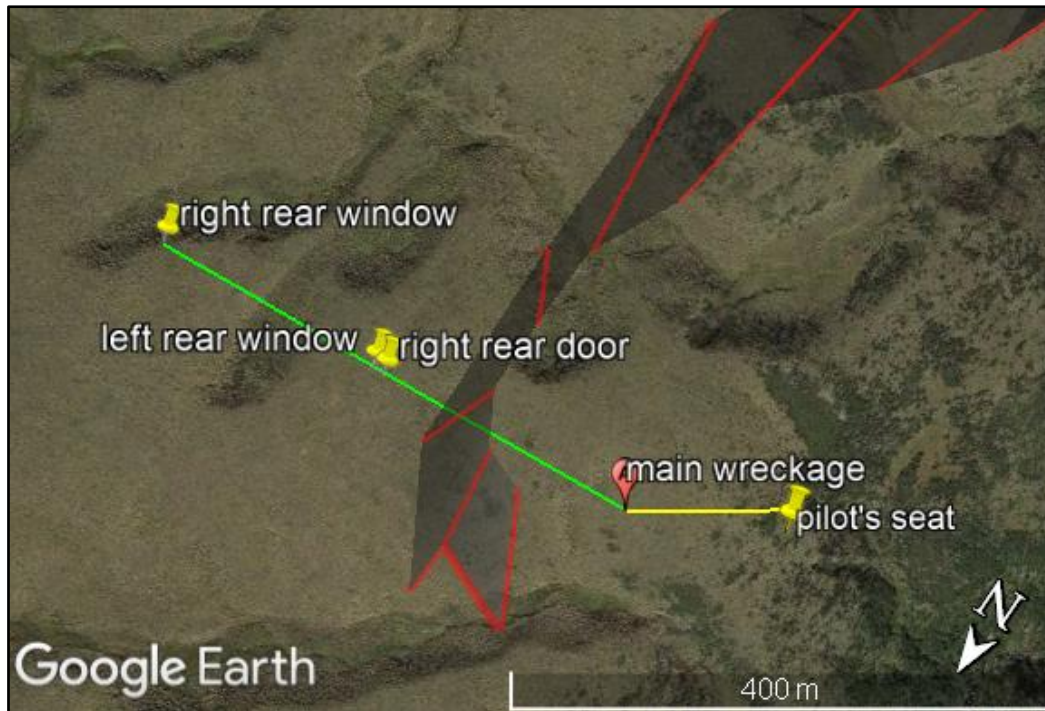
**Figure 7: Location of main wreckage relative to rear door and windows  
(340 m to right rear window)**

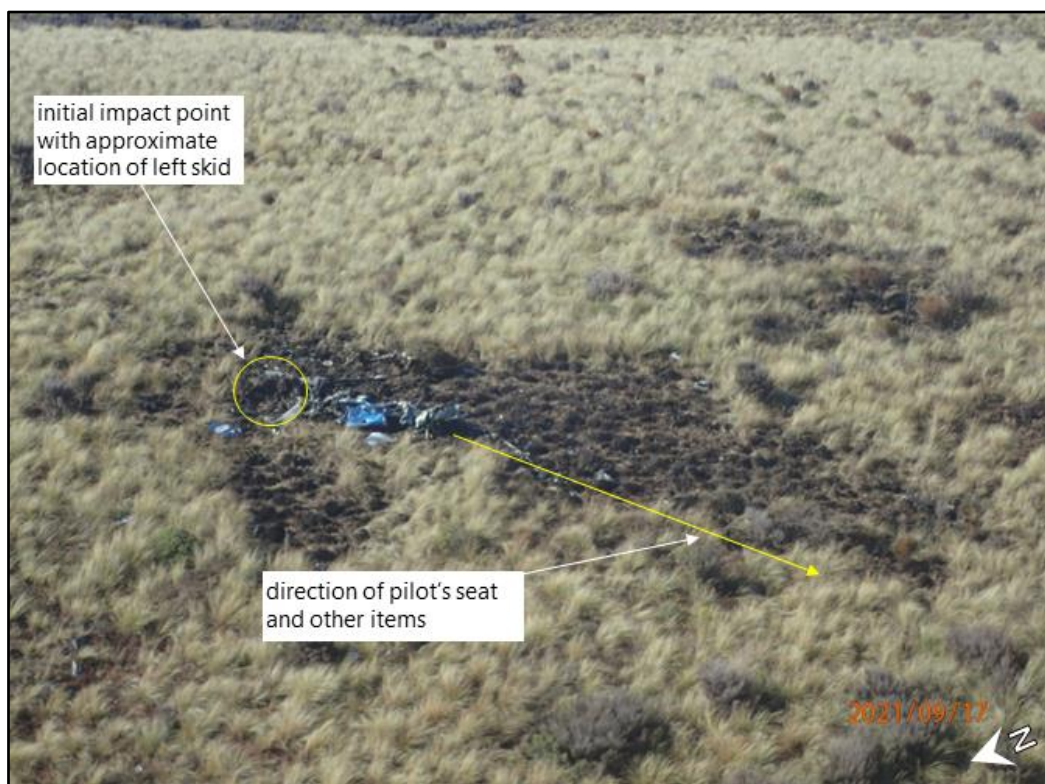
**Figure 8: Aerial view of main wreckage**

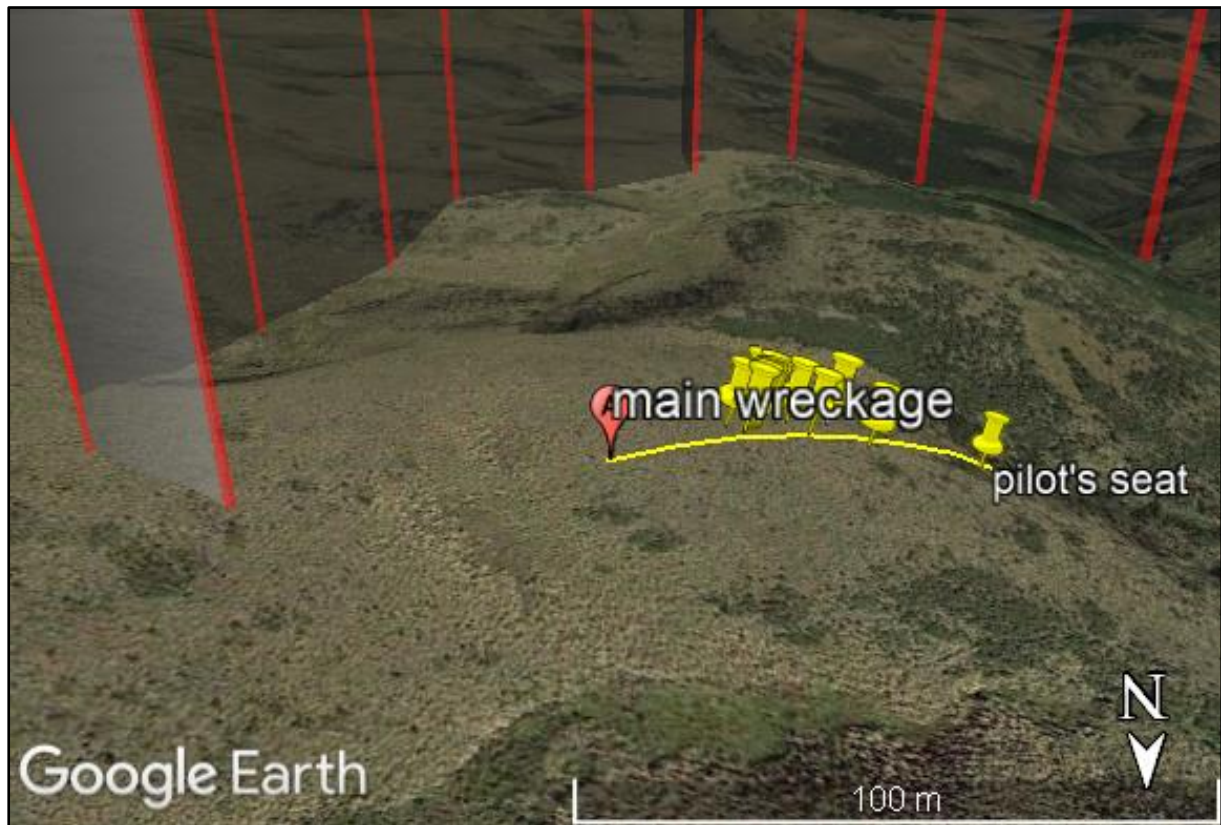
- 2.58. The rear section of the tail boom<sup>24</sup>, including the tail rotor and tail rotor gearbox were largely intact with damage consistent with the impact forces, and located to the north of the initial impact point.

**Figure 9: Wreckage distribution (about 130 m to pilot's seat)**

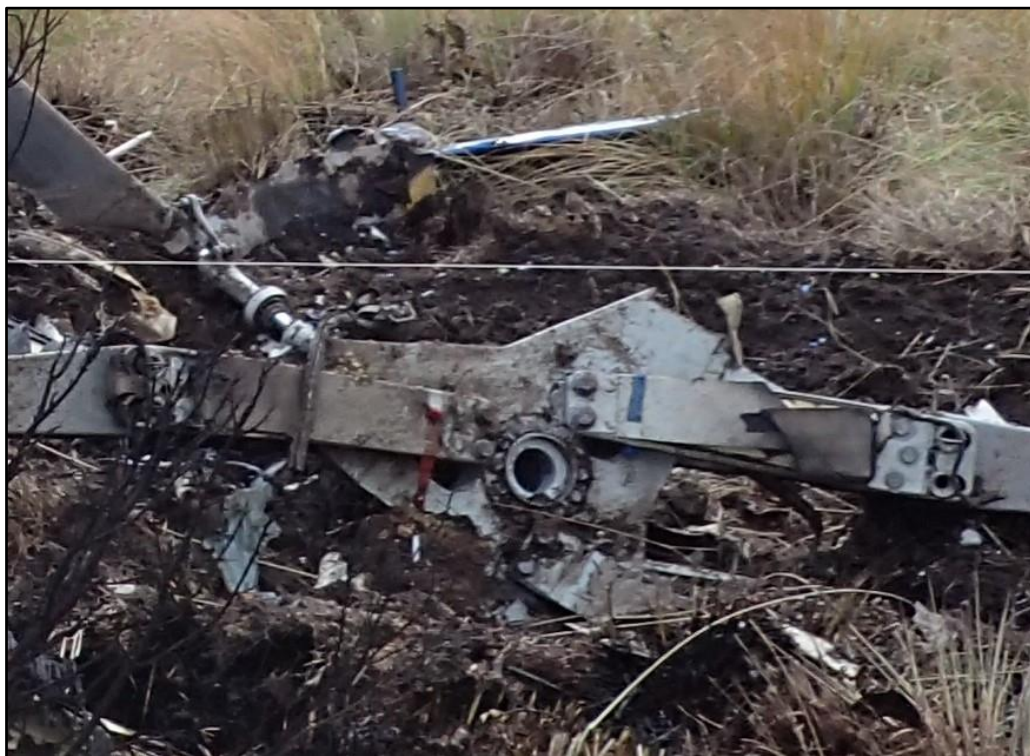
**Figure 10: Main rotor hub with tail rotor in background**

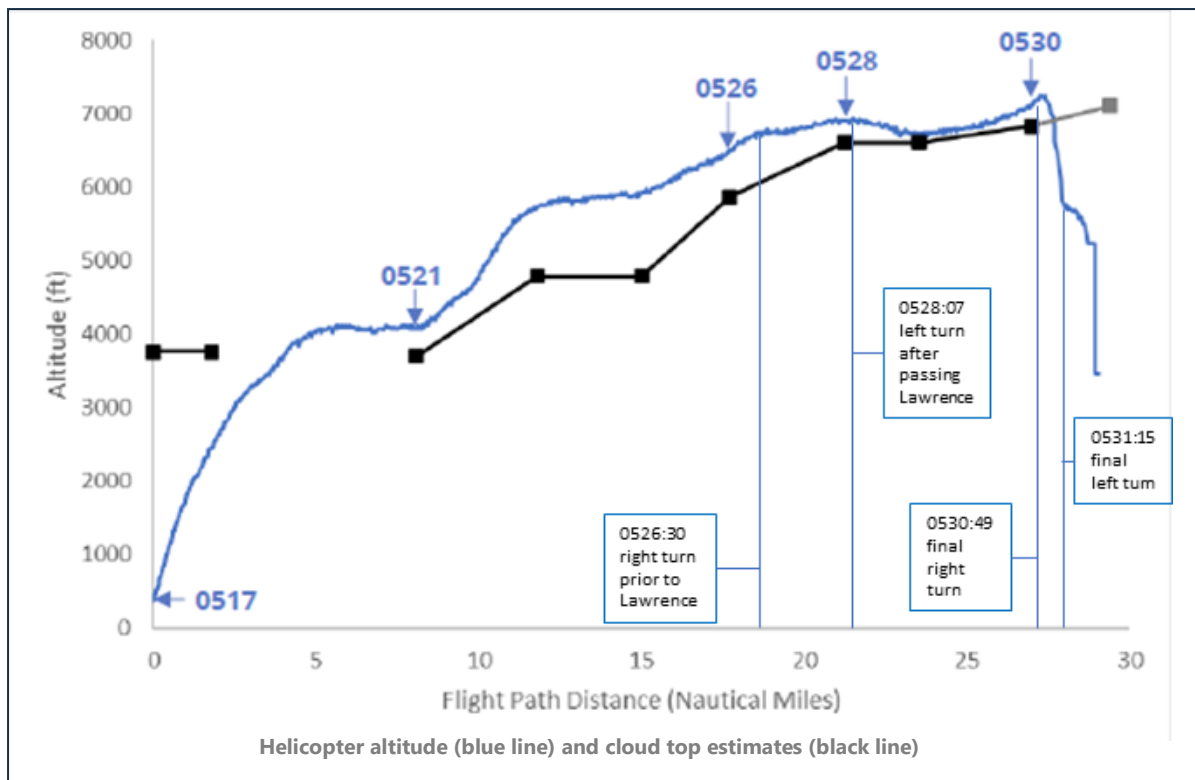
**Figure 11: Estimated altitude of helicopter and cloud tops along track**
